ASPHALT RUBBER – EXPERIENCE & SPECIFICATION DEVELOPMENT

Pavement Management Engineer

MassDOT – Highway Division

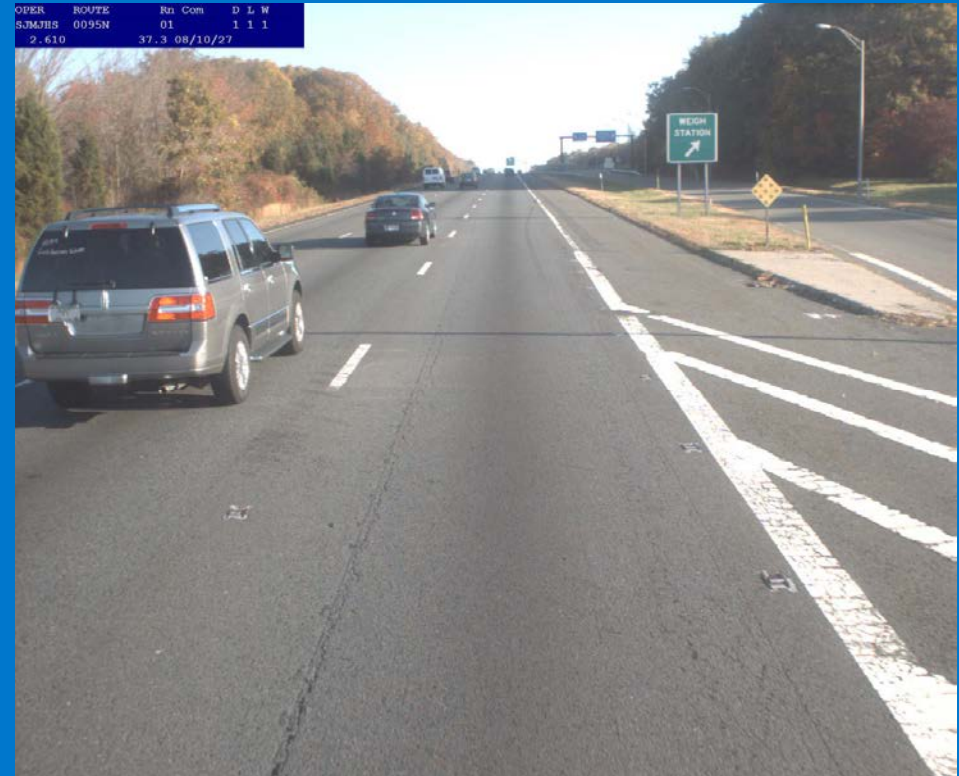
I-95 Attleboro “Before”

- I-95 Attleboro (2008)
- 4.57± miles (37.56 lane miles)
- 3 lanes + Breakdown lane & Shoulder
- Distress
 - Ravelling & Weathering OGFC
 - Delamination & Thermoplastic
 - Longitudinal Joints & Plow Damage
- Rehab
 - Micromill & 1.25” ARGG Thin Overlay
- Bid \$3,022,045.35
 - Clearing & Grubbing
 - Frames/Grates (lockdowns)
 - Guardrail repairs & Safety items
 - Traffic Control, Striping, etc.
- Cost \$82.6K/lane mile

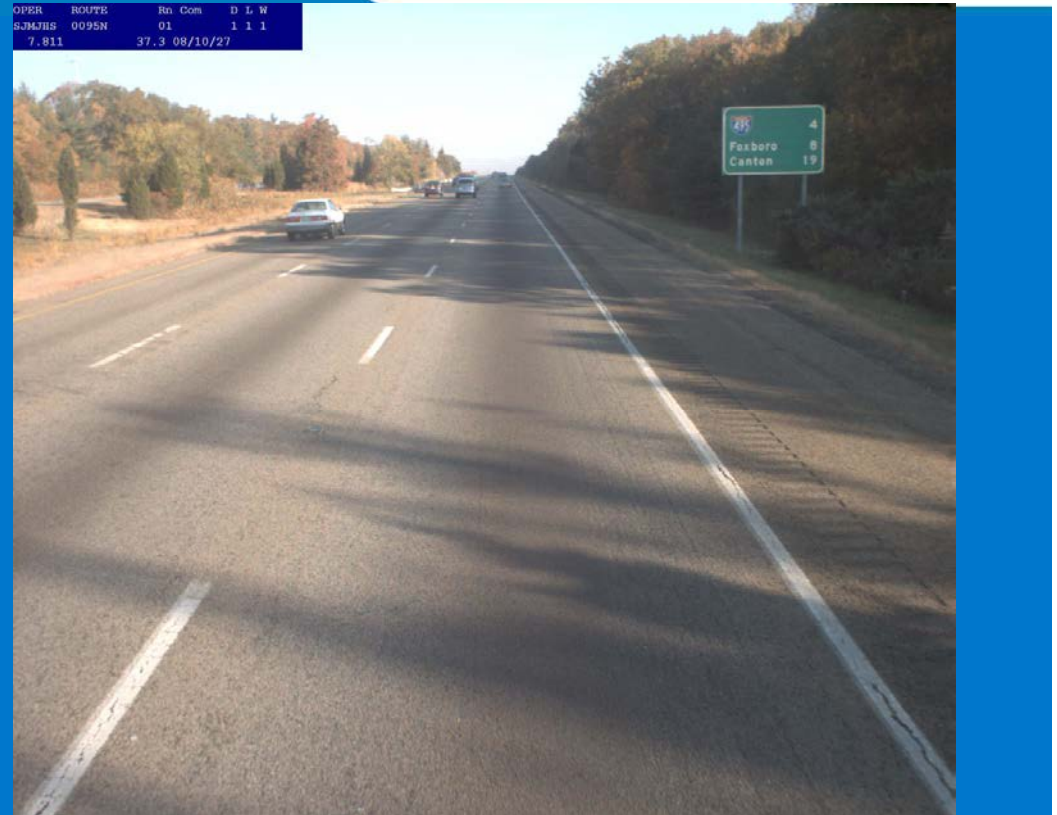
I-95 North Attleboro – Foxboro “Before”

- I-95 North Attleboro-Foxboro (2008)
- 6.39± miles (51.12 lane miles)
- 3 lanes + Breakdown & Shoulder
- Distress
 - Ravelling & Weathering OGFC
 - Delamination & Thermoplastic
 - Longitudinal Joints & Plow Damage
- Rehab
 - Micromill & 1.25" ARGG Thin Overlay
- Bid \$6,008,093.25
 - Bridge Repairs, ramp & interchanges (\$0.9M)
 - Clearing & Grubbing
 - Frames/Grates (lockdowns)
 - Guardrail repairs & Safety items
 - Traffic Control, Striping, etc.
- Cost \$ 117.5K/lane mile

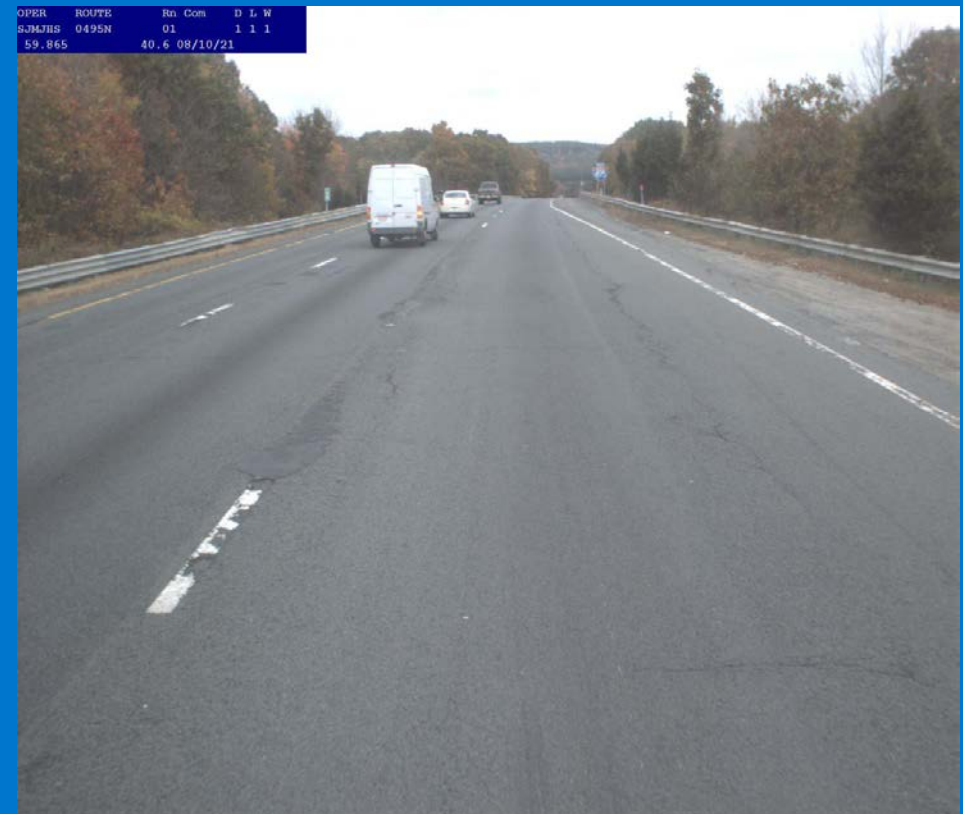
I-495N Milford – Southborough “Before”

- I-495N Milford - Southboro (2008)
- 11.12± miles (44.48 lane miles)
- 3 lanes + Breakdown & Shoulder
- Distress
 - Ravelling & Weathering OGFC
 - Delamination & Thermoplastic
 - Longitudinal Joints & Plow Damage
 - Structural Cracking north of I-90
- Rehab
 - Micromill & 1.25" ARGG Thin Overlay
 - Added 1.75" pavement structure north of I-90
- Bid \$4,800,781.00
 - Clearing & Grubbing
 - Frames/Grates (lockdowns)
 - Traffic Control, Striping, etc.
- Cost \$ 107.95K/lane mile

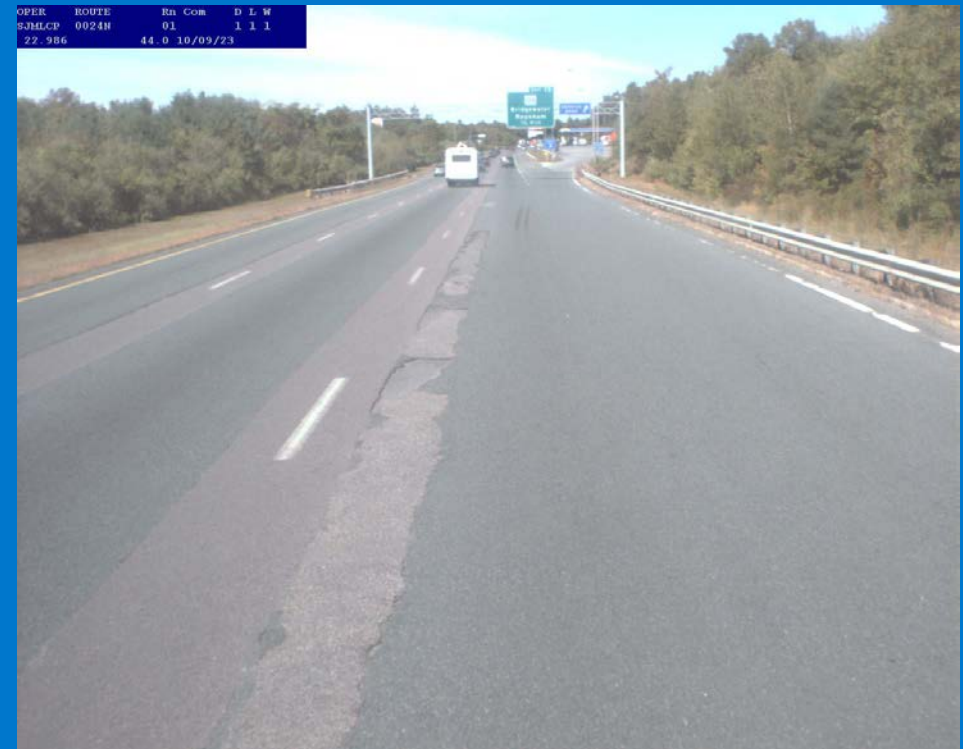
Rt 24 Brockton – Raynham

- 12.38± miles (99.04 lane miles)
- 3 lanes + Breakdown & Shoulder
- Distress
 - Ravelling & Weathering OGFC
 - Delamination & Thermoplastic
 - Extensive temporary patching
 - Structural Cracking at bridges only!
- Rehab
 - Micromill & 1.25" ARGG Thin Overlay
 - Added 2" pavement structural inlay at bridge approaches.
- Bid \$12,275,737.50
 - Extensive Bridge Work
 - Clearing & Grubbing
 - Frames/Grates (lockdowns)
 - Traffic Control, Striping, etc.
 - Major Interchange work at I-495.
- Cost \$ 123.9K/lane mile

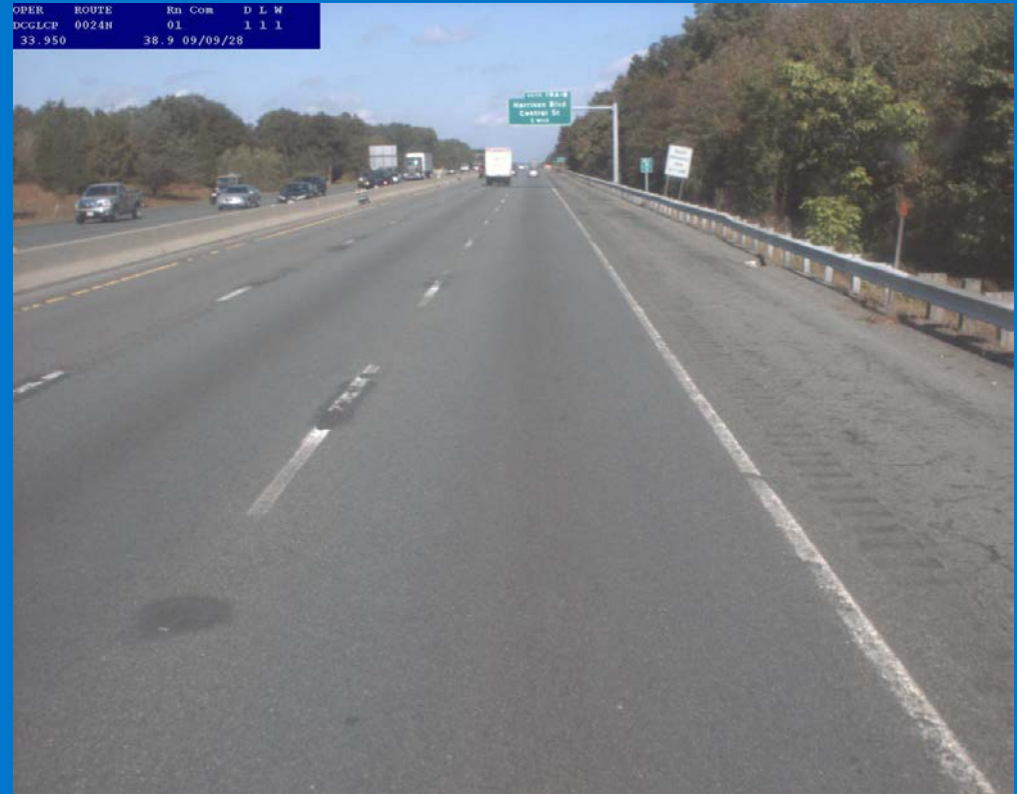
RT 24 Avon Stoughton “Before”

- 4.02± miles (31.16 lane miles)
- 3 lanes + Breakdown & Shoulder
- Distress
 - Ravelling & Weathering OGFC
 - Delamination & Thermoplastic
 - Thermoplastic markings gone
- Rehab
 - Micromill & 1.25" ARGG Thin Overlay
- Bid \$4,349,096.25
 - Bridge Patching & Repairs
 - Clearing & Grubbing
 - Frames/Grates (lockdowns)
 - Traffic Control, Striping, etc.
 - Guardrail repairs & interchanges.
- Cost \$ 139.5K/lane mile

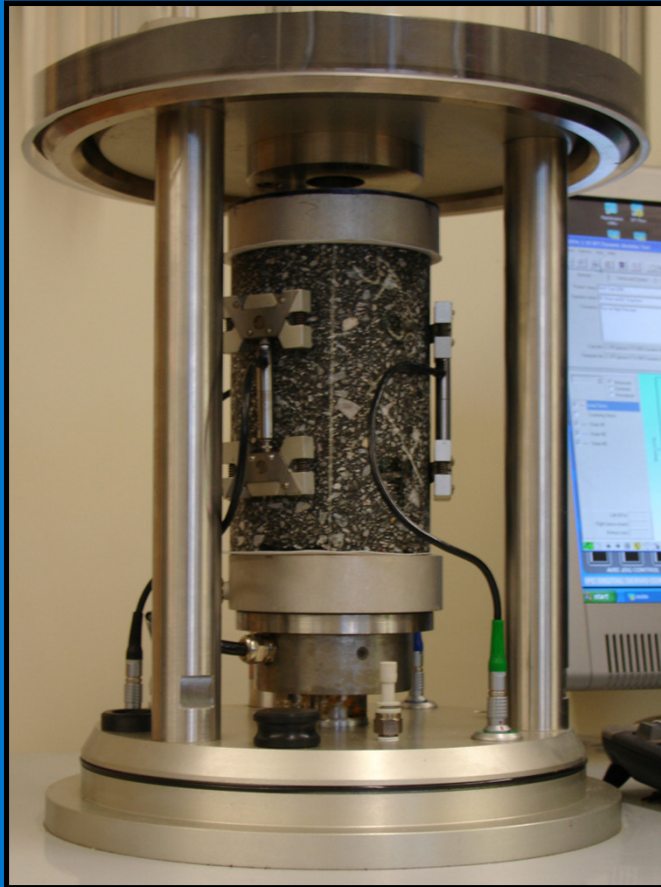
Conducted to determine changes in mixture stiffness due to the incorporation of RAP and/or WMA Technology.

AASHTO TP62 in Asphalt Mixture
Performance Tester
(AMPT)

Temperature	Frequency
4°C	10 Hz, 1Hz, 0.1Hz
20°C	10 Hz, 1Hz, 0.1Hz
40°C	10 Hz, 1Hz, 0.1Hz, 0.01Hz

Specimens were fabricated at a target air void level of $7.0 \pm 1.0\%$.

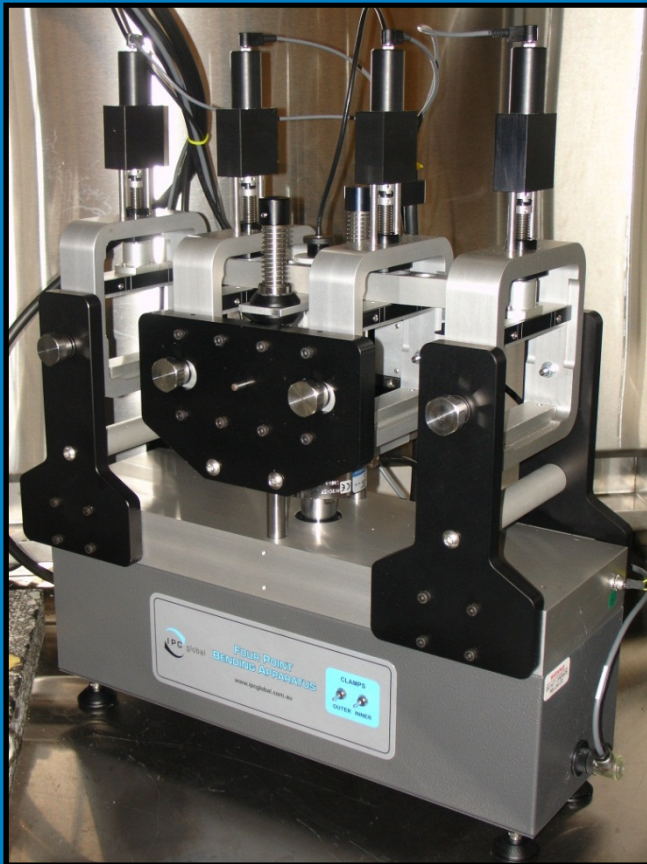
Fatigue – Four Point Bending Beam

Testing in Accordance with
AASHTO T321

- Specimens were fabricated at a target air void level of $7.0 \pm 1.0\%$
- Testing conducted in strain control mode
- Loading Frequency = 10Hz
- Sinusoidal Wave Form
- Failure Criteria = 50% reduction in initial stiffness per AASHTO T321 method

Temperature	Strain Levels
15°C (59°F)	300 $\mu\epsilon$, 500 $\mu\epsilon$, 700 $\mu\epsilon$ & 900 $\mu\epsilon$

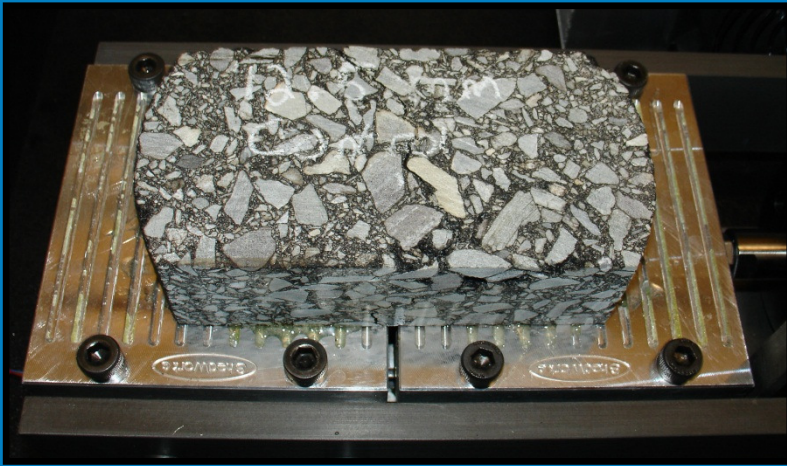
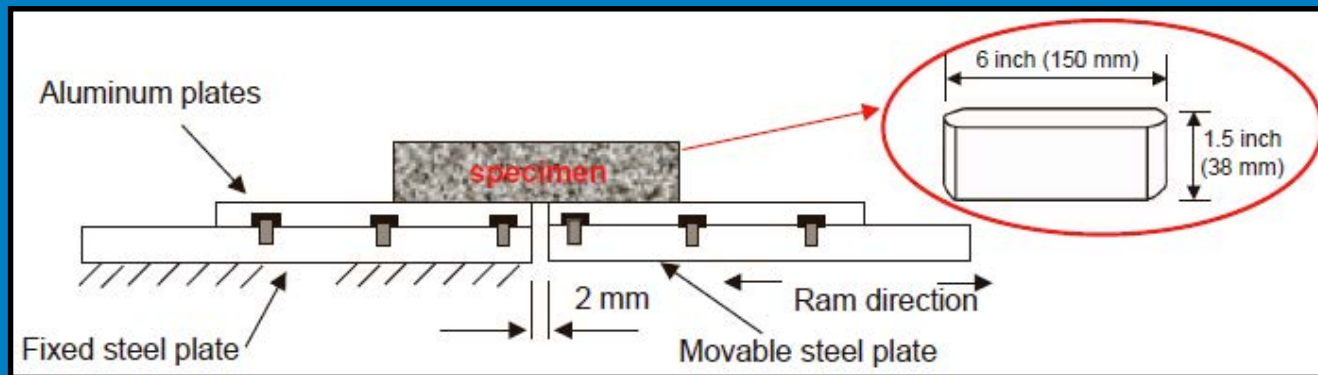
Reflective Cracking – +Overlay Tester

- Test Temperature = 15°C (59°F)
- Test Termination at 1,200 cycles or 93% Load reduction
- Testing in accordance with Tex-248-F

Diagram from: Zhou et al. "Overlay Tester: Simple Performance Test for Fatigue Cracking" Transportation Research Record: Journal of the Transportation Research Board, No. 2001, Transportation Research Board of the National Academies, Washington, D.C., 2007, pp. 1–8.

- The reflective cracking resistance of the mixture decreased with the incorporation of higher amounts of RAP. The same trend was apparent when WMA was incorporated.
- Generally, the OT data agreed with the results of the beam fatigue which showed a reduced cracking resistance for the mixture incorporating WMA.

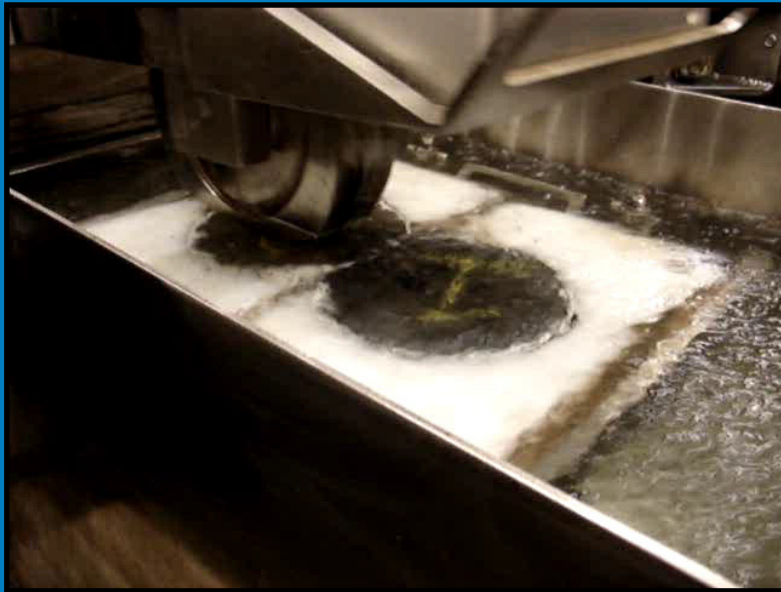
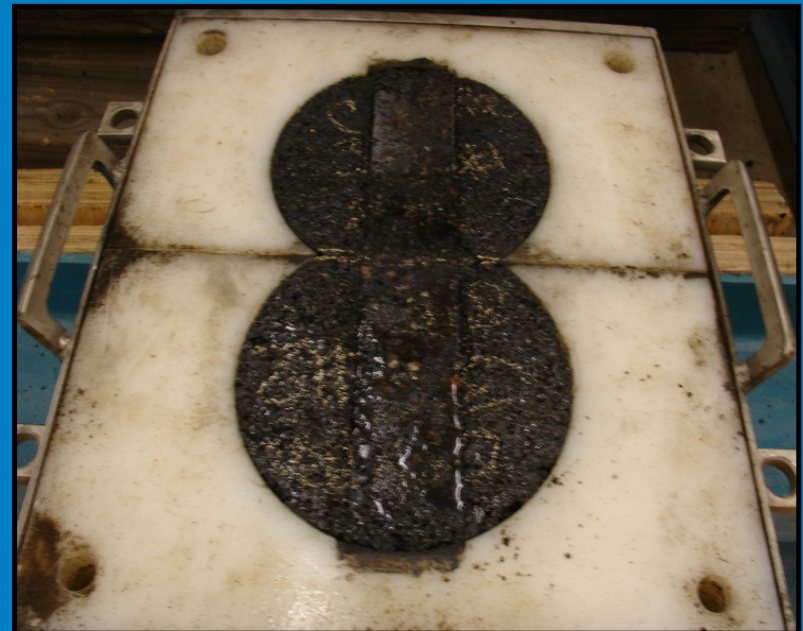
Hamburg Wheel Tracking Device (HWTd)

- HWTd testing conducted in accordance with AASHTO T324

- Water temperature of 50°C (122°F) during testing
- Test duration of 20,000 cycles

- All mixtures evaluated passed the moisture susceptibility testing in the HWTD.
- The magnitude of the average total rut depth observed at the end of each test was less than 1.10 mm (0.043 inch).

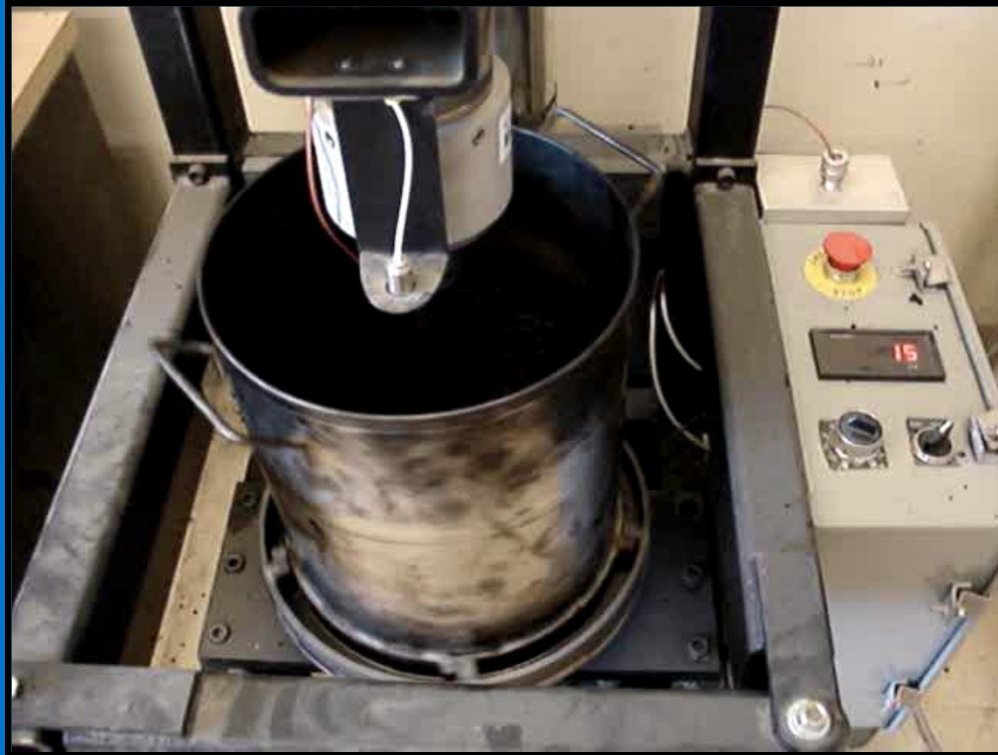
UMass Dartmouth AWD

- Mixture workability evaluation was conducted to determine the impact of RAP, AR and/or WMA on mixture workability.
- Workability evaluation was conducted using prototype device designed and built by UMass Dartmouth known as the Asphalt Workability Device (AWD).
- The AWD operates on the torque measurement principles.

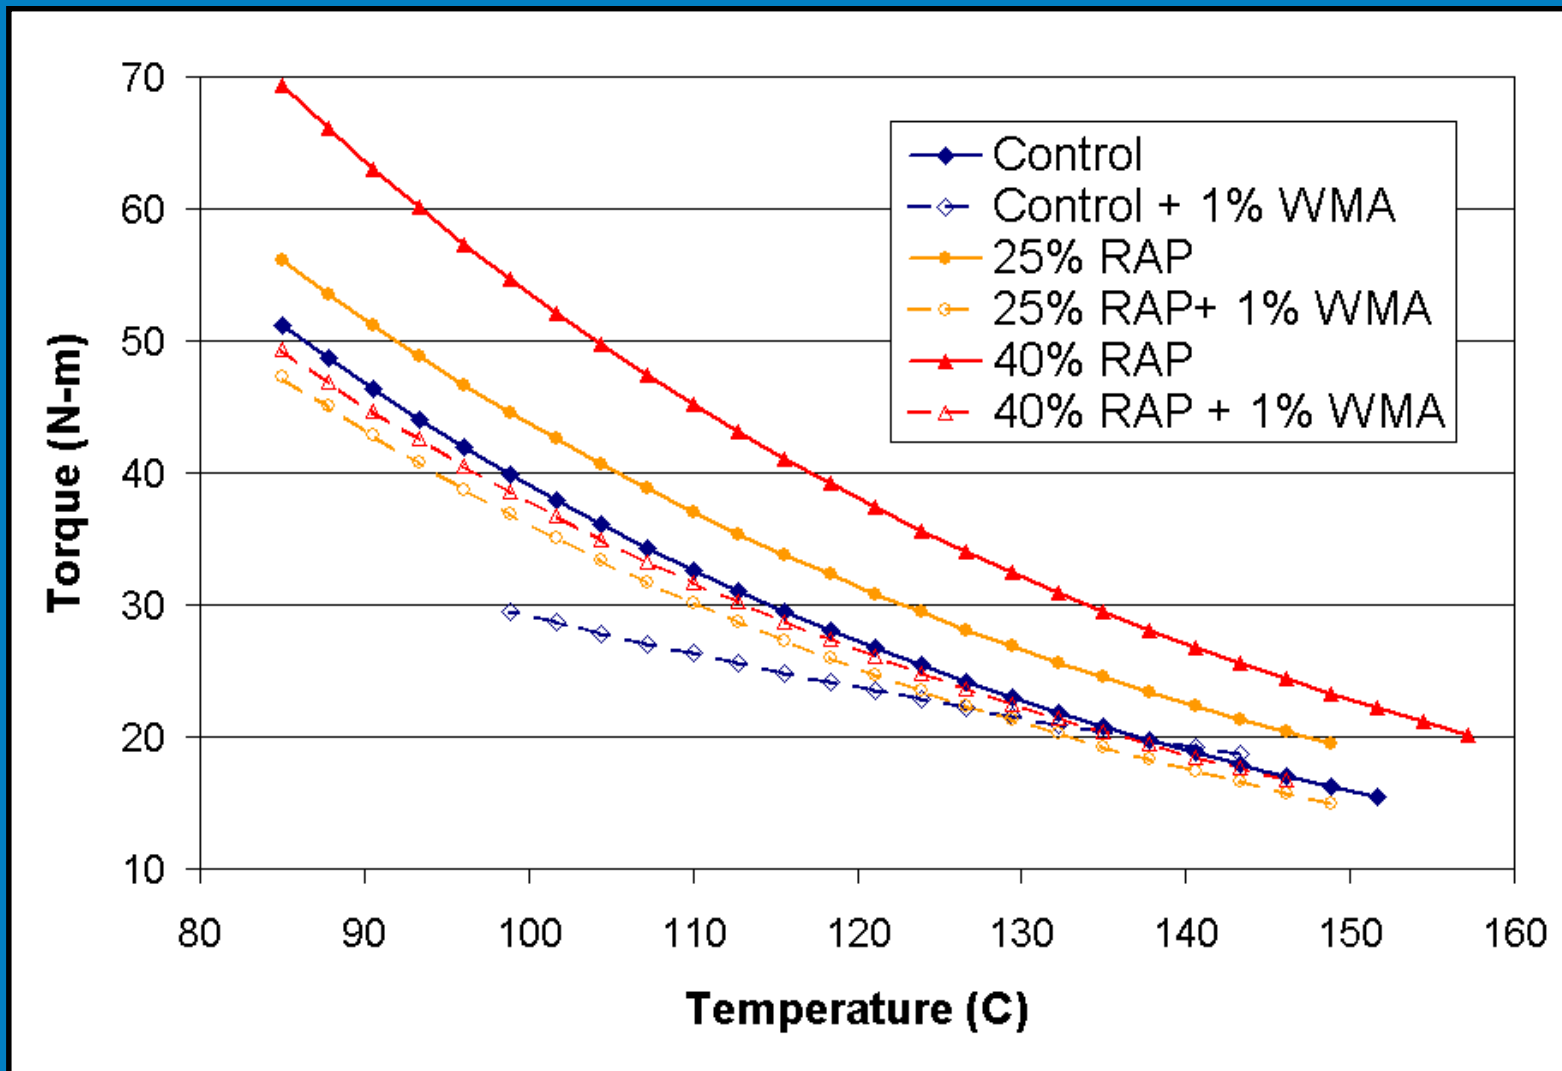
Workability Results

- Mixtures without the WMA technology showed that as the amount of RAP incorporated into the mixture was increased there was a corresponding decrease in mixture workability (i.e. increase in torque).
- Overall, the addition of the WMA improved the workability of the mixtures with RAP to a level similar to the control mixture without RAP and WMA.

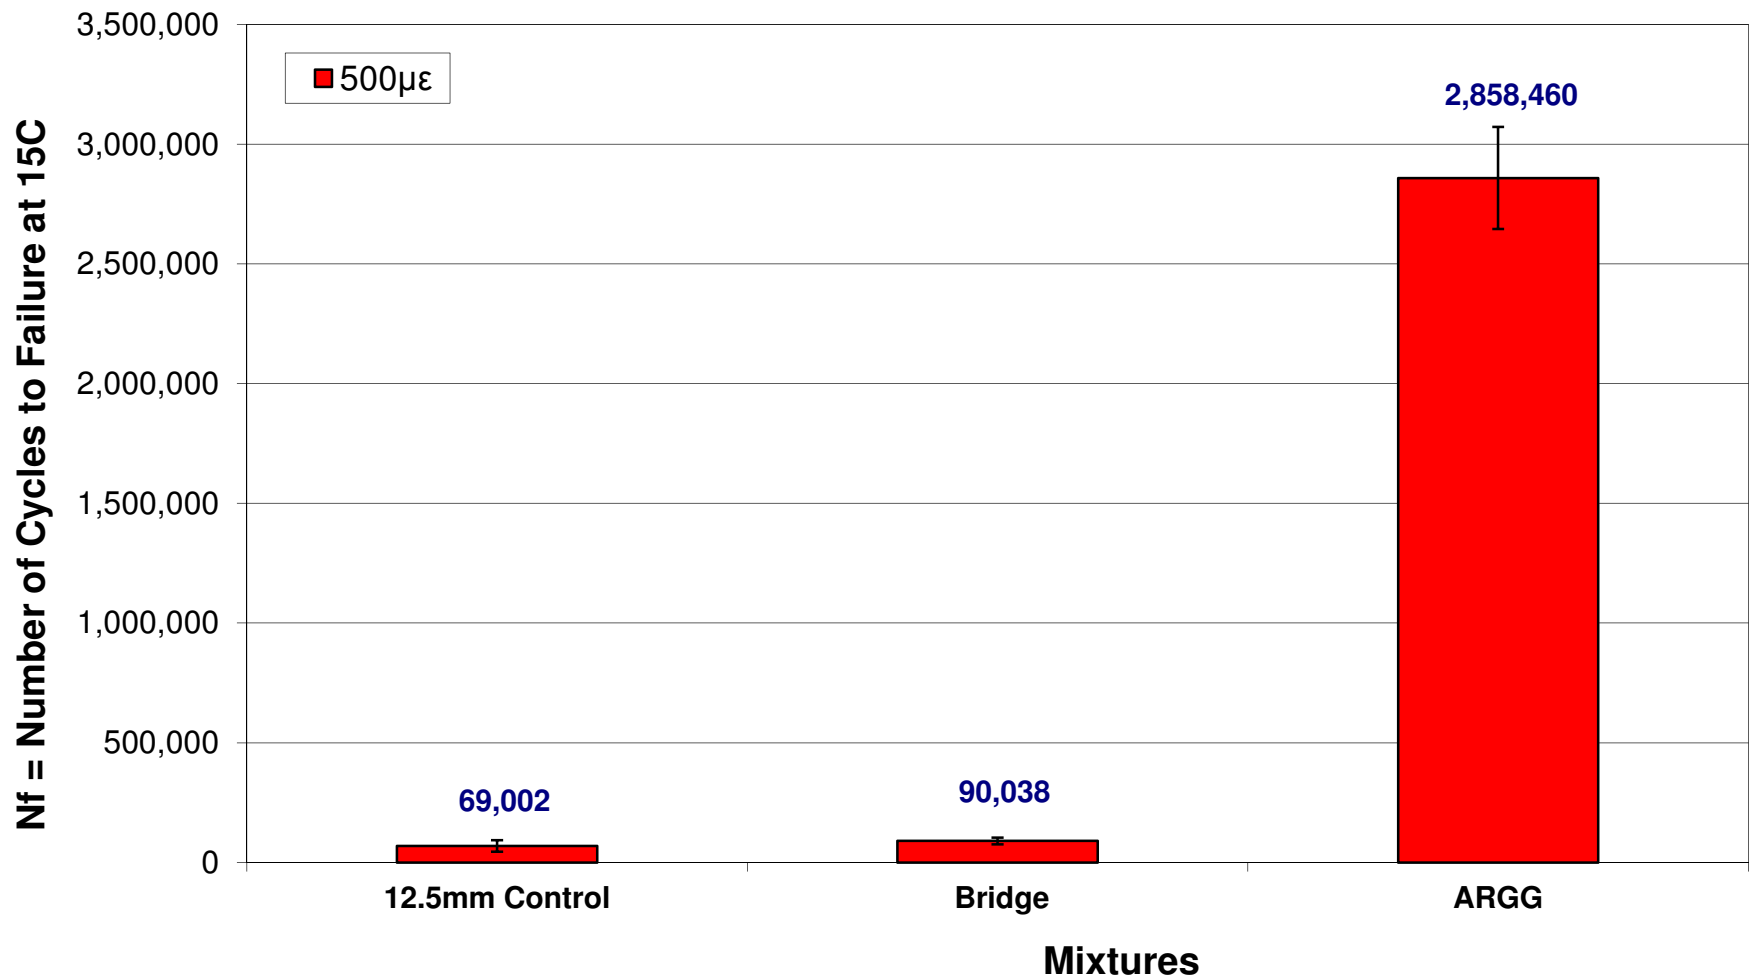
Beam Fatigue (500 μ strain)

AASHTO T321 Beam Fatigue Nf to 50% Reduction in Initial Stiffness

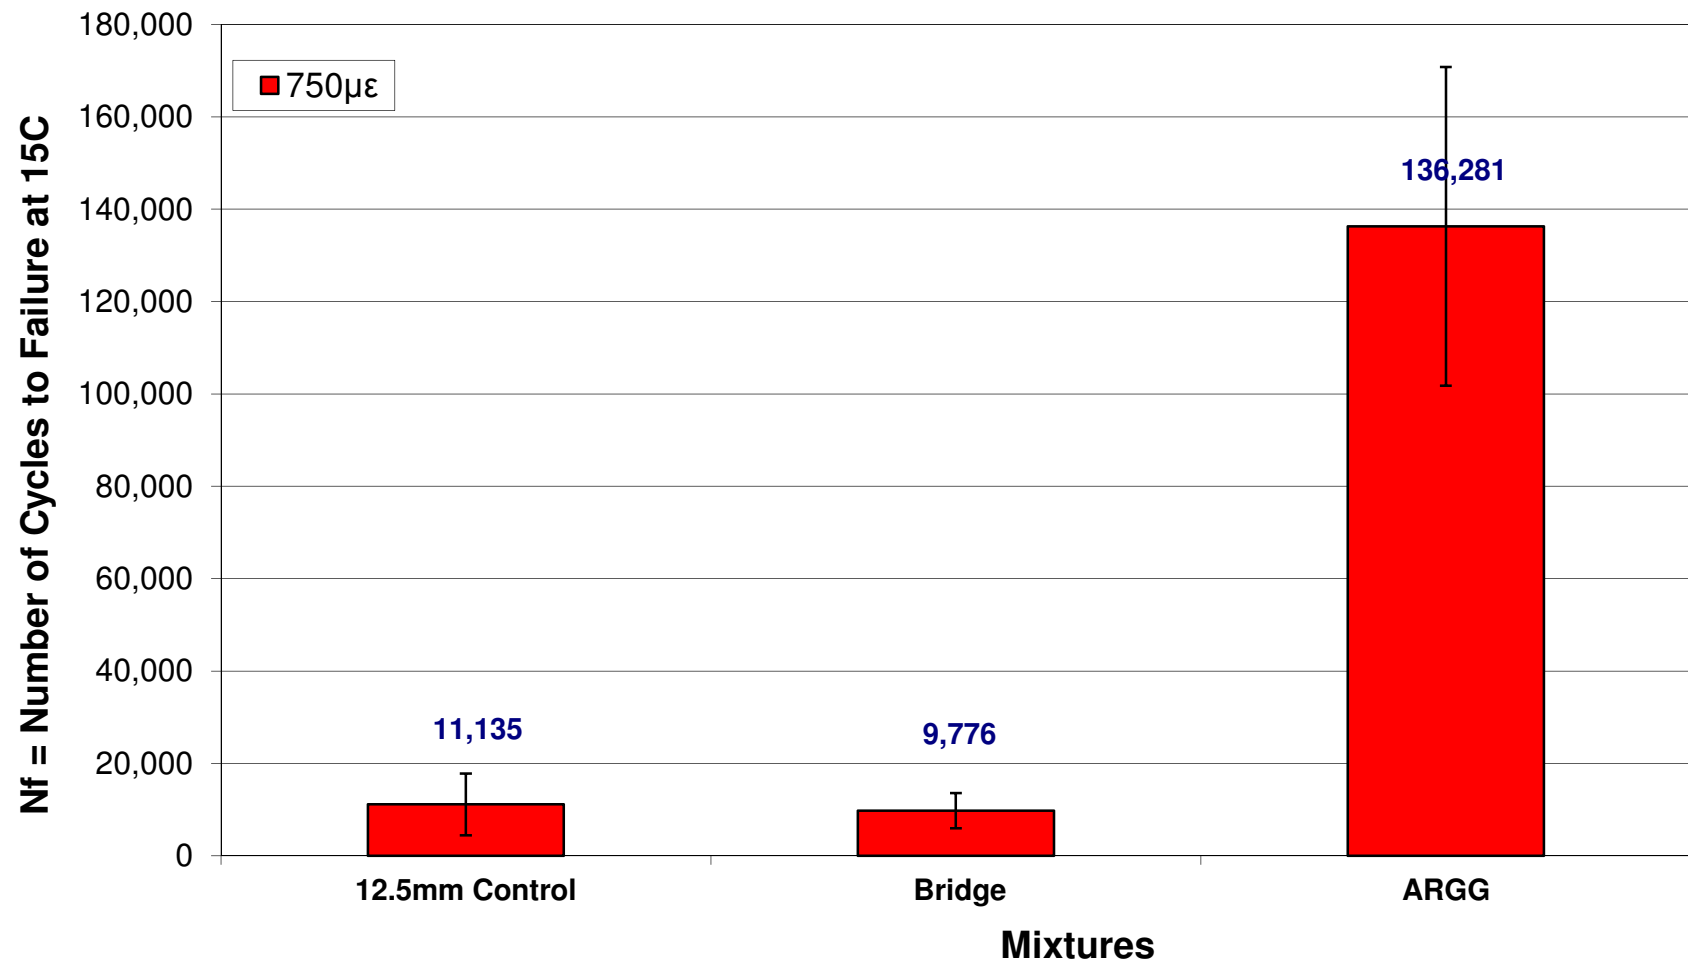
Plant Mix Beam Fatigue (750 μ strain)

AASHTO T321 Beam Fatigue Nf to 50% Reduction in Initial Stiffness

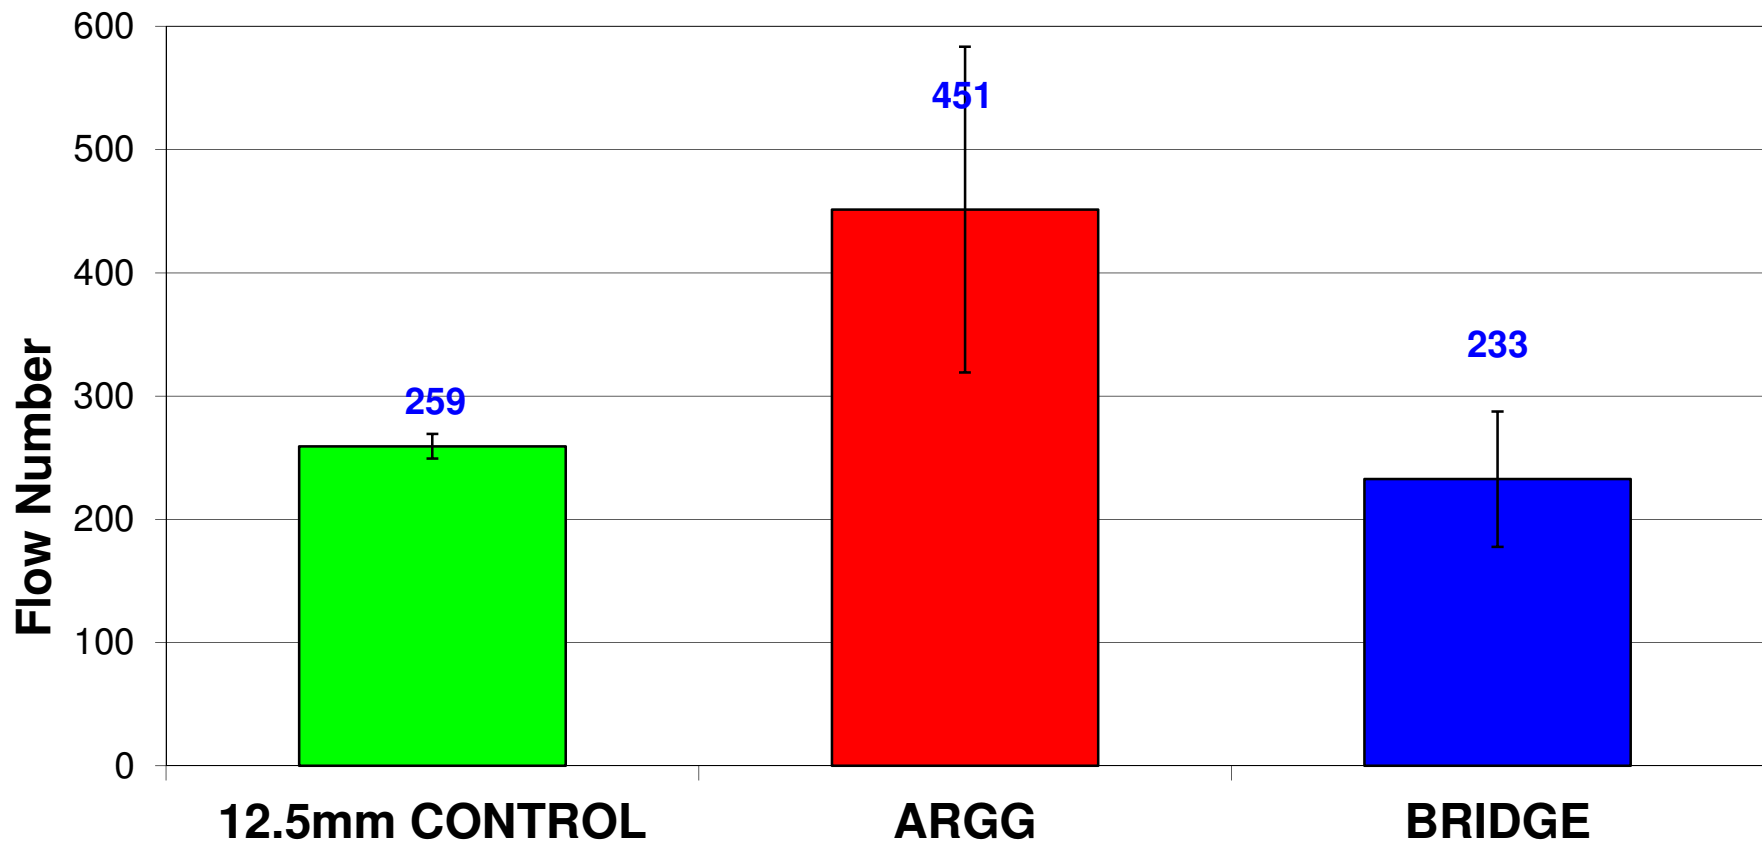
Plant Mix Flow Number

Flow Number - AASHTO TP79 - 50°C 600 kPa Deviator Stress
MassDOT Control vs ARGG vs BRIDGE

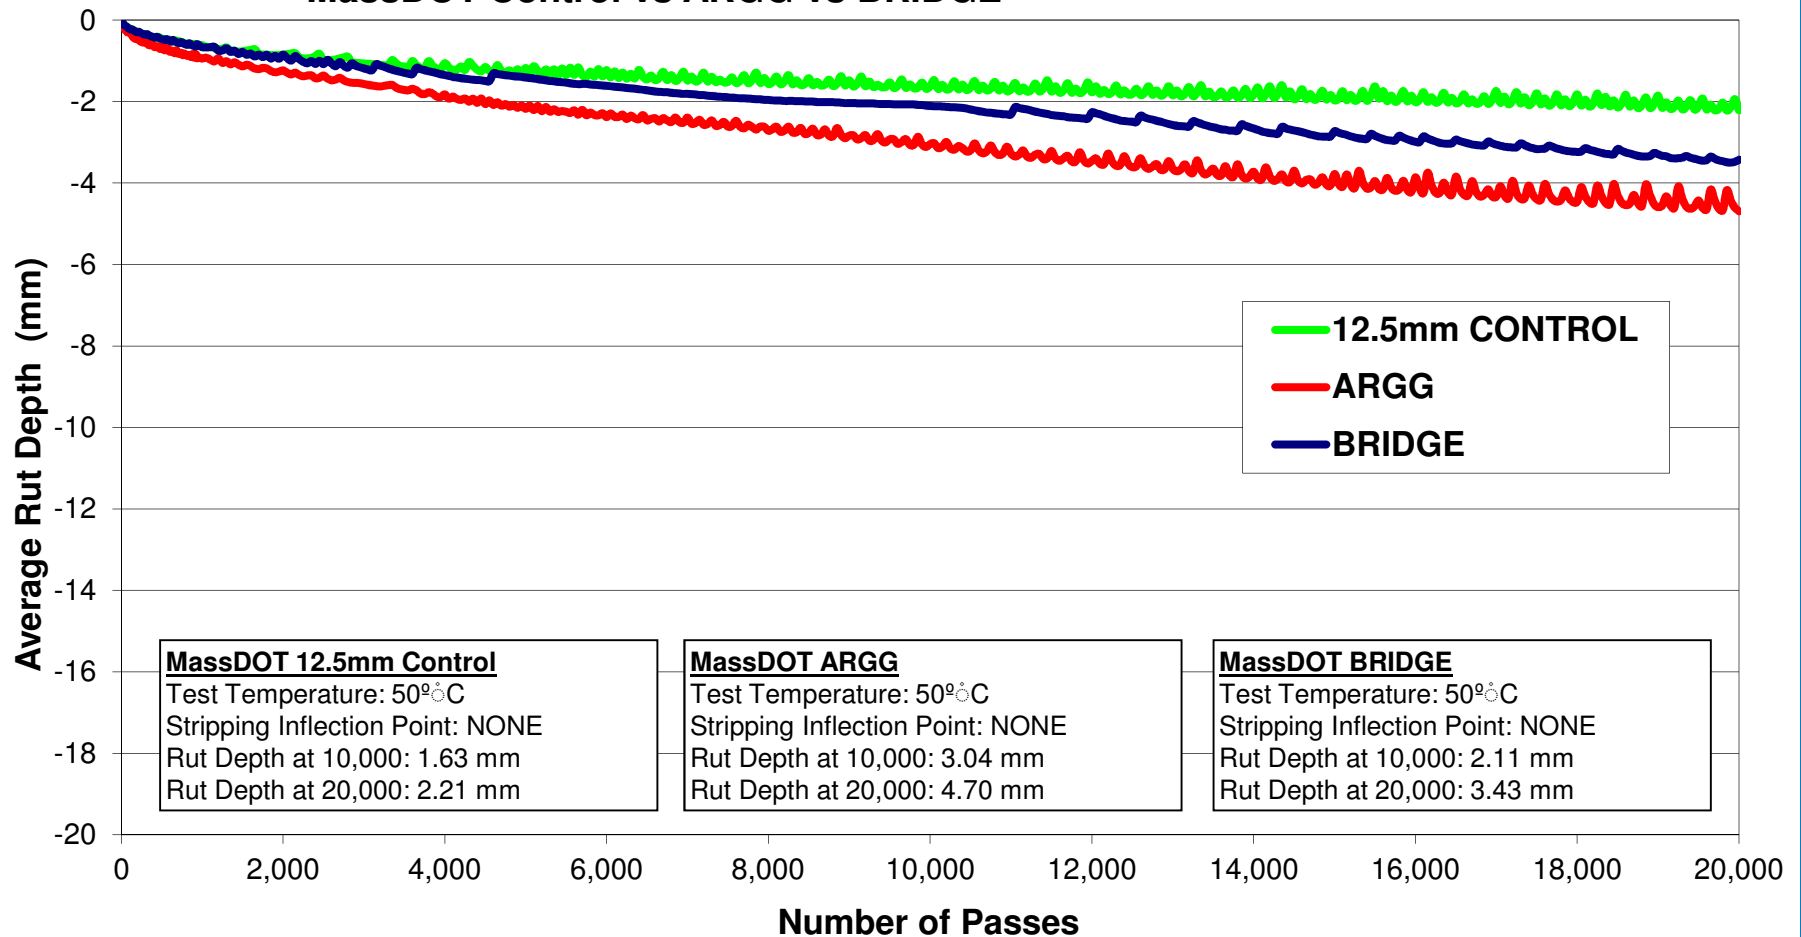
Plant Mix Hamburg Wheel Testing

AASHTO T324 Hamburg Results
MassDOT Control vs ARGG vs BRIDGE

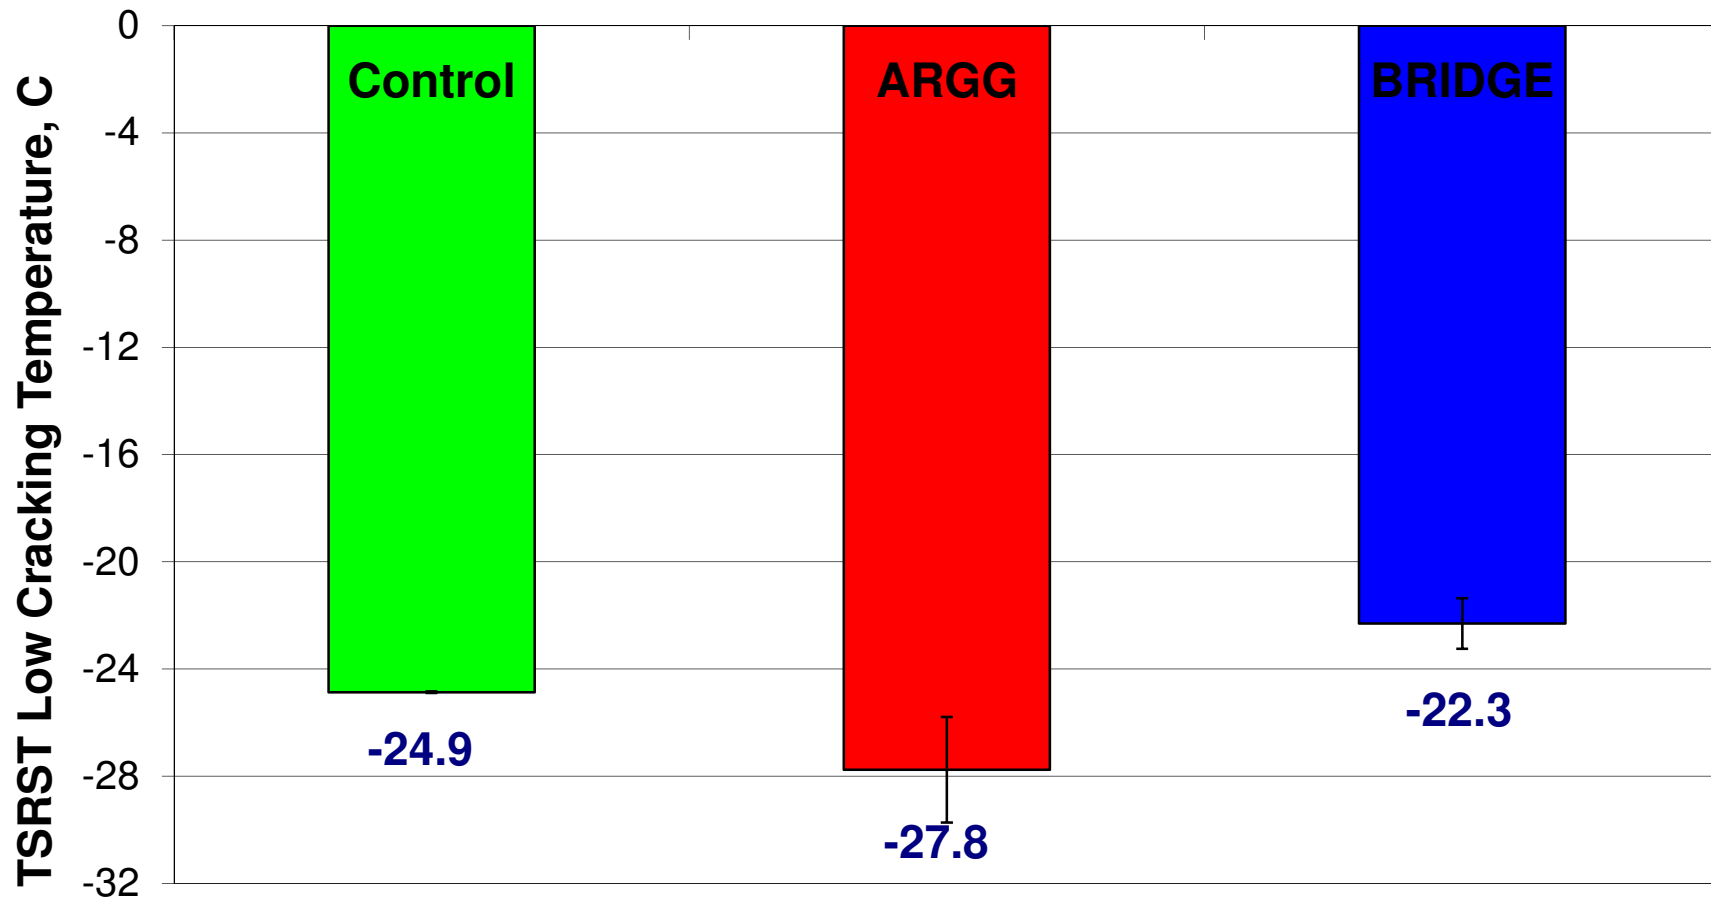
Plant Mix TSRST Results

TSRST Results - AASHTO TP10

MassDOT Control vs ARGG vs BRIDGE

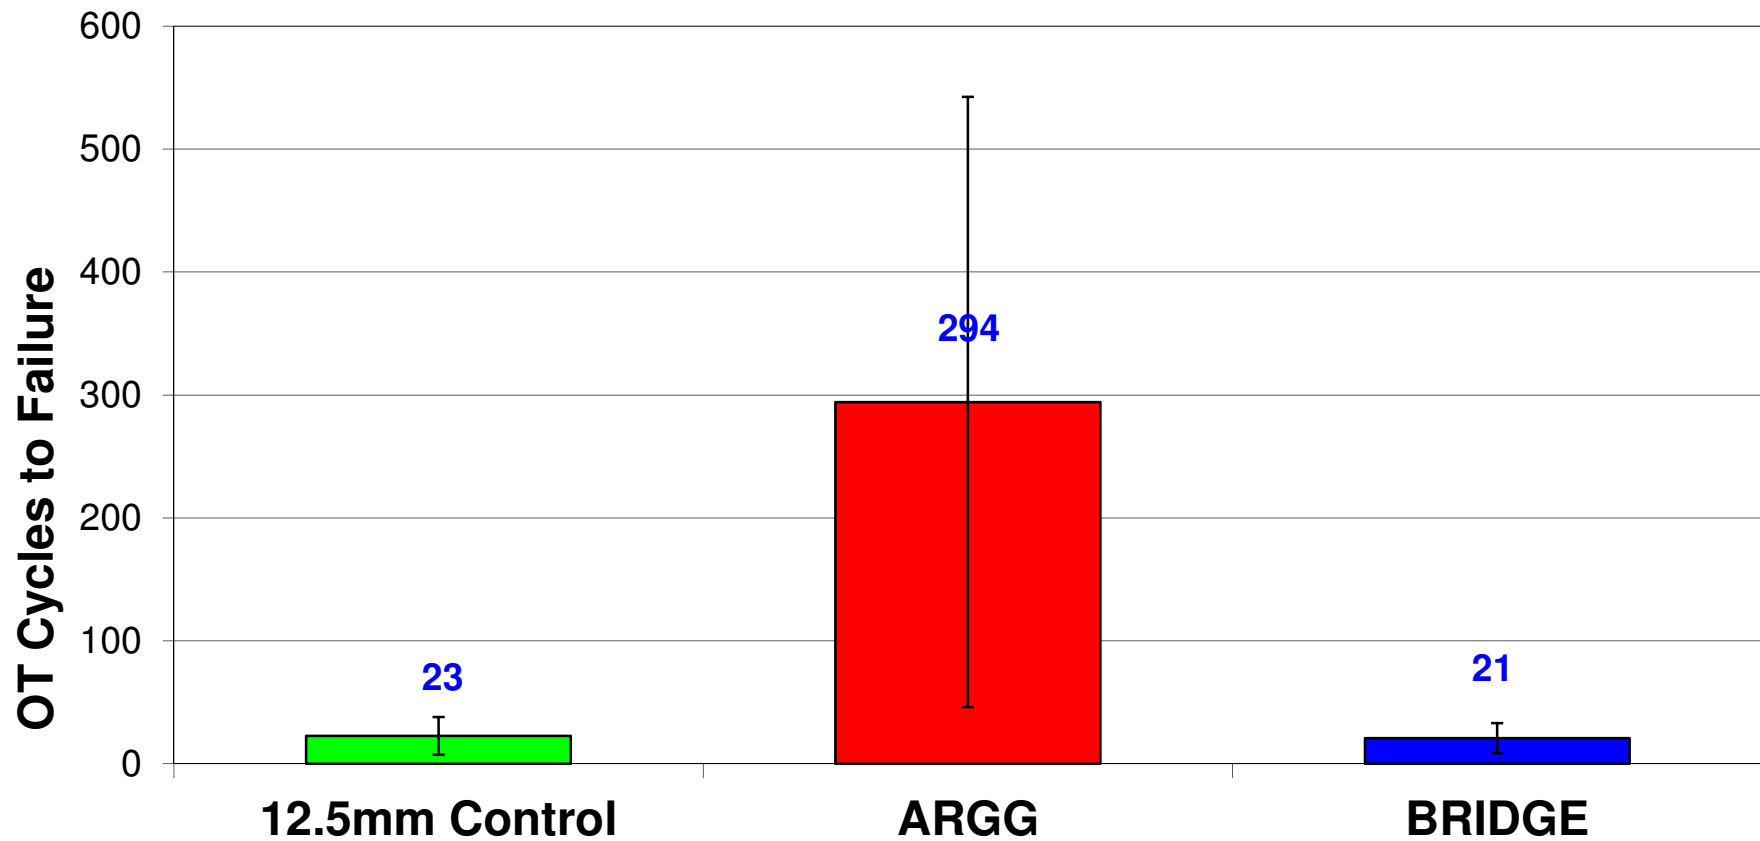
Plant Mix Overlay Test Results

Overlay Test Results - Tex-248-F - 15°C
MassDOT Control vs. ARGG vs BRIDGE

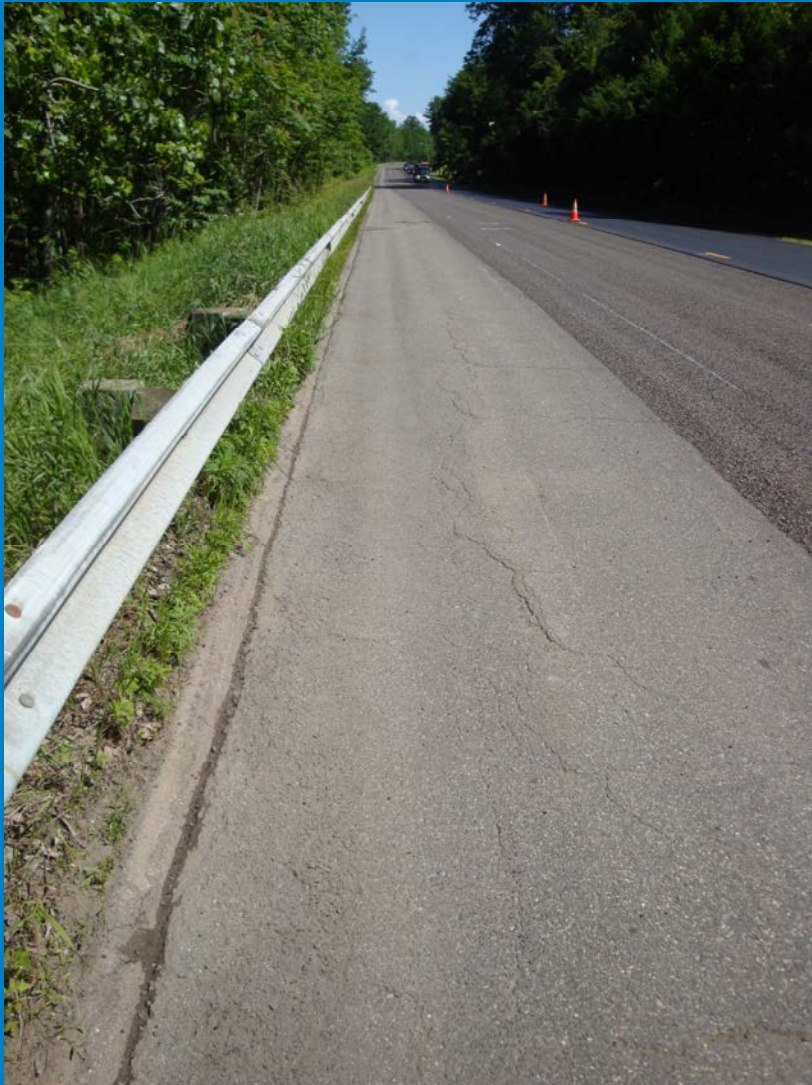
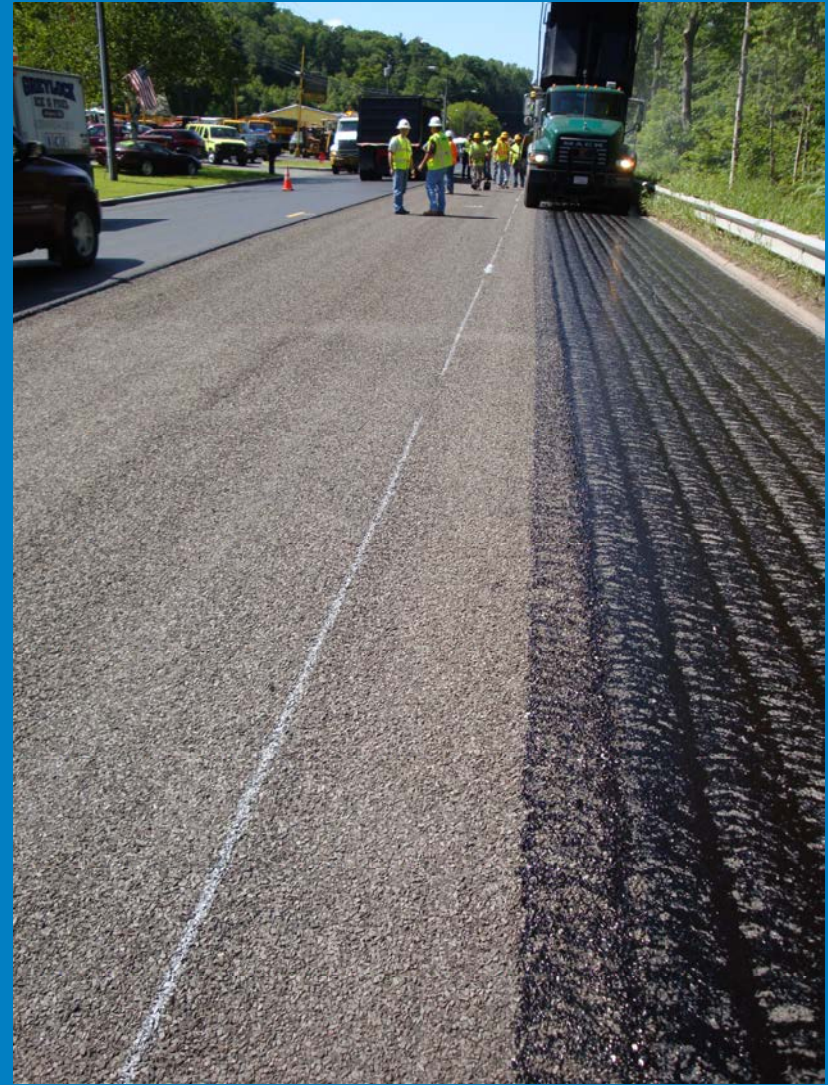
Route 8 Cheshire Lanesboro Construction

- MassDOT specifies Stress Absorbing Membrane Interlayers (SAMI) to mitigate reflective cracking in some applications. Item #466.
- SAMI can be placed independent of an overlay and left open to traffic.
- Four test sections were constructed on Route 8 in the towns of Cheshire- Lanesboro.
- Two Sections included a Rubber Chip Seal SAMI.
 - SAMI & HMA Overlay
 - SAMI & Bonded Thin Overlay
