ASPHALT RUBBER – EXPERIENCE & SPECIFICATION DEVELOPMENT

Pavement Management Engineer

MassDOT – Highway Division

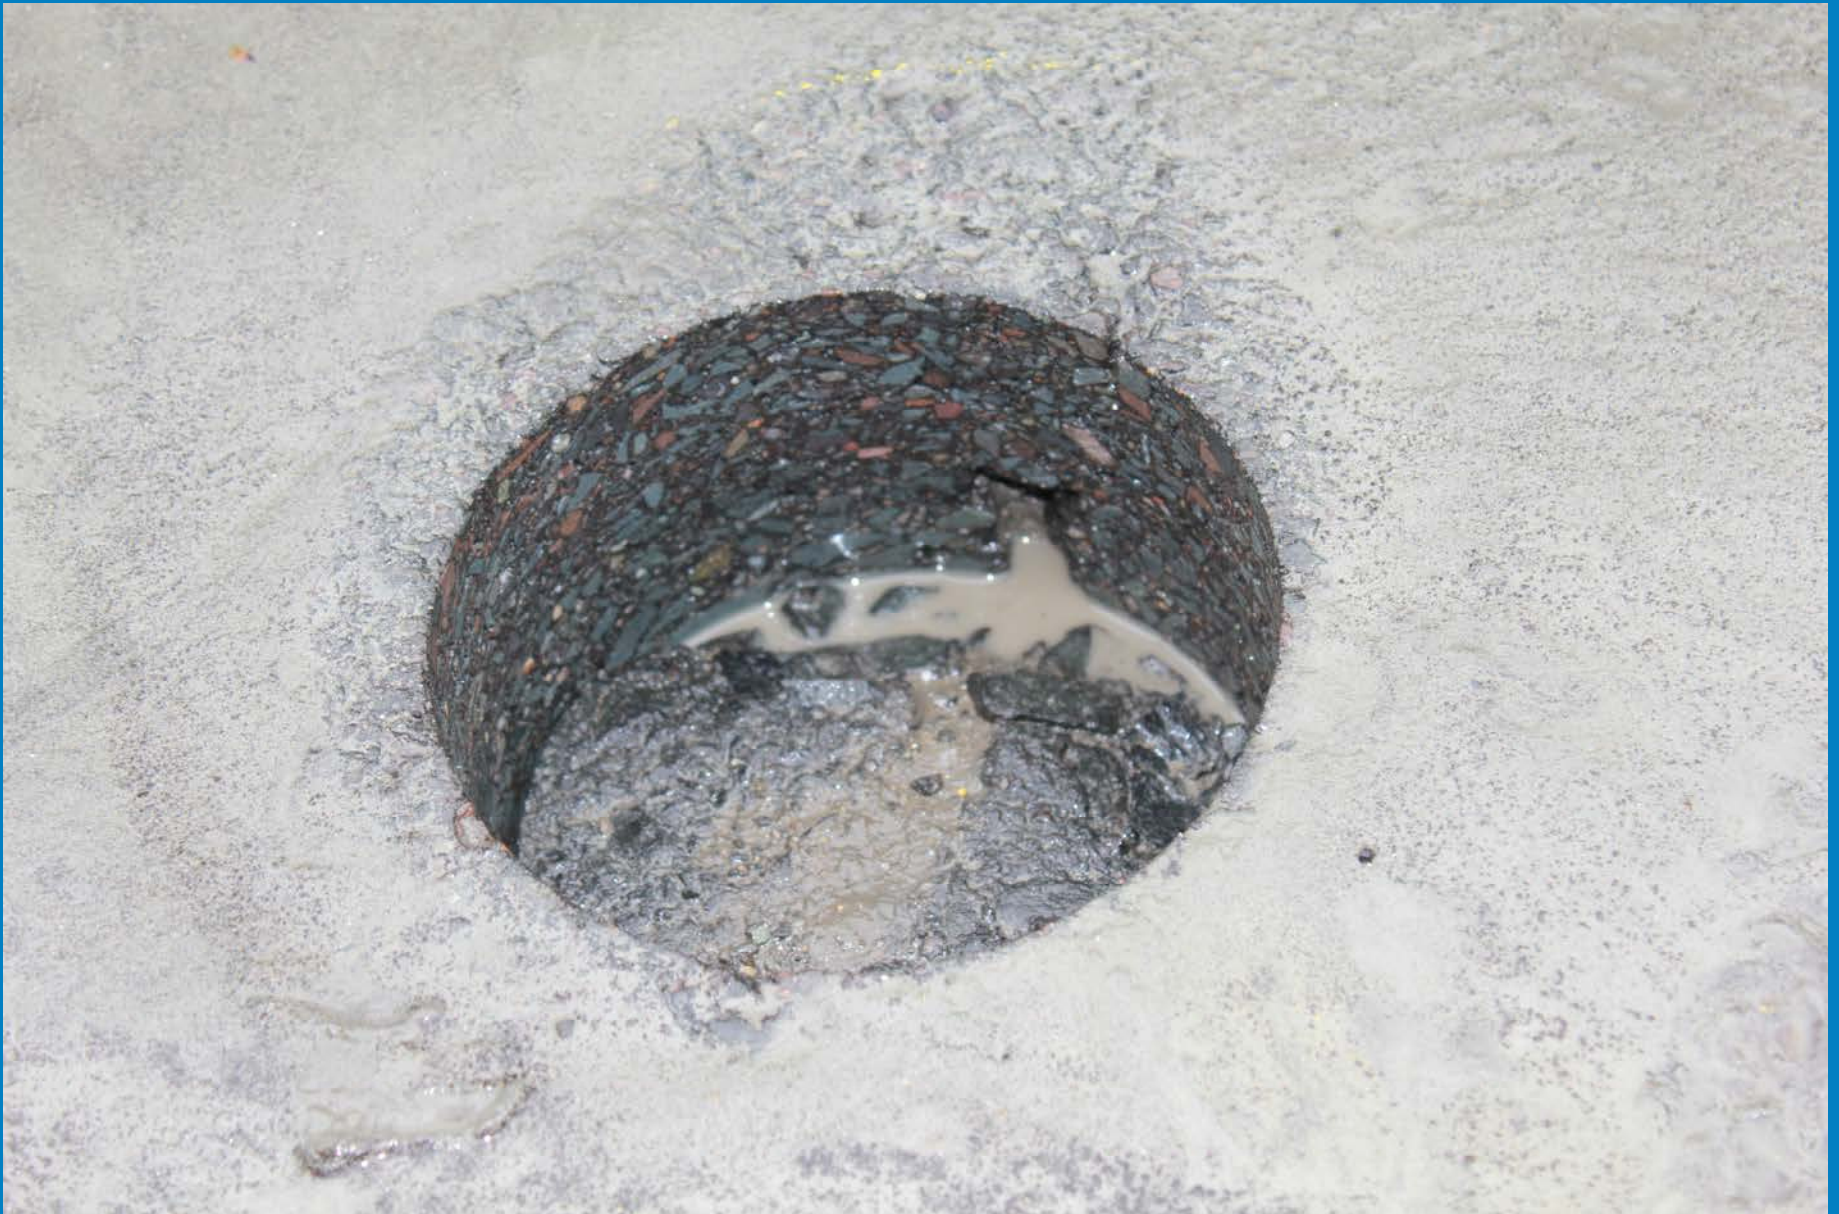
Cheshire-Lanesboro – Two Years Later HMA Overlay on Shoulder – No SAMI

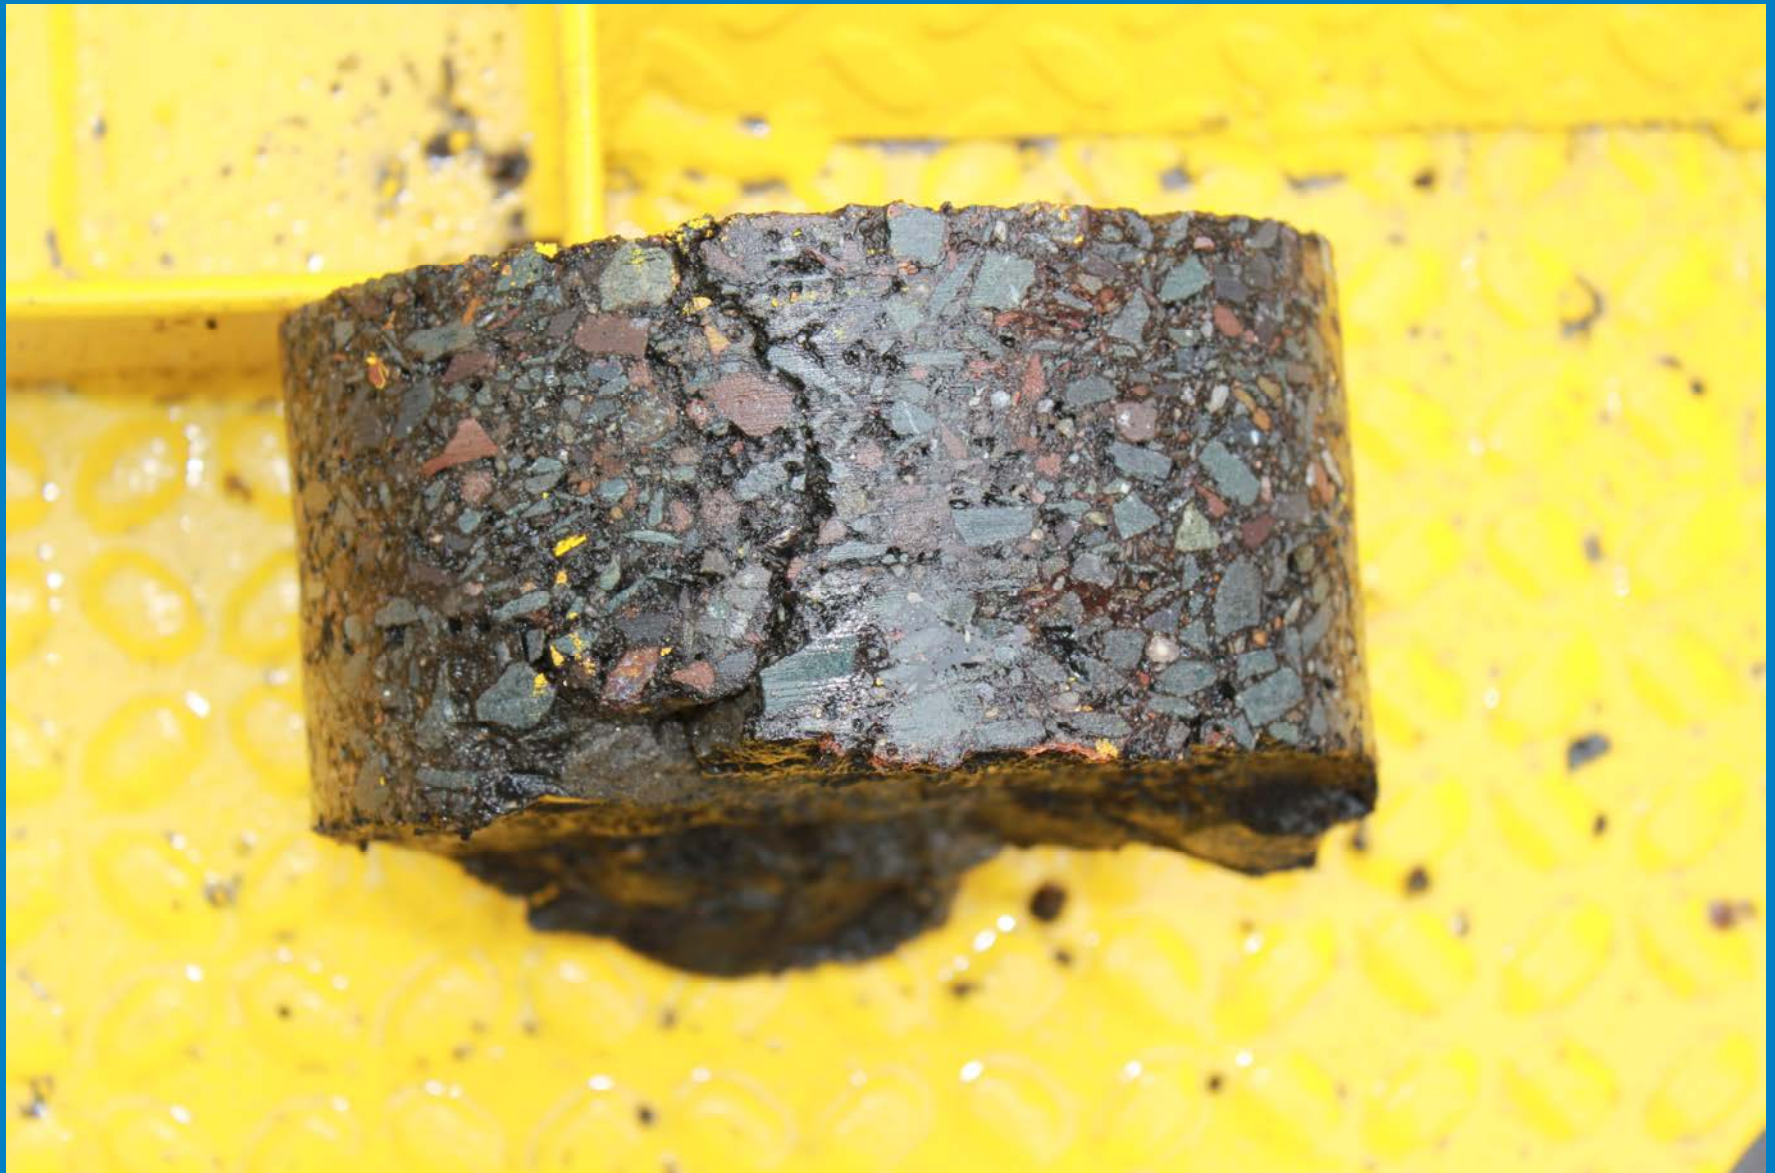
Cheshire Lanesboro – Two Years Later No SAMI - Core

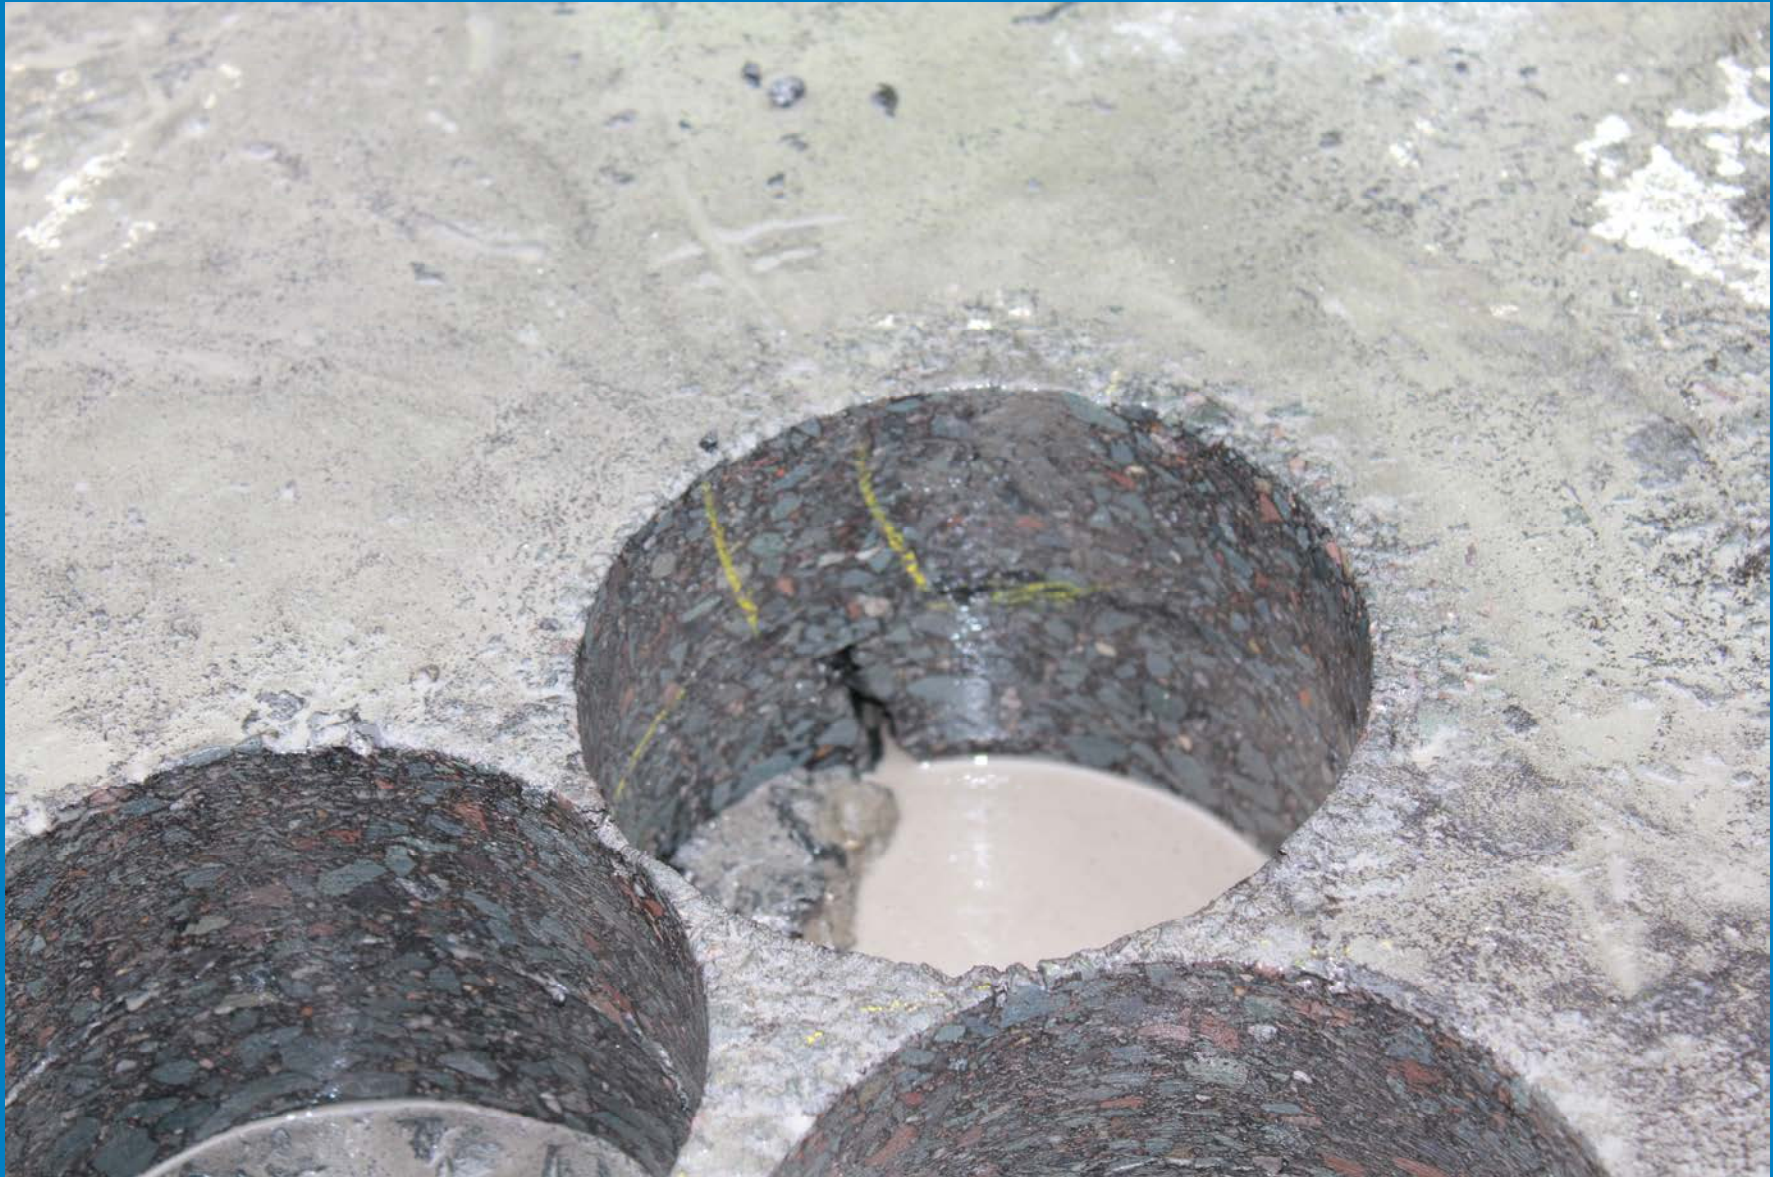
Cheshire Lanesboro HMA over SAMI

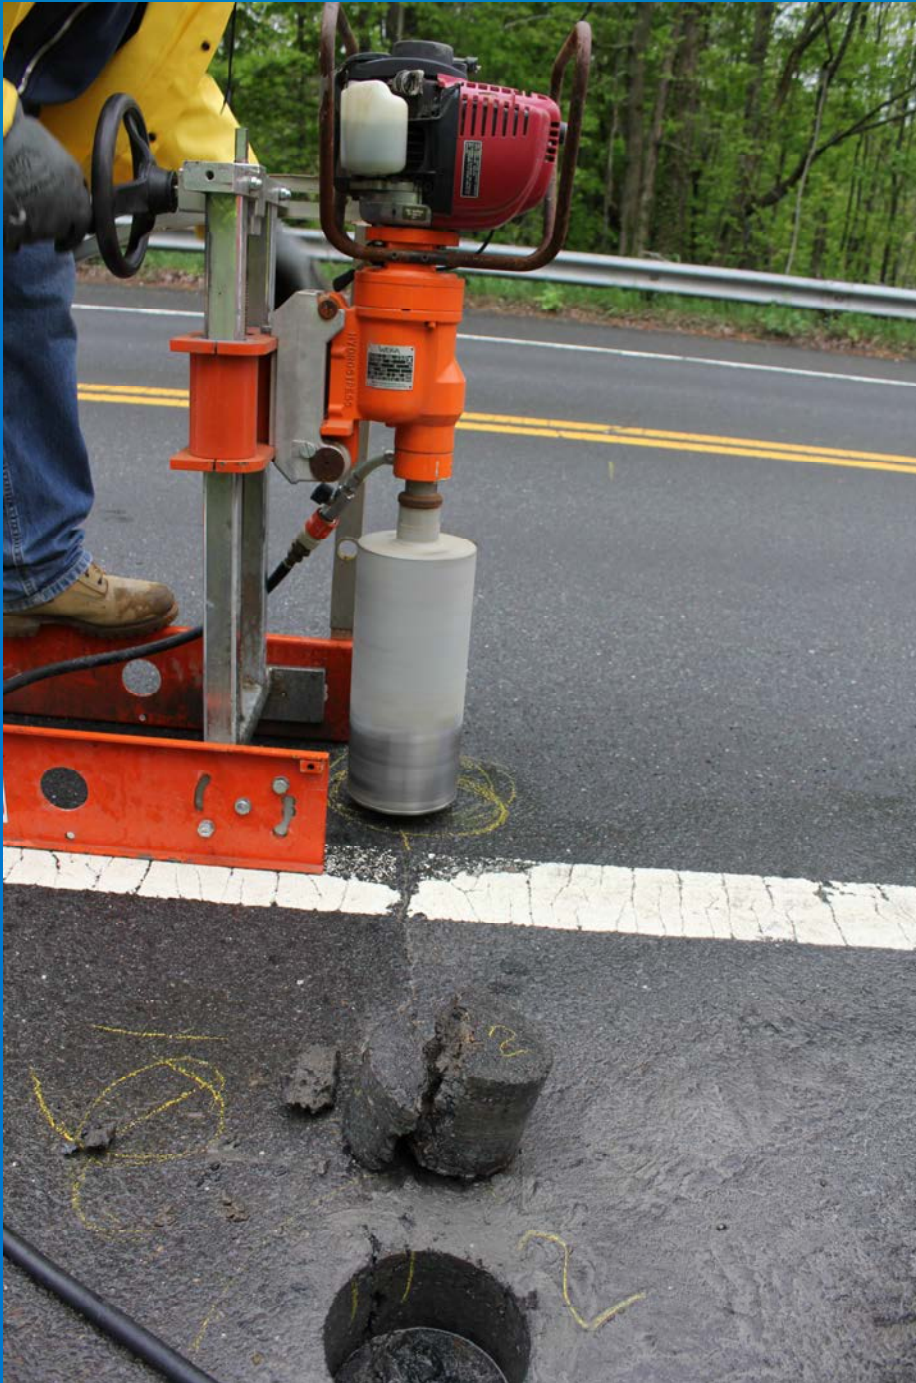
Cheshire - Lanesboro HMA over Rubber Chip Seal SAMI

- First Core on shoulder – no SAMI
- Second Core through SAMI
- Effective on most longitudinal cracking
- Effective on less light to moderate transverse cracking

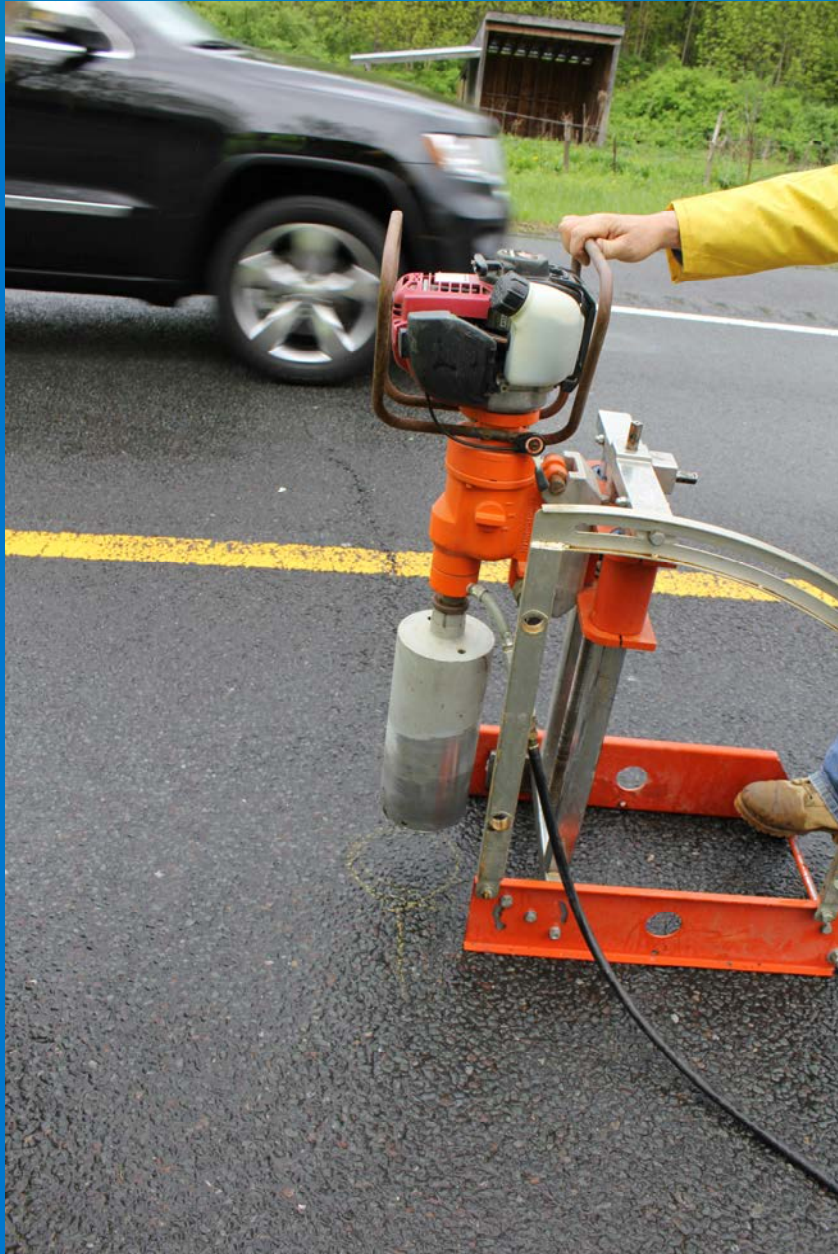
- HMA over Rubber Chip Seal SAMI
- Crack stops at SAMI.
- Effective on most longitudinal cracking.
- Effective on less severe transverse cracking.

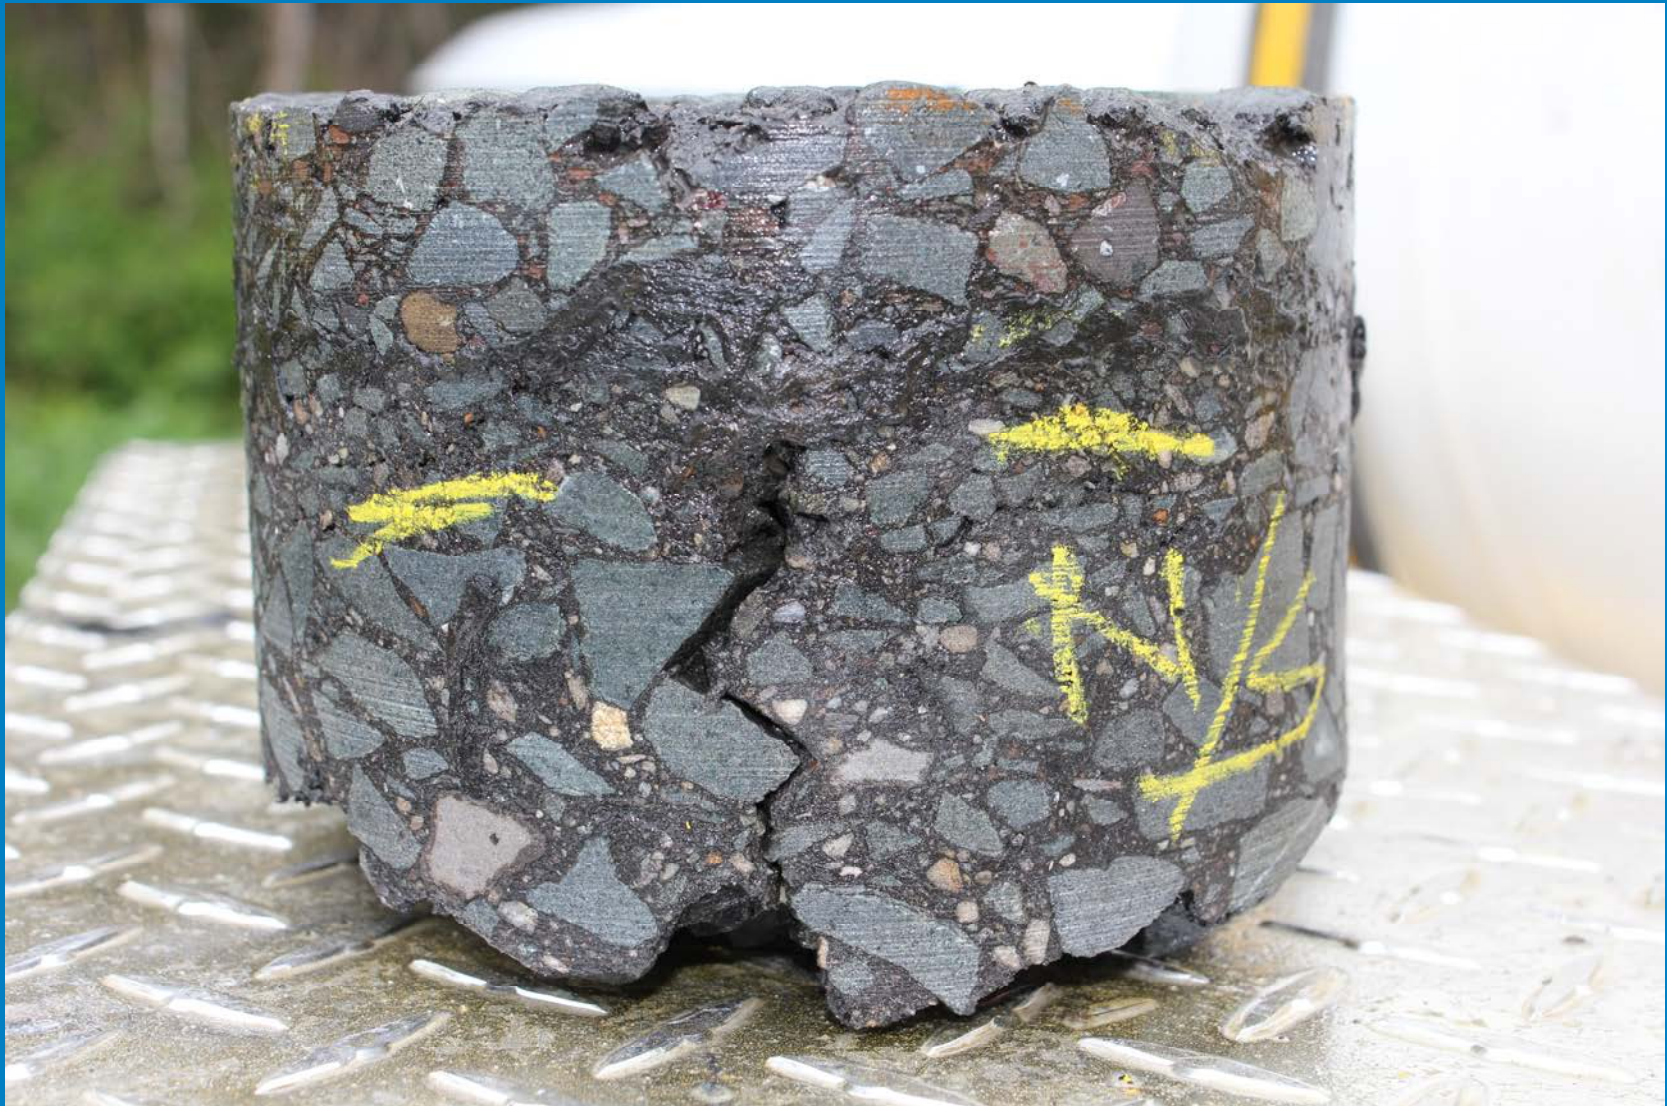
- Route 8 Cheshire Lanesboro
- Bonded Thin Overlay on Asphalt Rubber SAMI
- Light Reflective Cracking visible
- SAMI and core appear intact.

Cheshire Lanesboro Bonded Thin Overlay on Rubber Chip SAMI
