# NDIA DESIGN & CONSTRUCTION OF HIGH PERFORMANCE MIXES

## Terminal Taxiway Layout

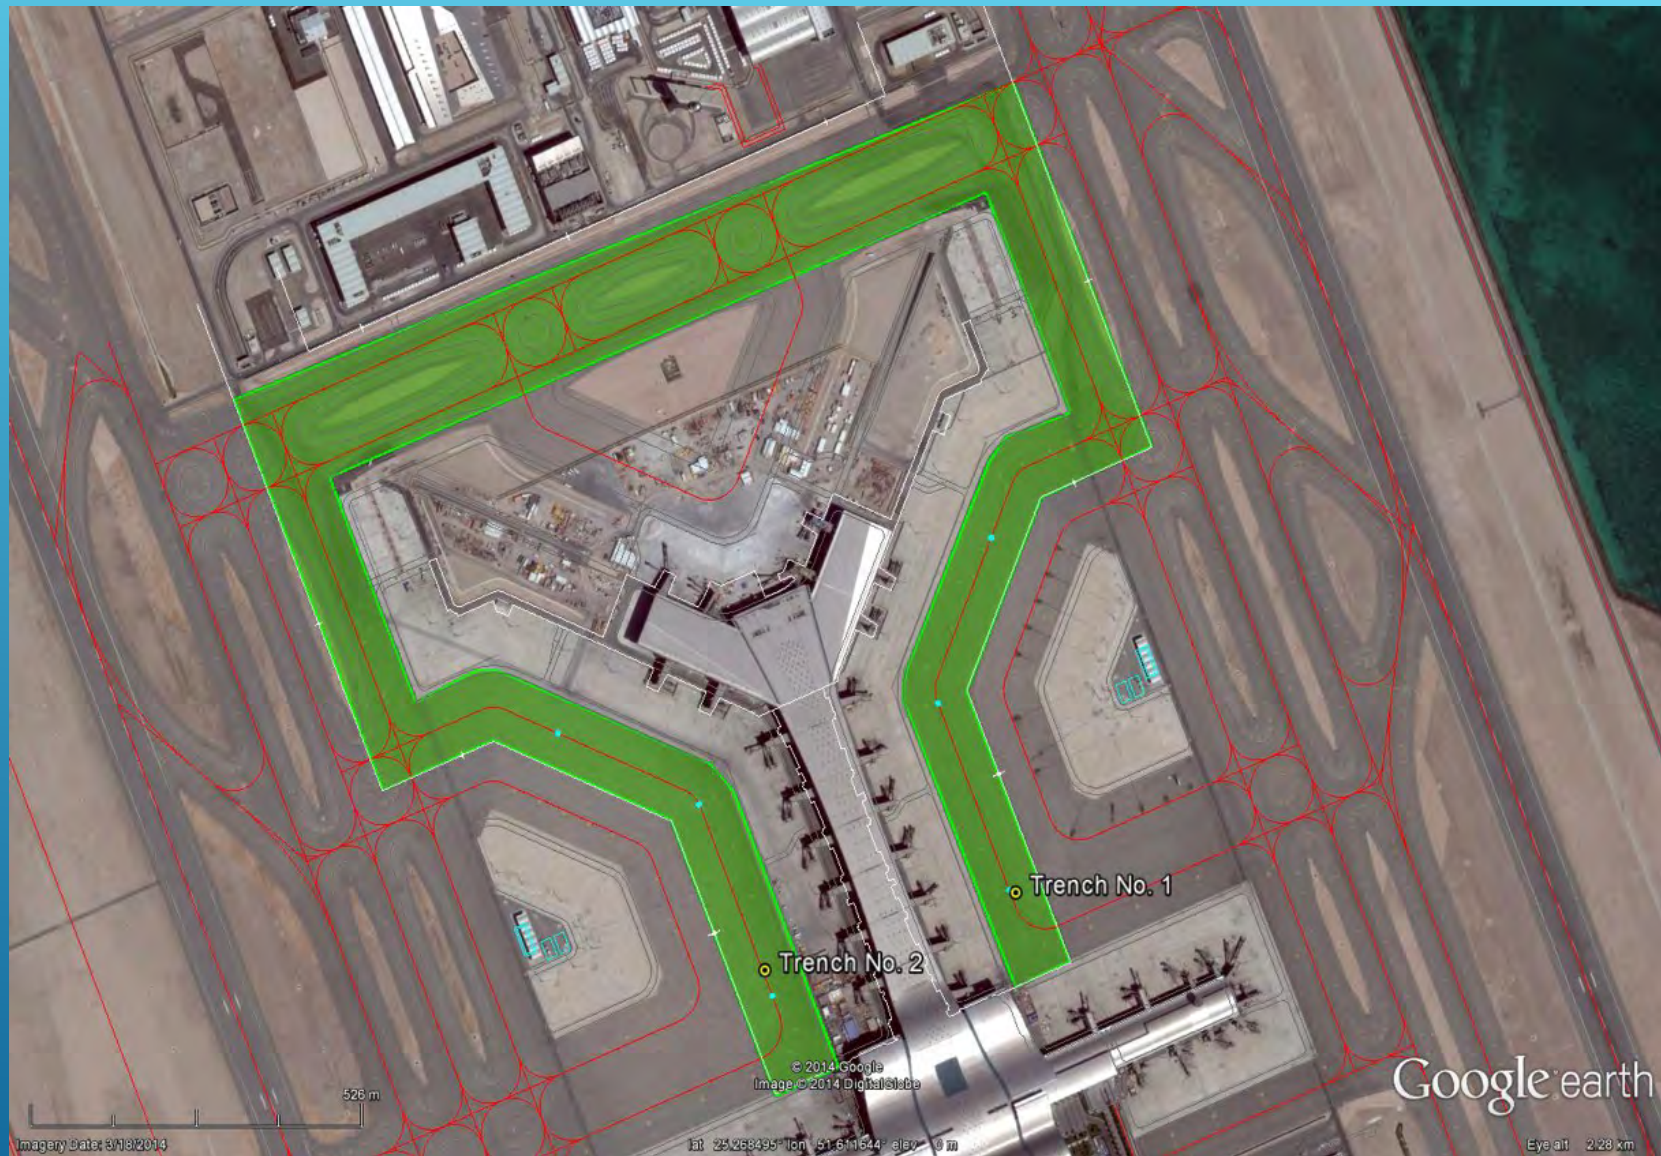
Existing taxiway 500mm of HMA over dense aggregate base. 200mm of PMB WC 300mm 60/70 pen Base.

Paved in 2010 2011 opened to traffic spring 2014

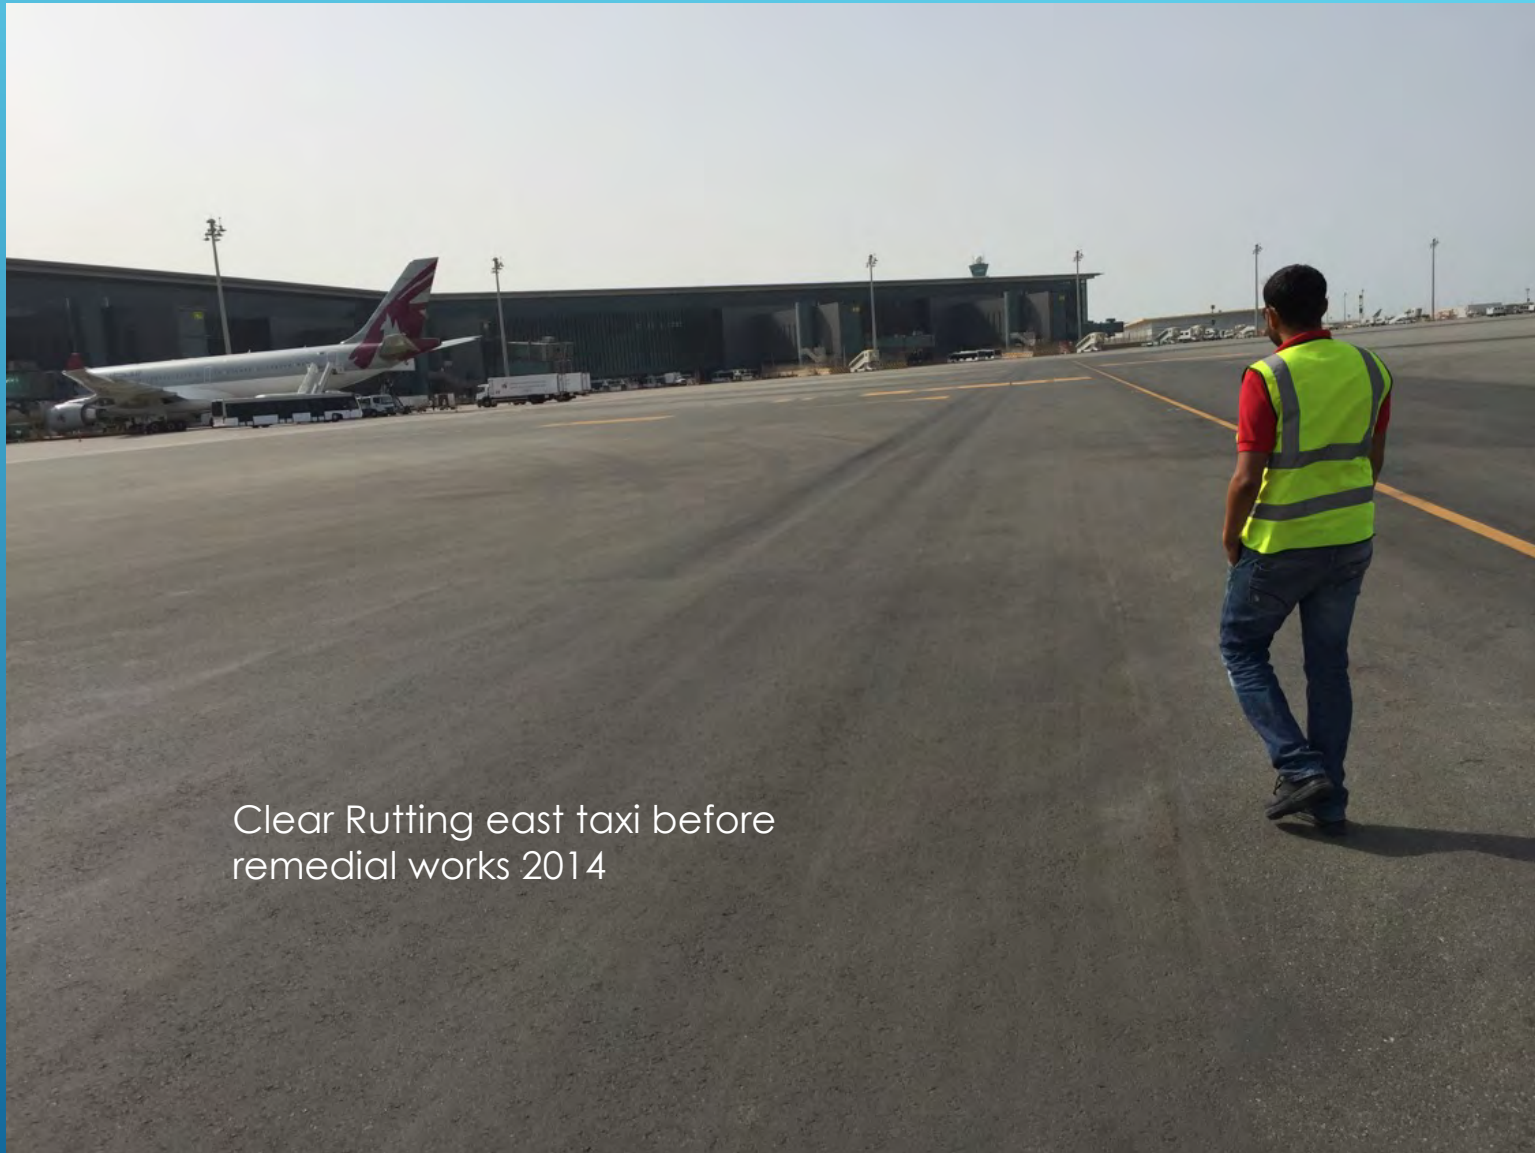
Clear Rutting east taxi before  
remedial works 2014

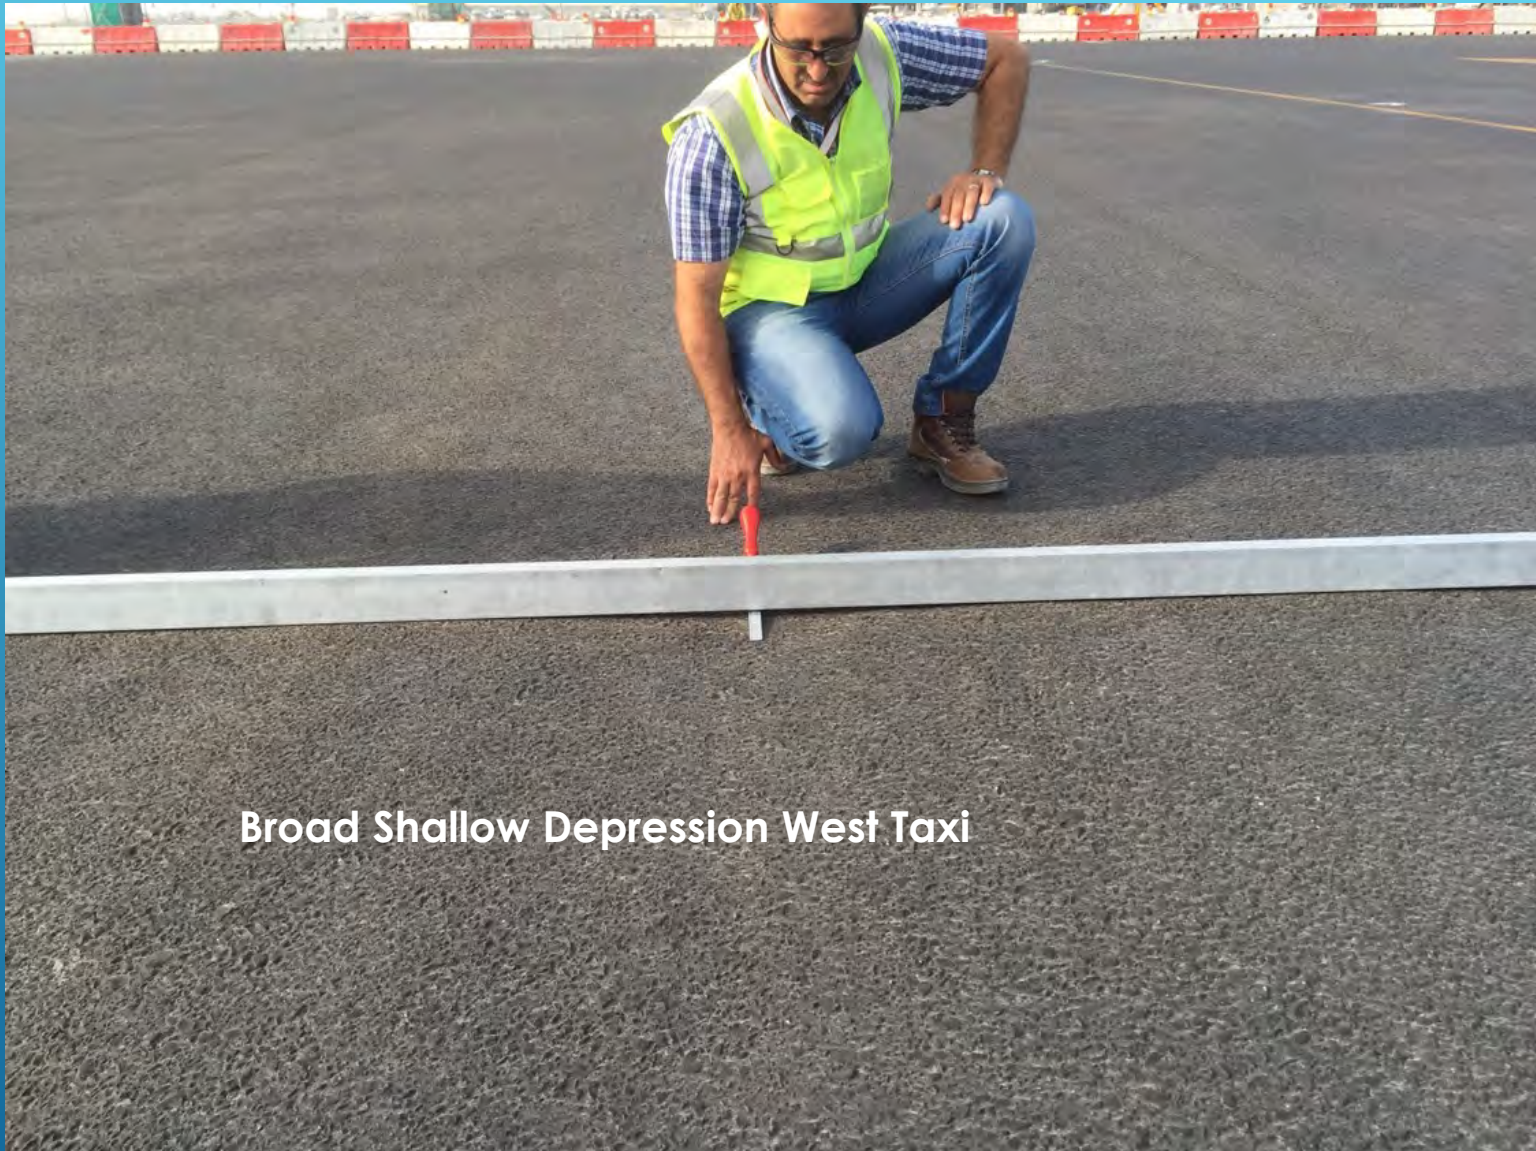
**Broad Shallow Depression West Taxi**

Heavy rutting and cracking on the west taxiway.

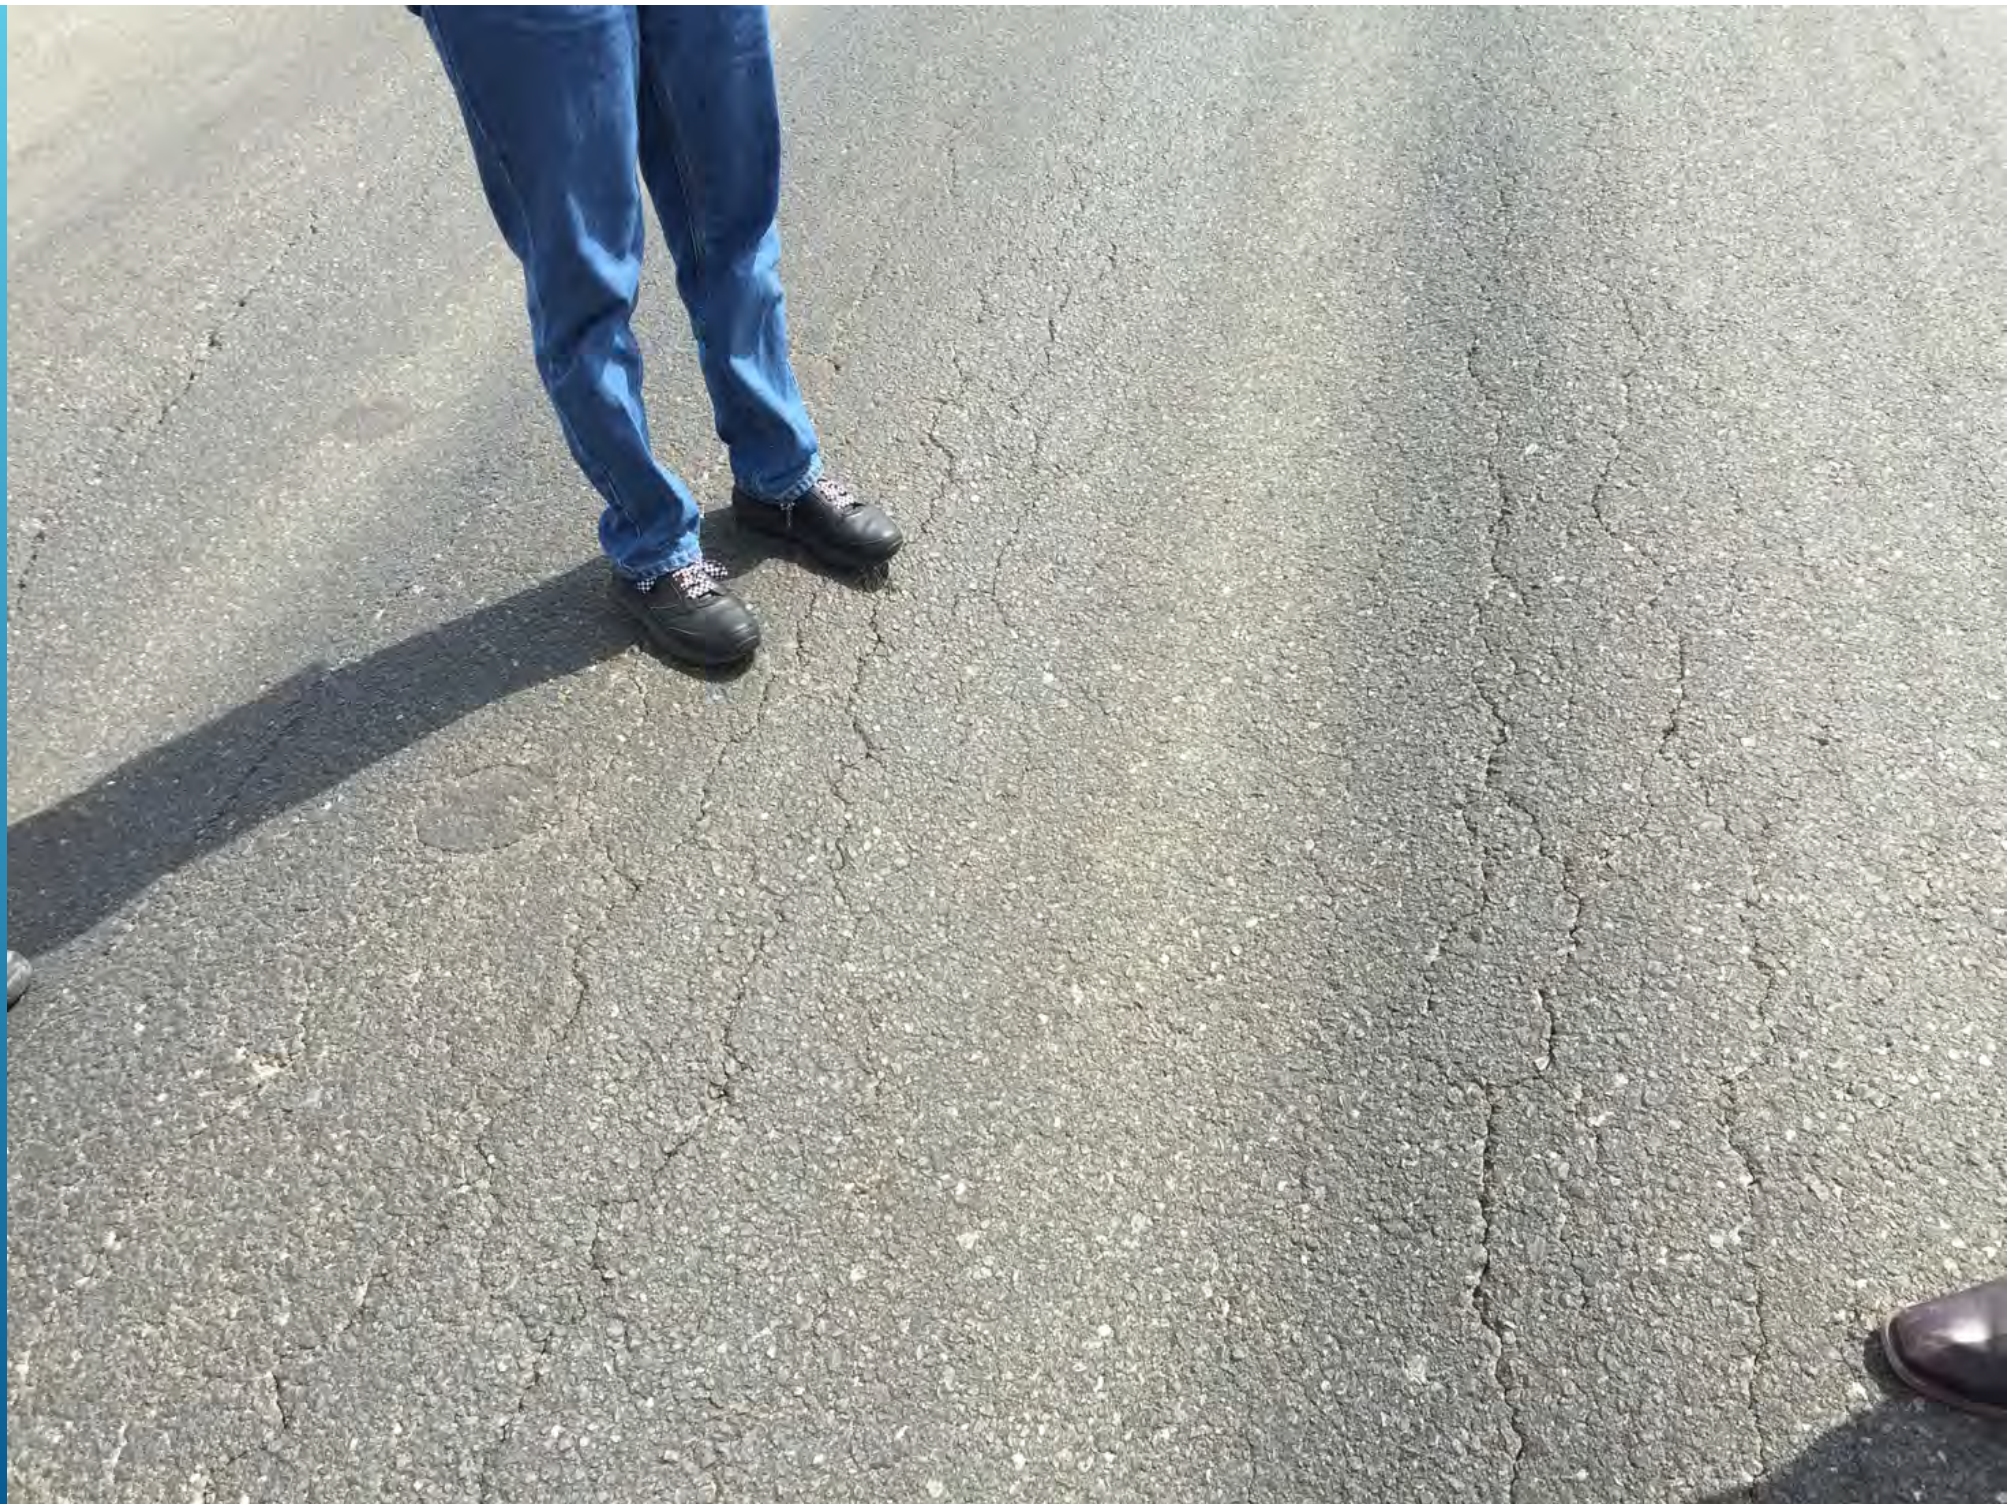
Soon after opening to traffic the taxiways experienced severe rutting.

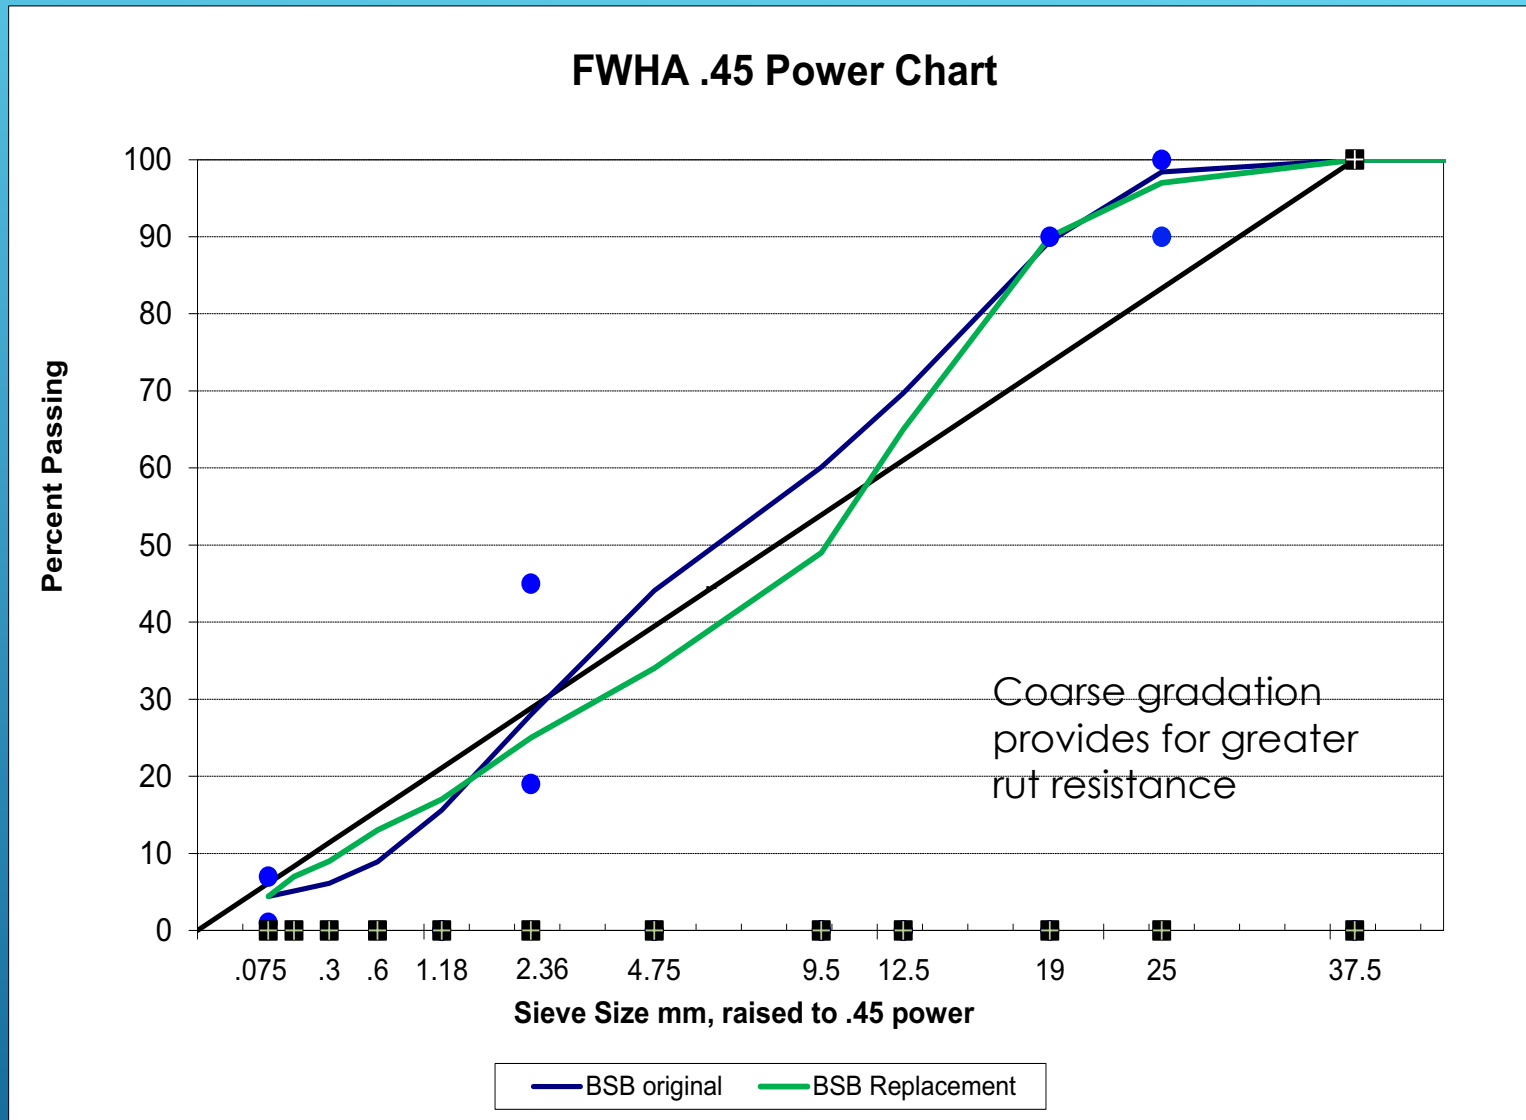
## Comparison of the original BSB to the New 25mm BSB

Mix	New CCC 25mm
Gyrations level	100
Voids Ndes	4.0
Voids Nmax	3.2
VMA	14.2
AC	4.6
VFA	70.8

Binder PG 76E -10

Design air voids of 4% for good stiffness and  
Design VMA @ 14% for good durability

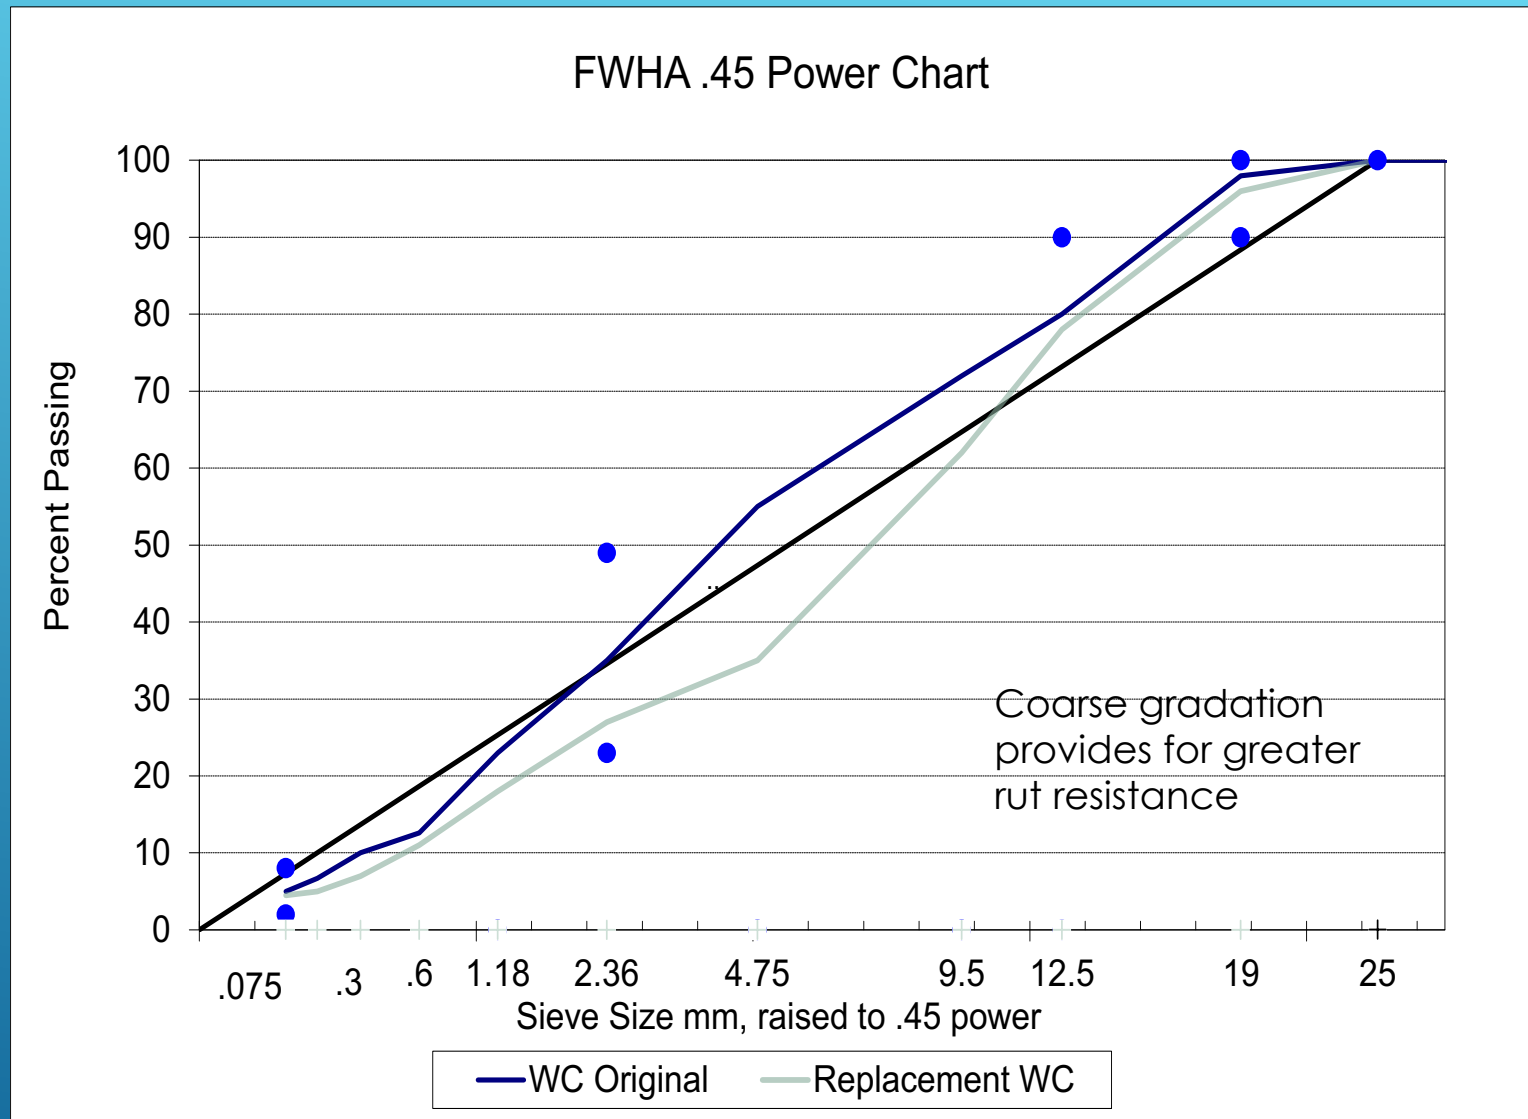
## Comparison of the original WC to the New 19mm WC

Mix	New CCC 19mm
Gyrations level	100
Voids Ndes	4.0
Voids Nmax	2.8
VMA	14.6
AC	4.2
VFA	72.2

Binder PG 76E -10

Design air voids of 4% for good stiffness and  
Design VMA @ 13% for good durability

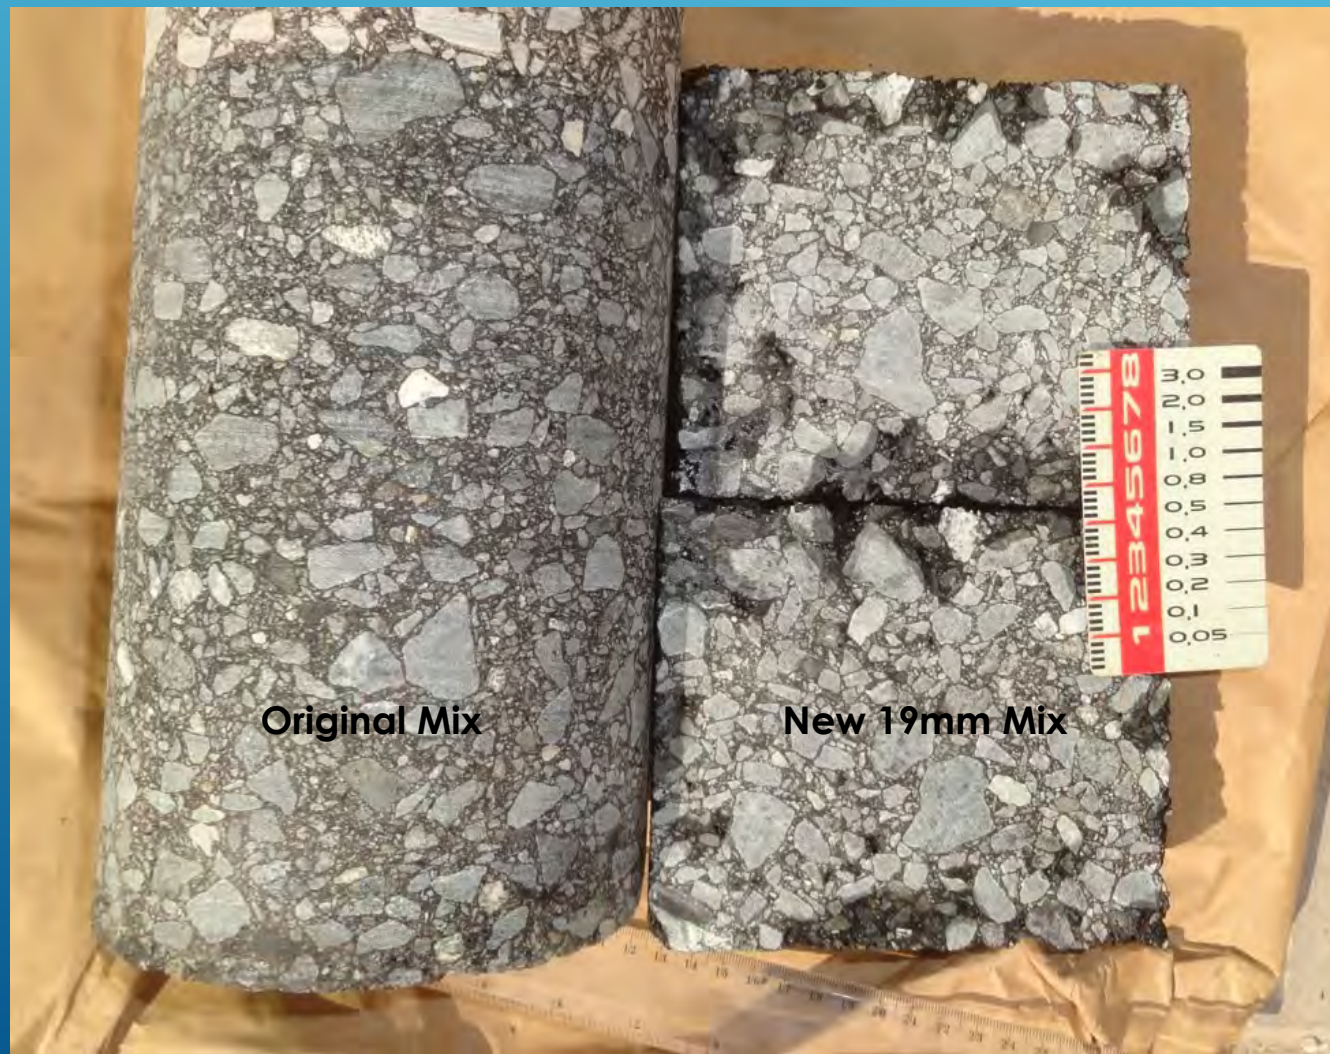
# COMPARISON OF GRADATIONS FOR THE 19MM WC

New mix has significantly more aggregate structure to resist depressions and rutting.

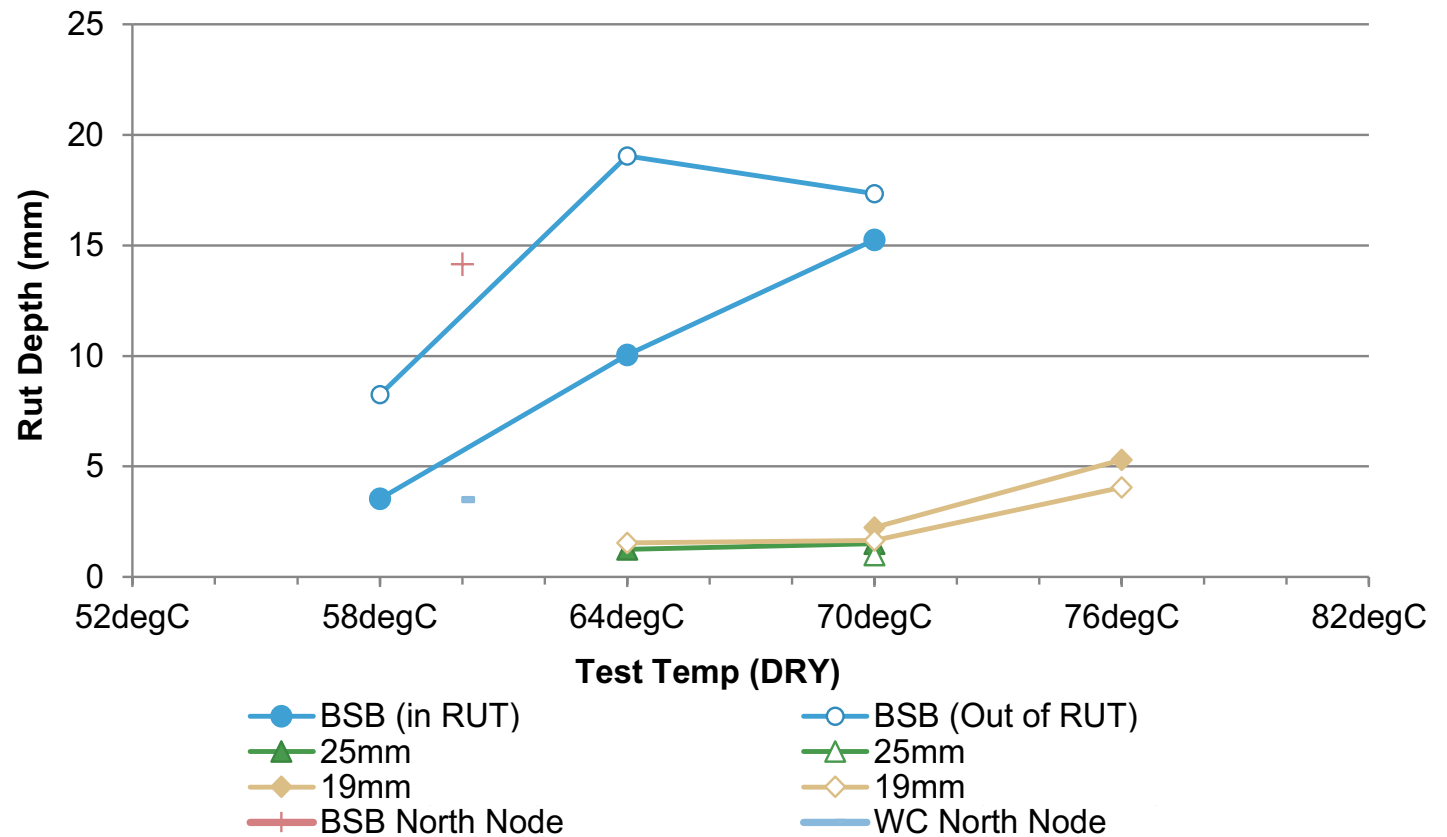
### Average of 2 central Rut Depths (HWTT)

New mixes show very strong rut resistance.

Initial consolidation is not rutting.

After initial consolidation minimal additional movement.

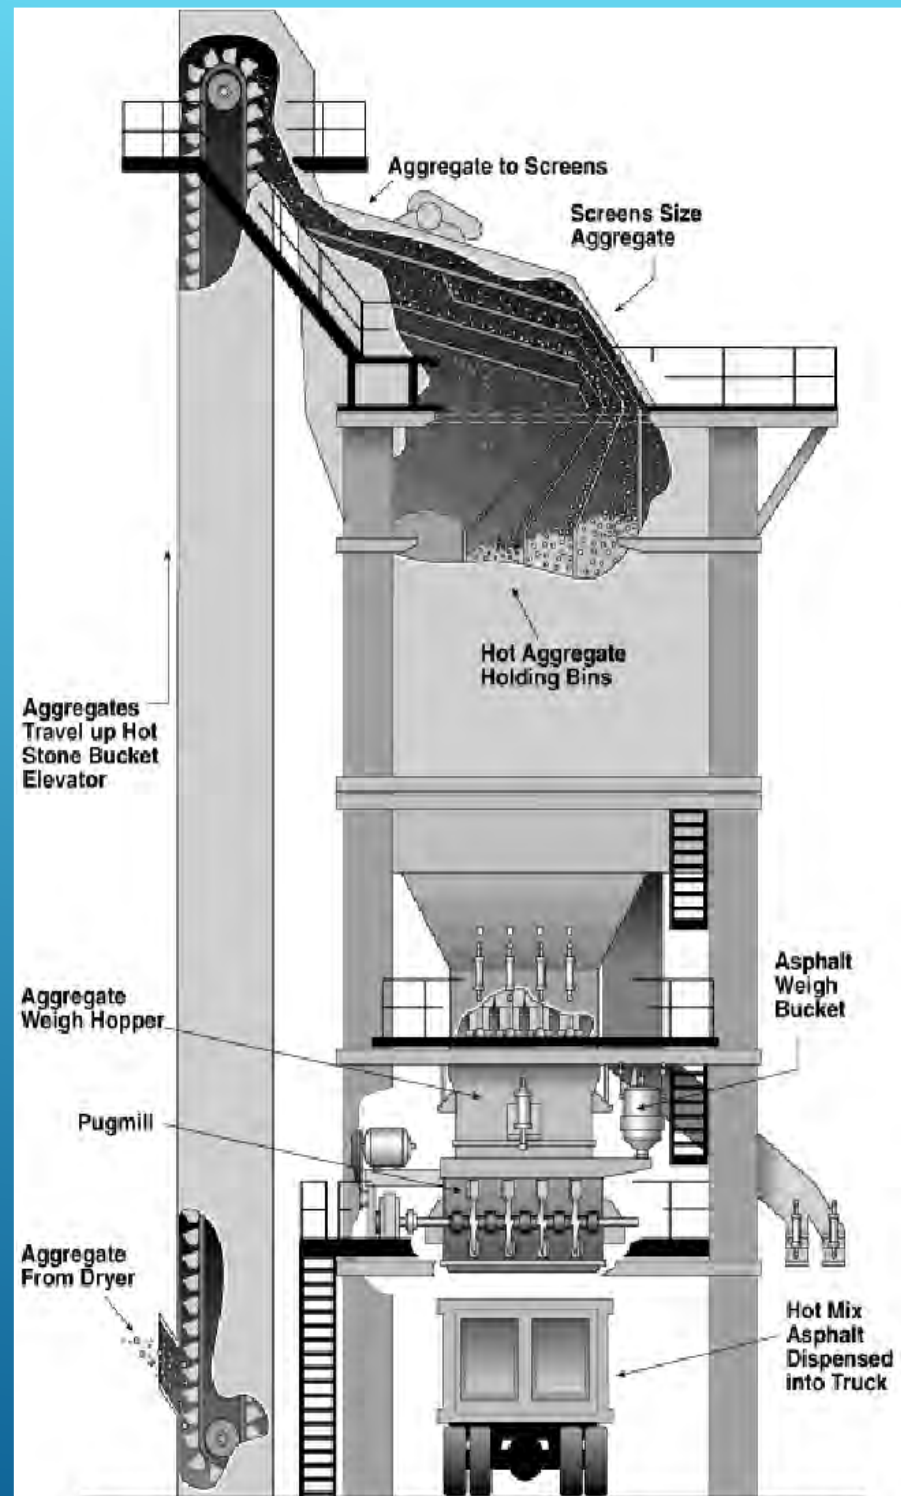
# The Modern Batch Plant Facility

- gradation control at the hot bins
- asphalt binder control at the weigh bucket
- things change from design to production

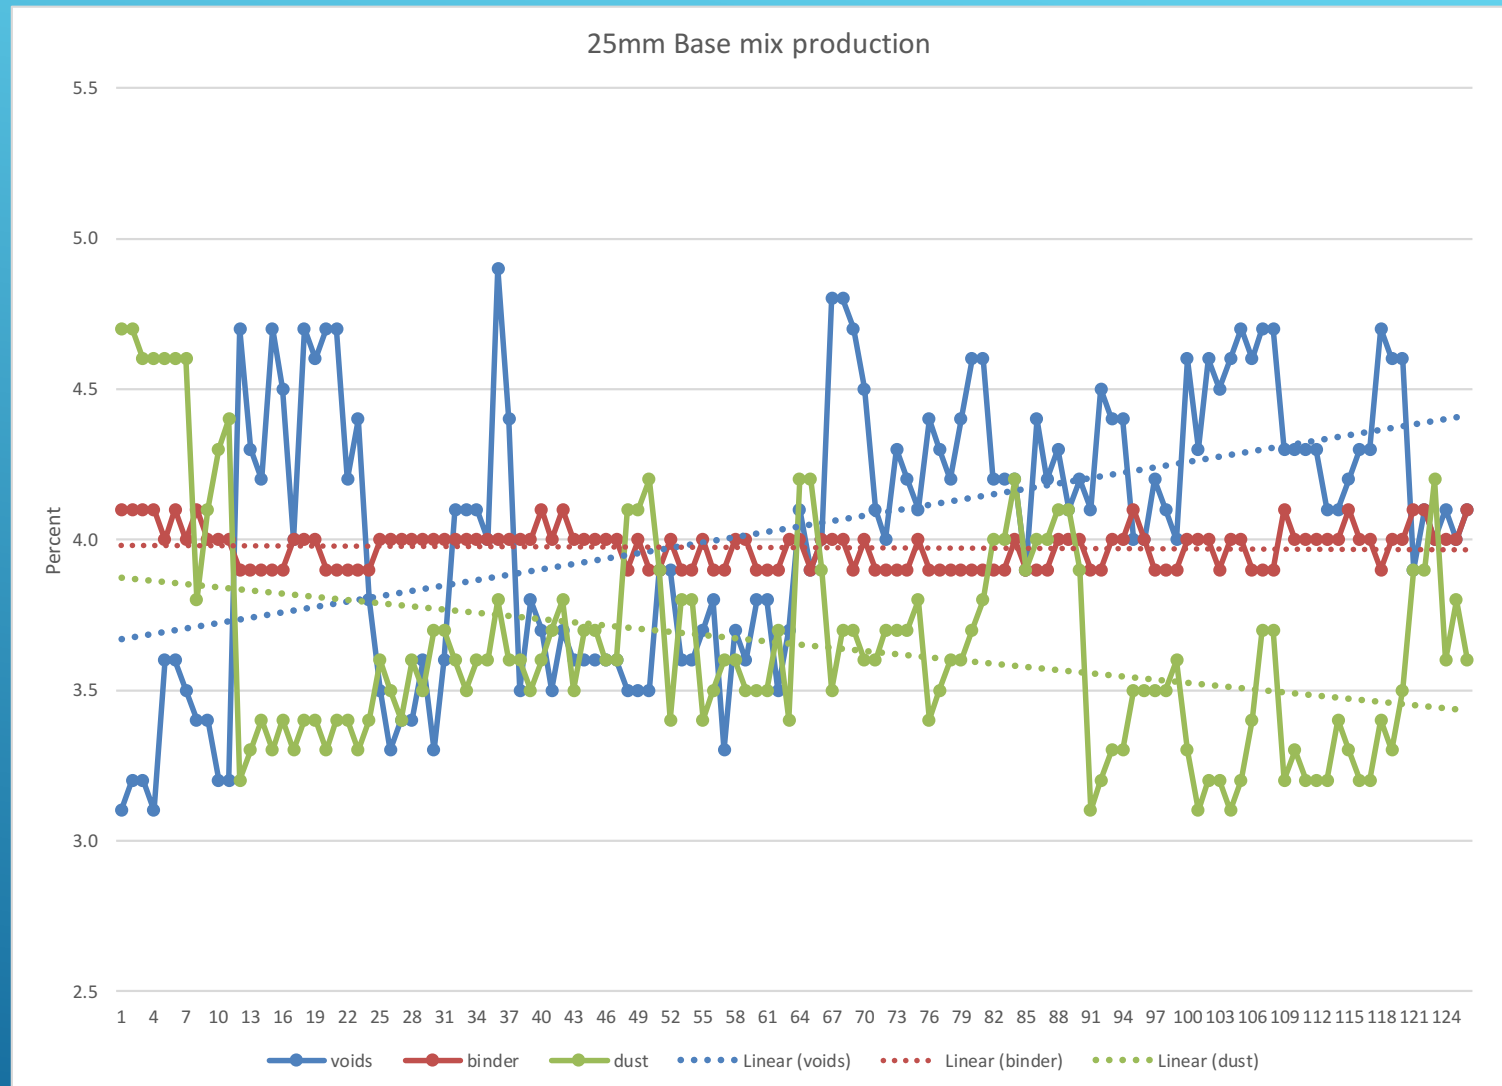
## Production Data

Bituminous content on target.

Gradation on Target  
Voids trending lower.

Need Field adjustment to bring voids back on target.

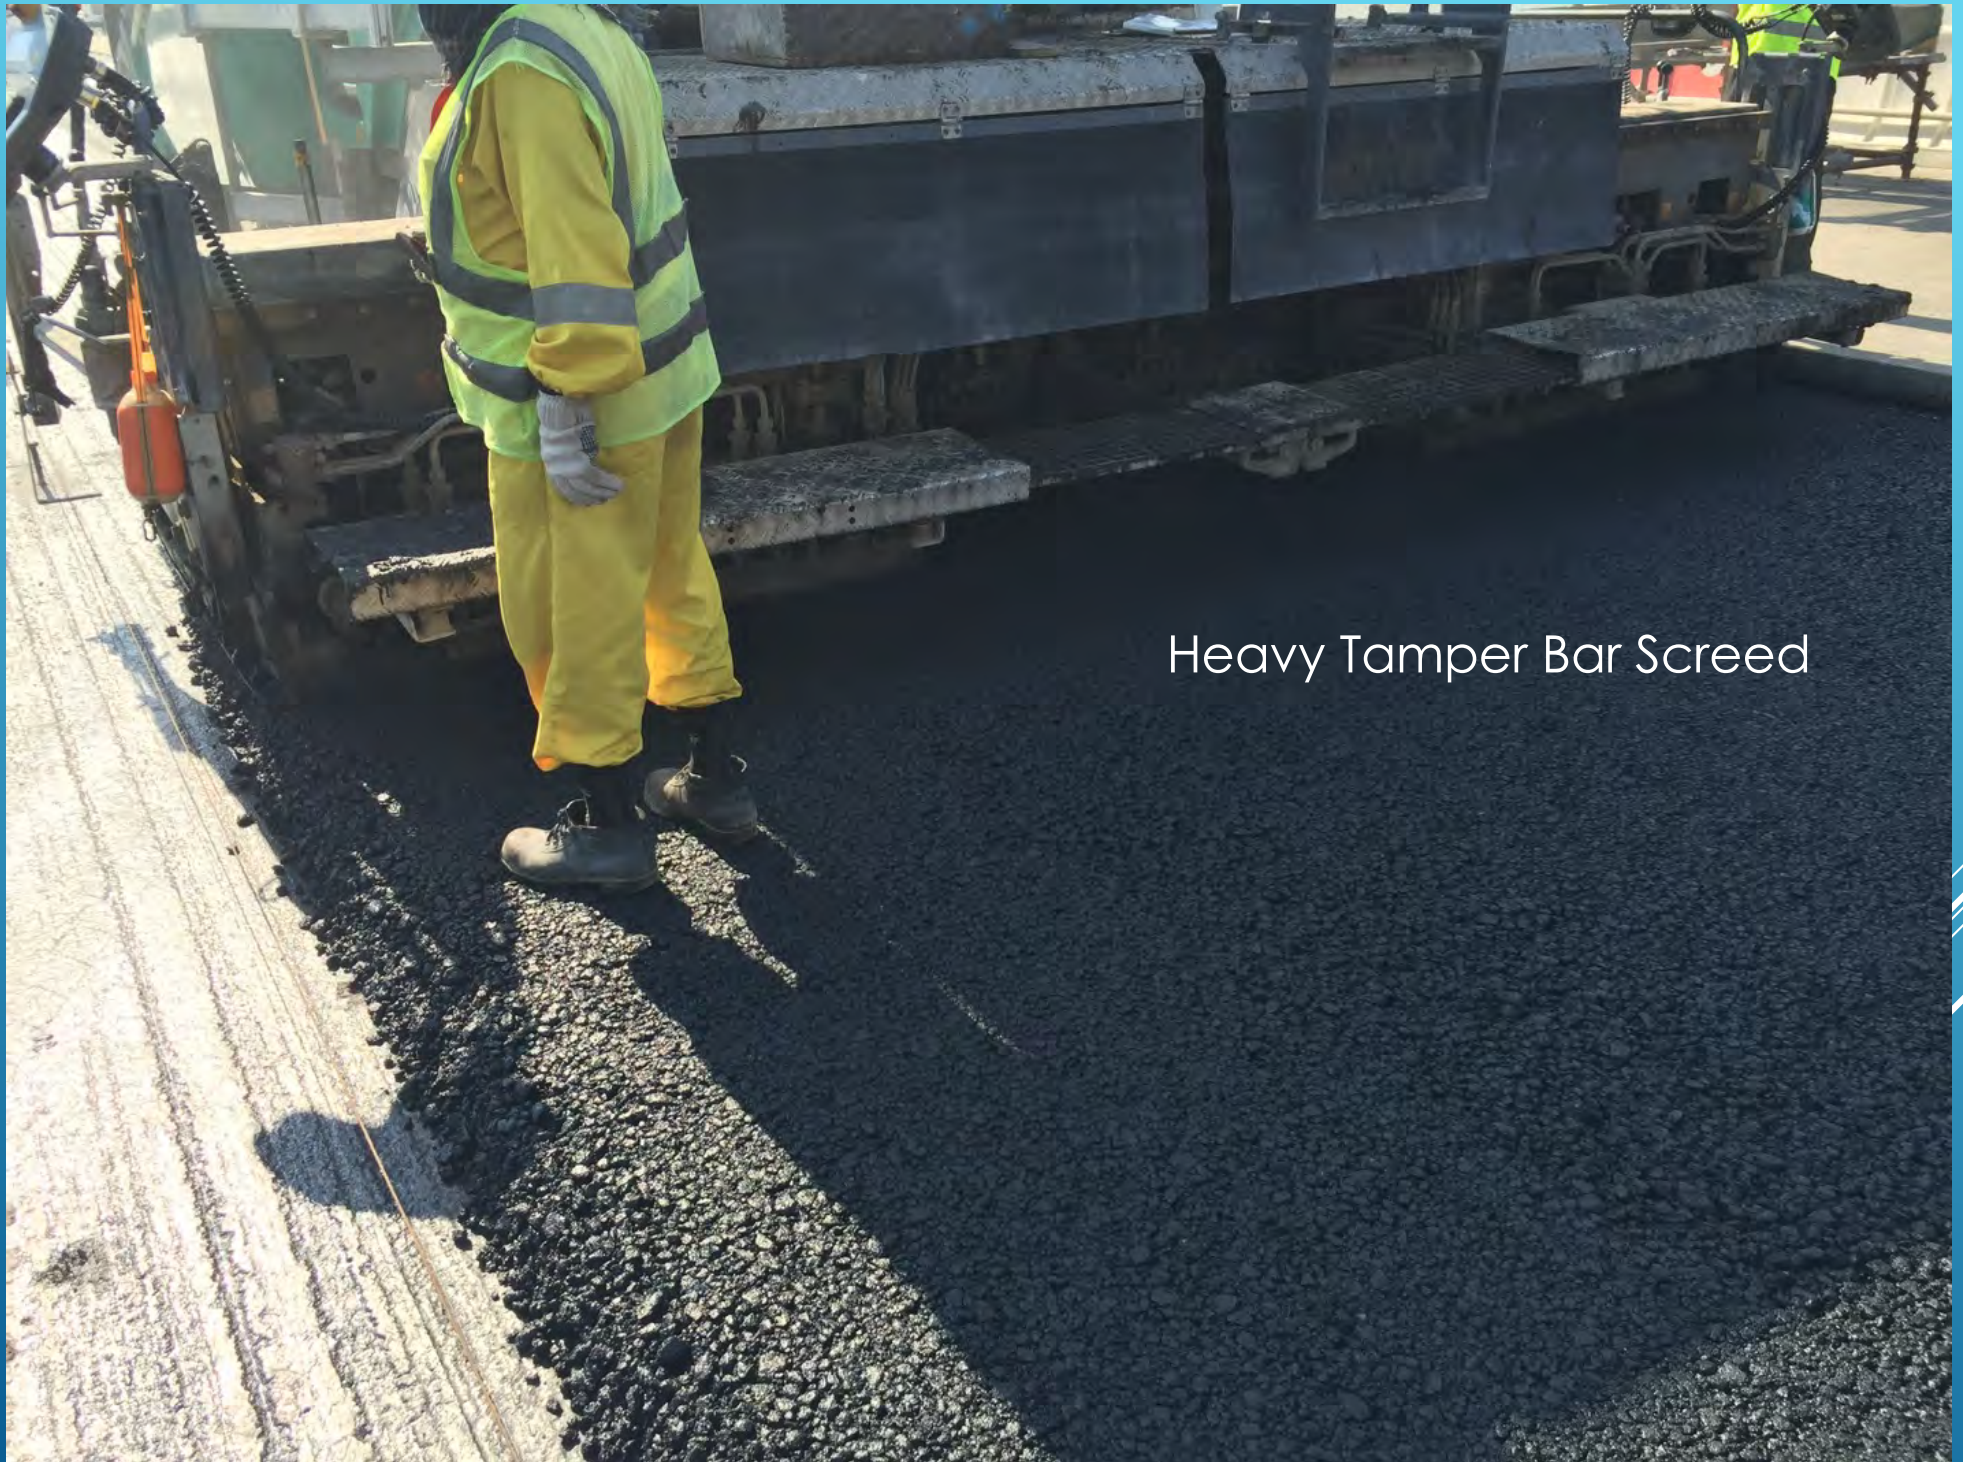
Heavy Tamper Bar Screed

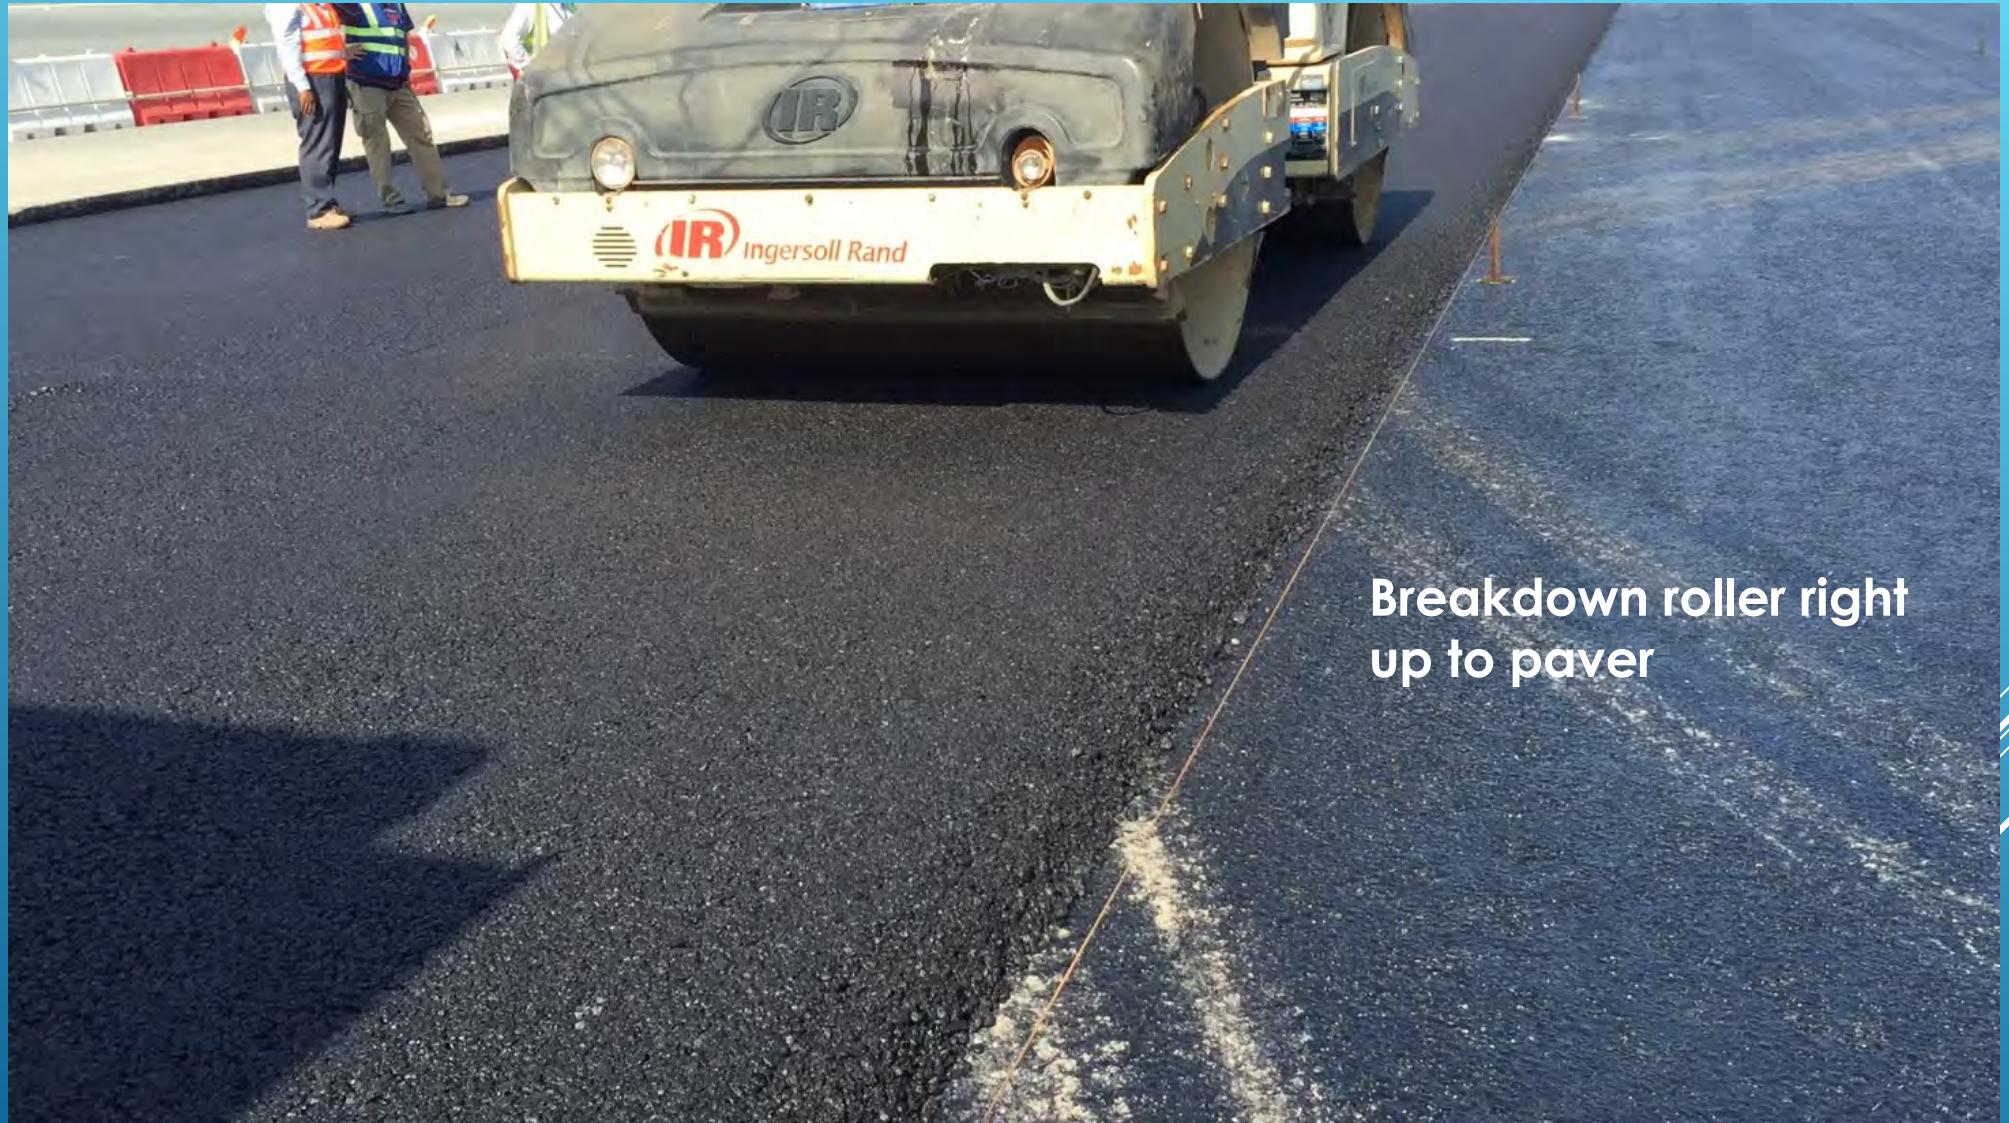
Breakdown roller right  
up to paver
