# NDIA DESIGN & CONSTRUCTION OF HIGH PERFORMANCE MIXES

## Terminal Taxiway Layout

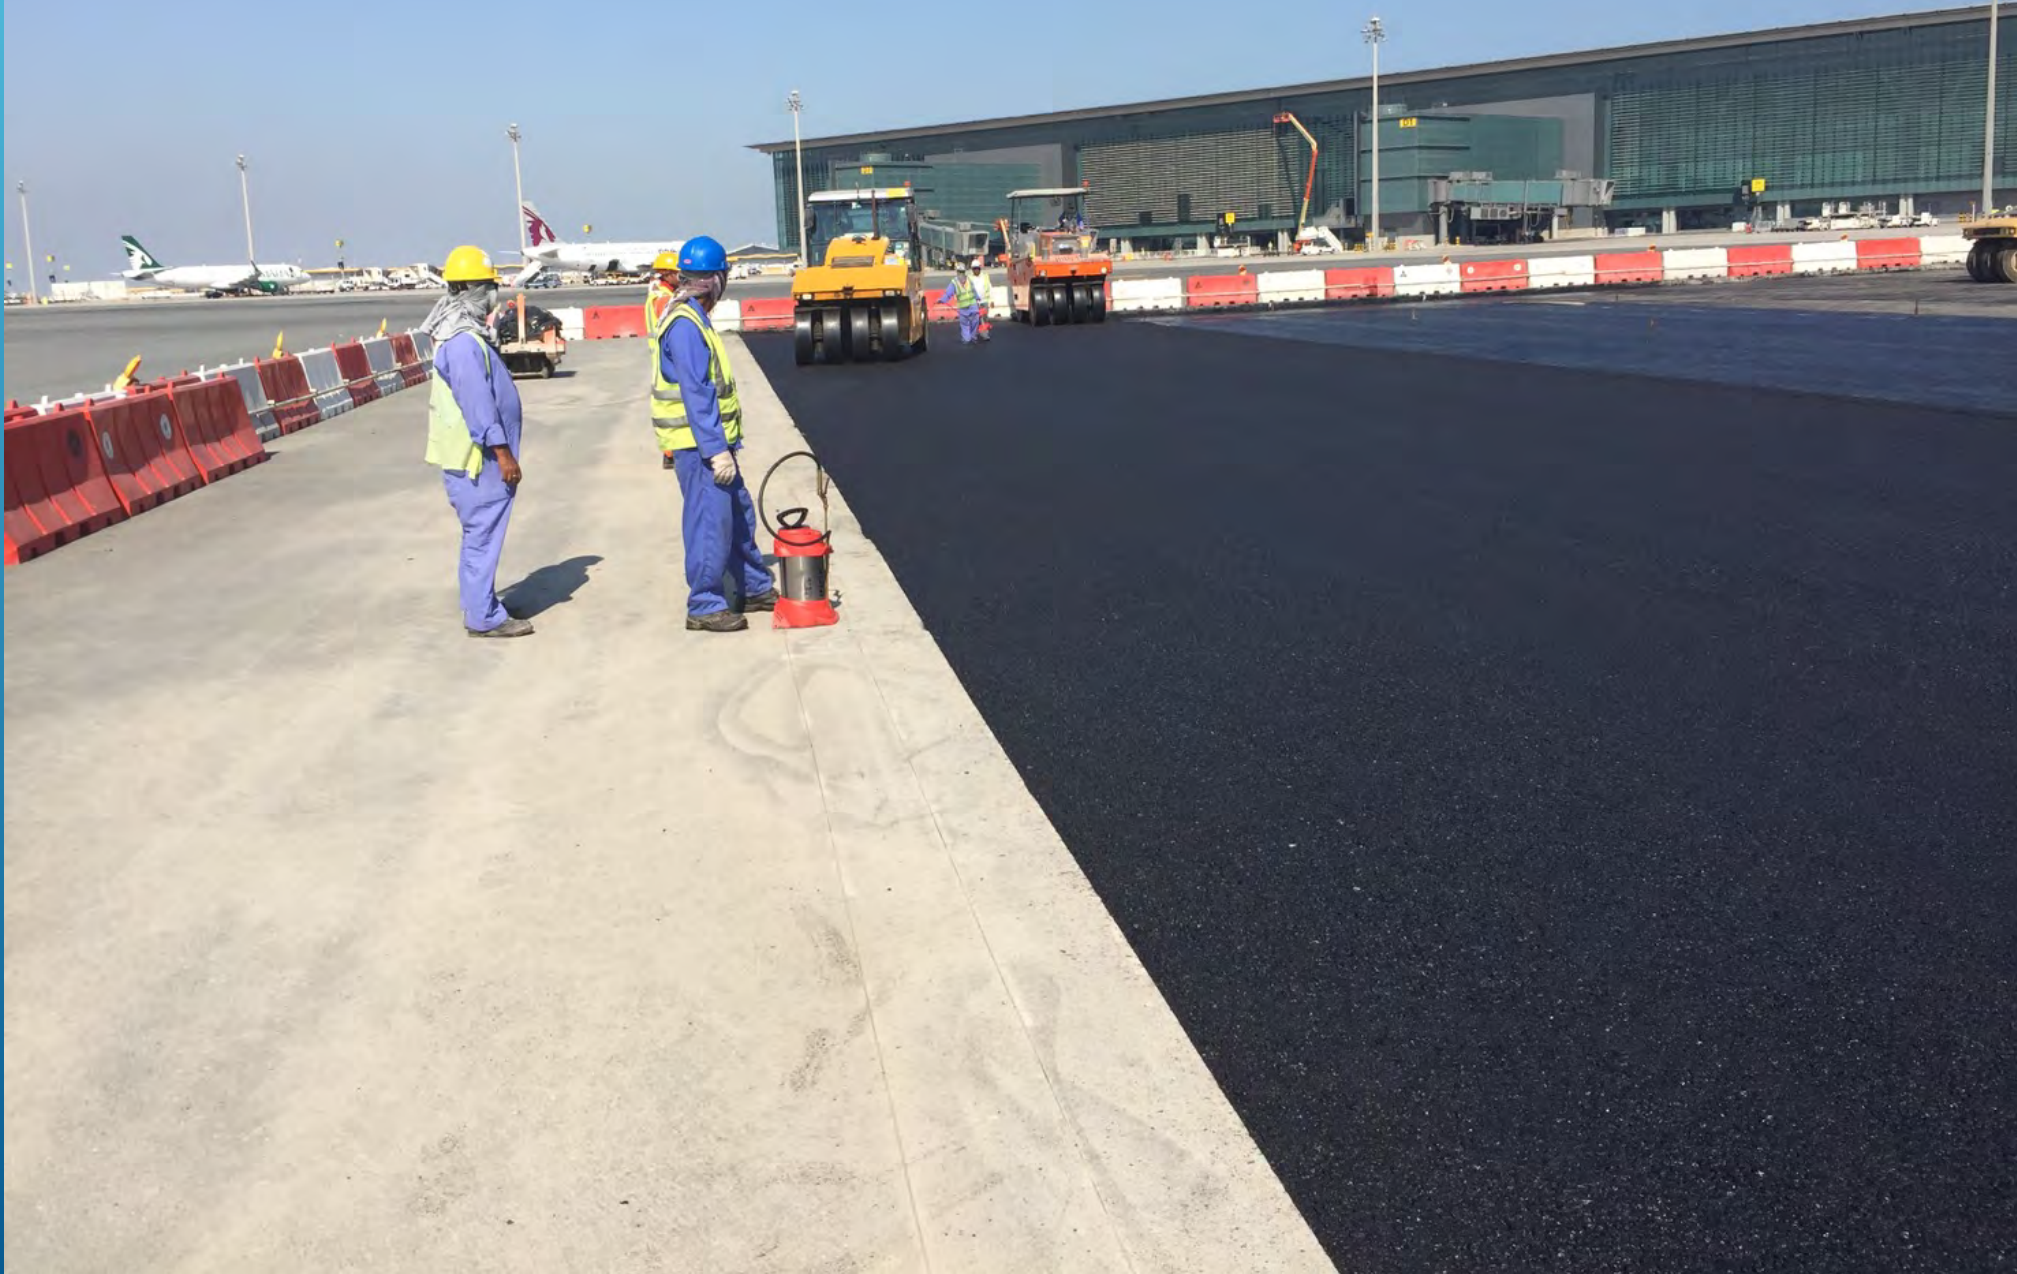
# Real Key to Compaction pneumatic tire rollers

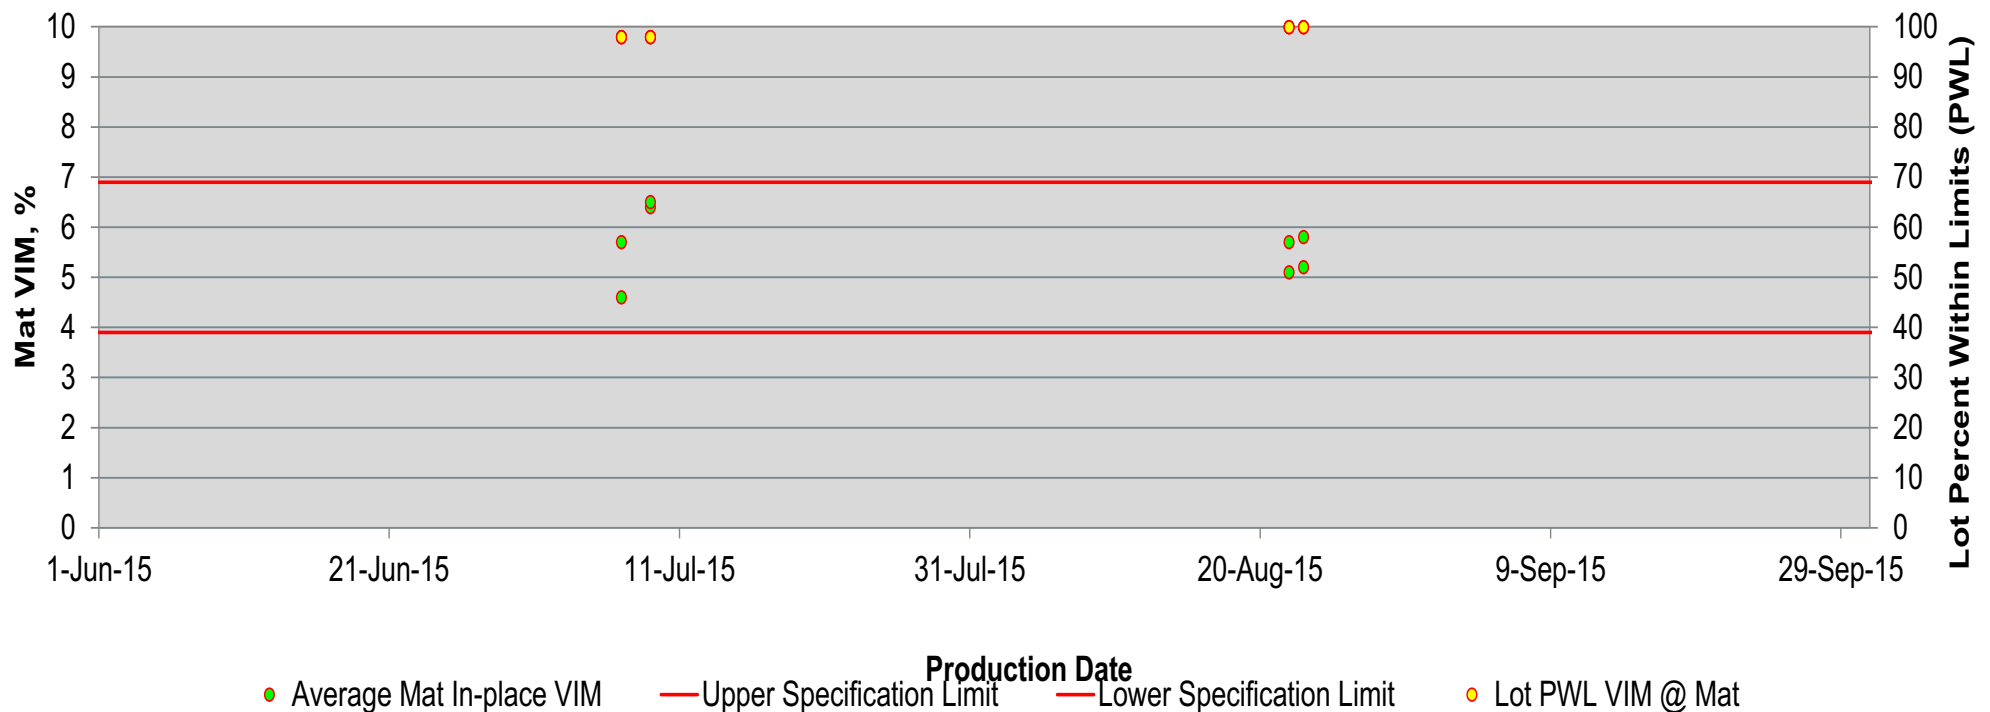
## CP 27 - Remedial Works - Quality Control Chart 25mm mix Mat Voids in Mix (VIM) (%)

Good mat densities

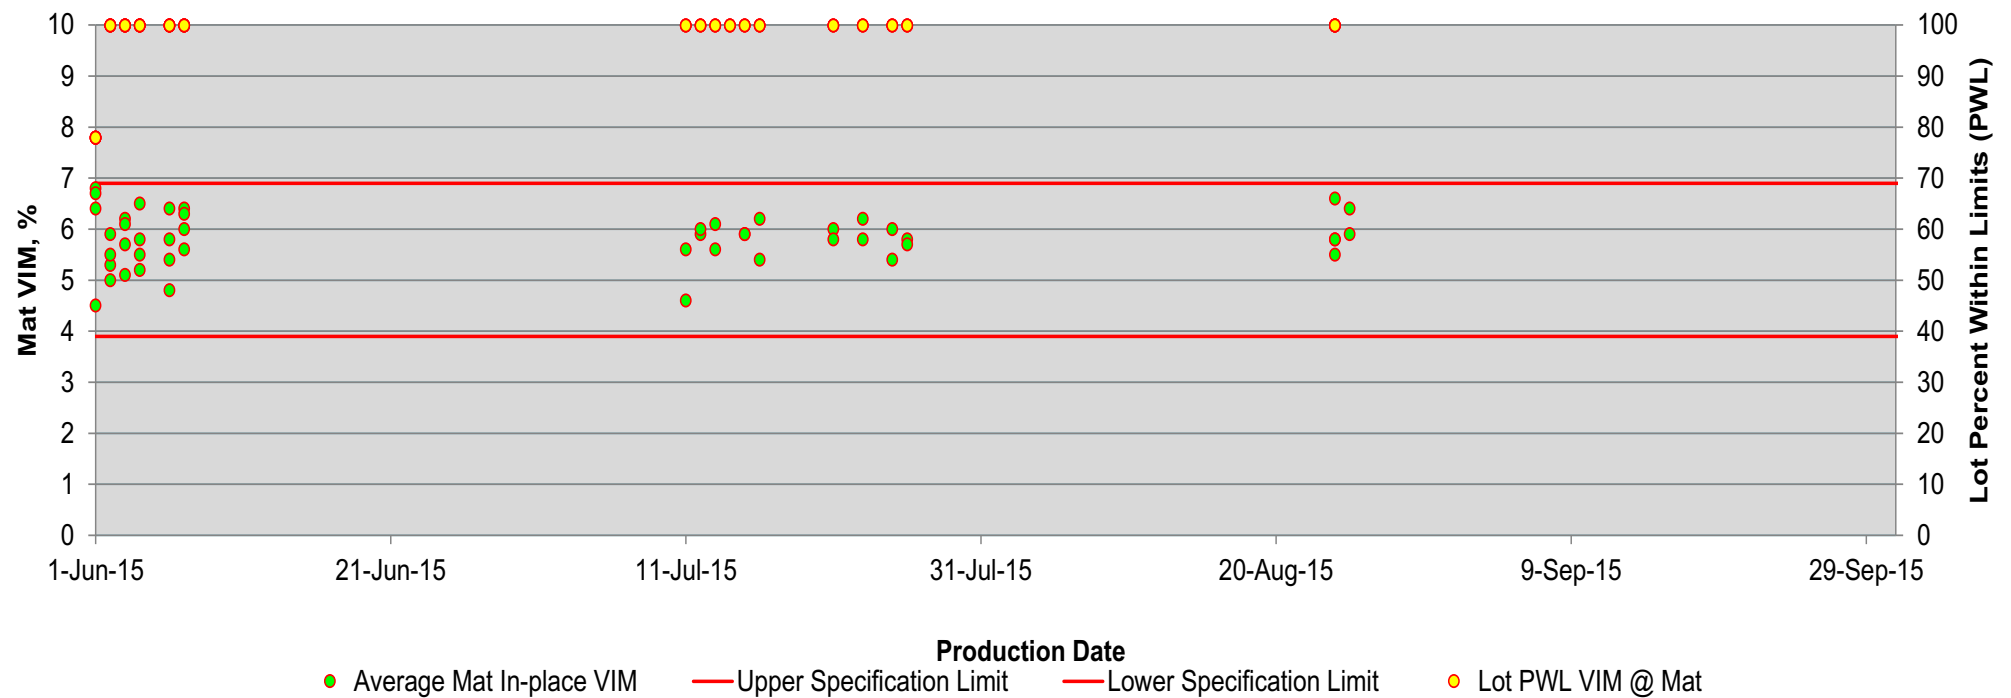
### Chart 19mm mix Mat Voids in Mix (VIM) (%)

Good mat densities

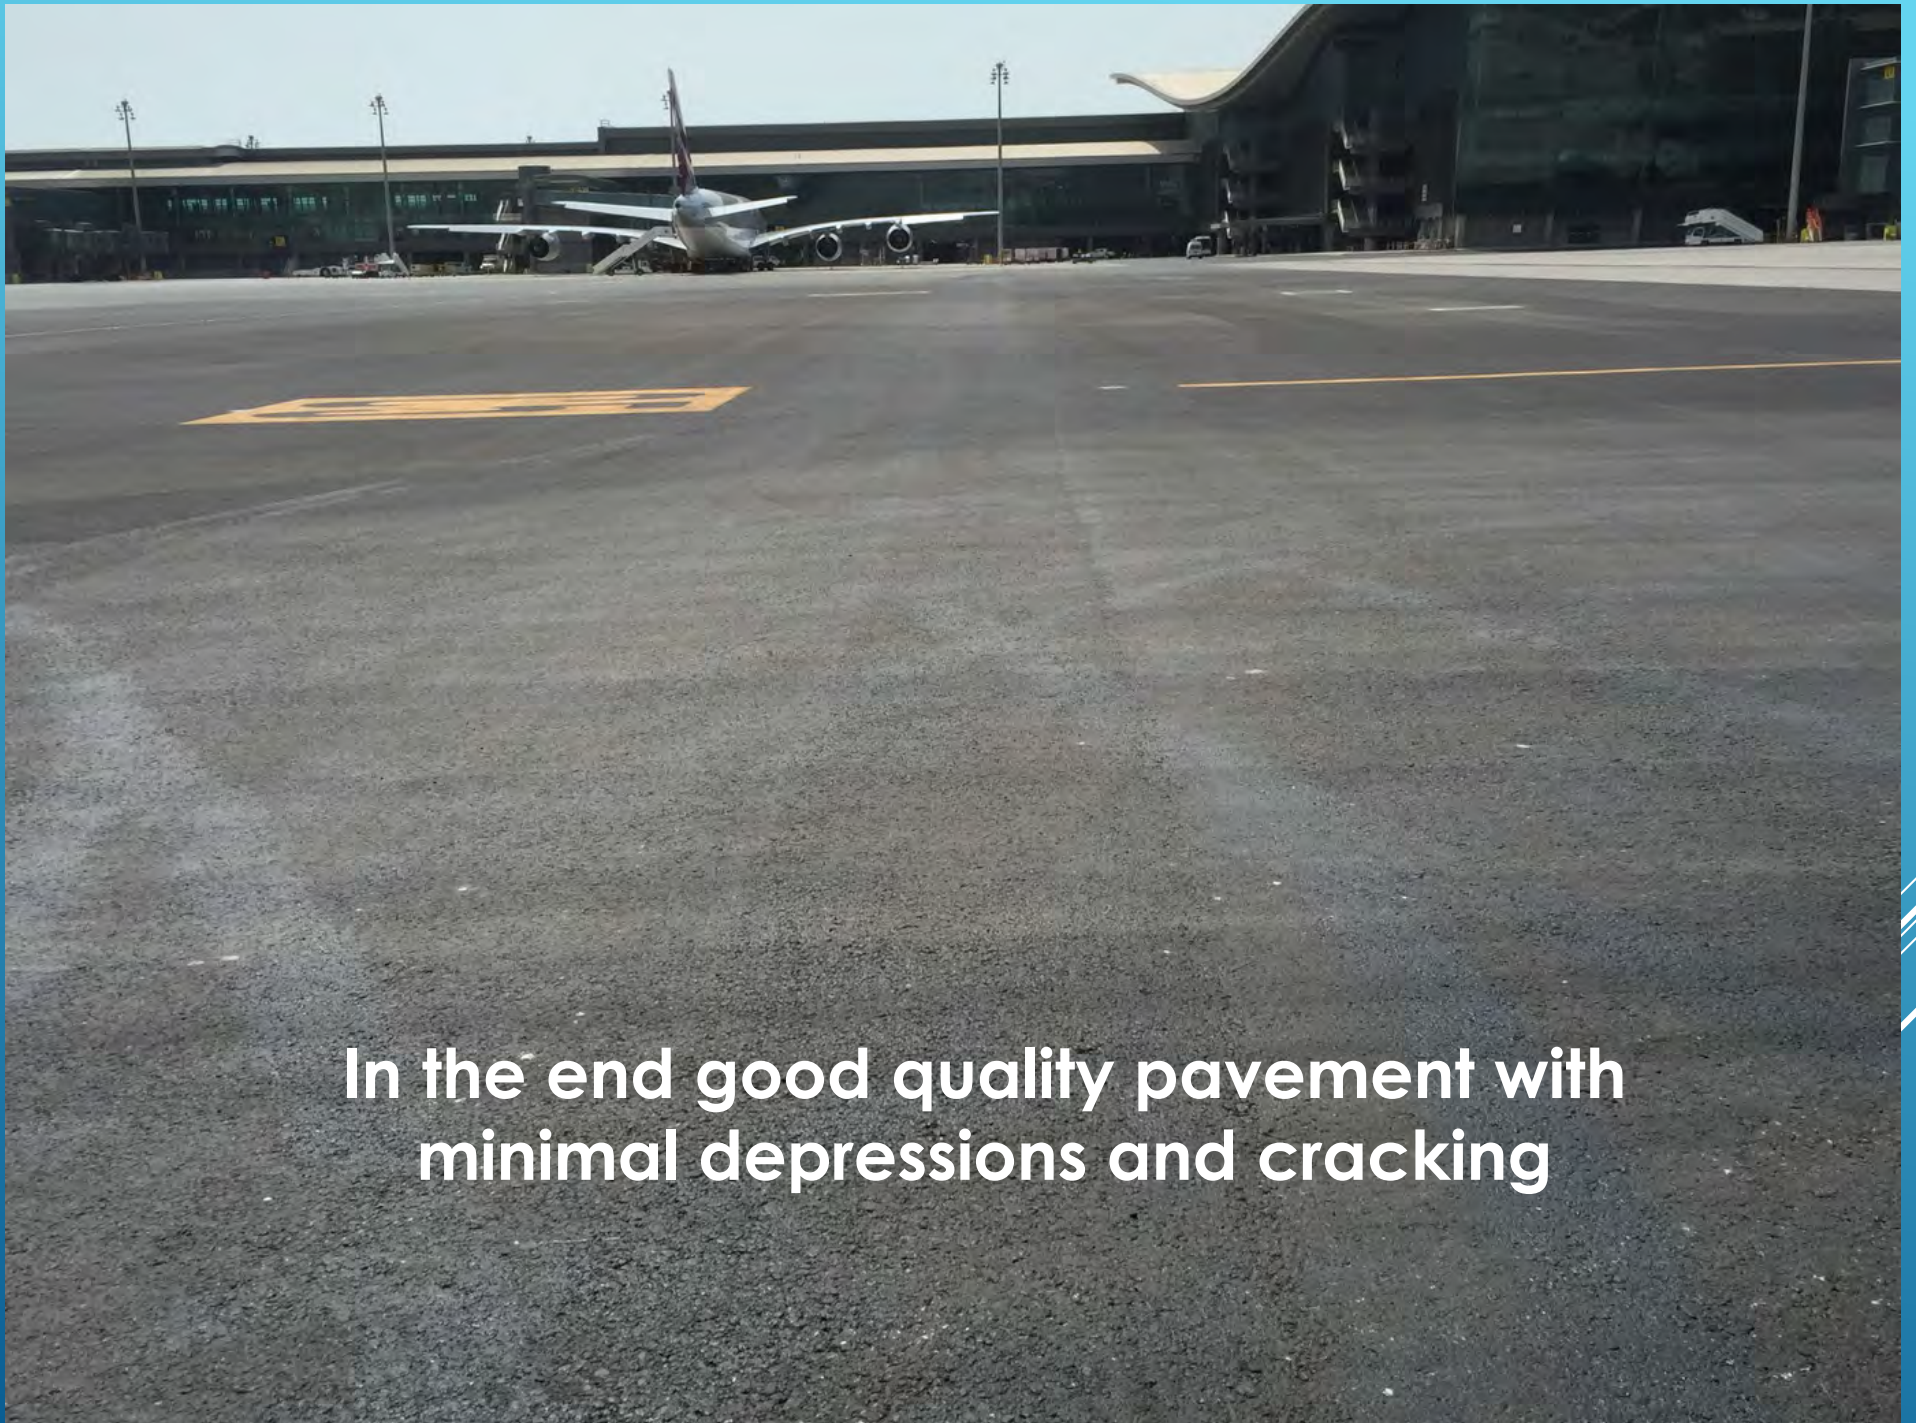
**In the end good quality pavement with  
minimal depressions and cracking**
