NESMEA UPDATE October 2014

PAVE IR UPDATE

New QC/QA Technology for Asphalt Contractors/DOTs

PAVE-IR Update

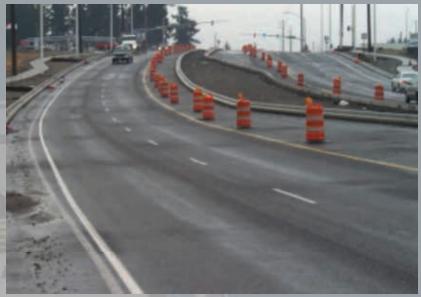
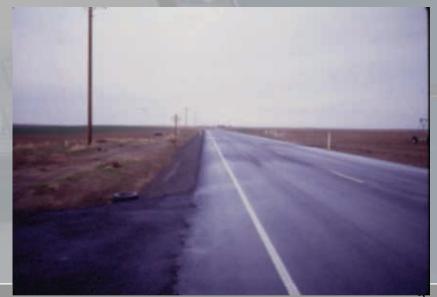
The Problem

- Localized "spots" of coarse surface texture
- Premature failure due to fatigue cracking, raveling, and moisture damage
- Increased roughness

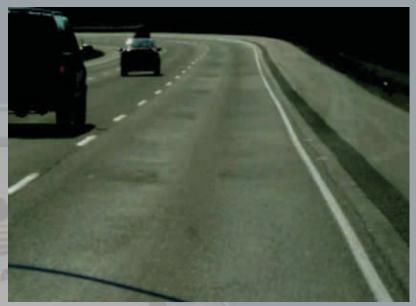
The Problem

- Cooling of mix during transport is not remixed during the laydown process.
- Paver Set-up
- Results in erratic mat temperatures that are not apparent to the laydown crew.

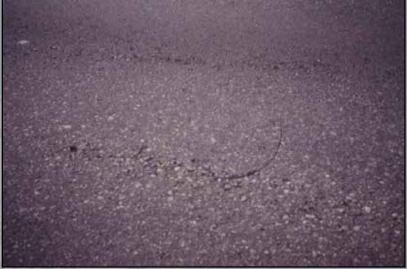
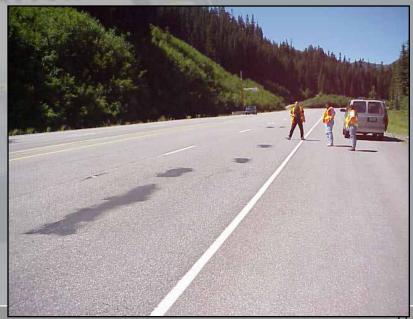
Effects on Pavement

- Same as insufficient compaction
 - Increased raveling and moisture damage
 - Reduced fatigue life
 - Increased roughness
- One percent increase in air voids results in a minimum of 10% reduction in pavement life (a rule of thumb)
- 25° F Differential=1 to 2% more air voids

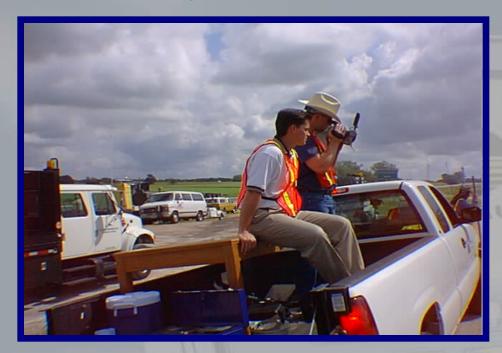
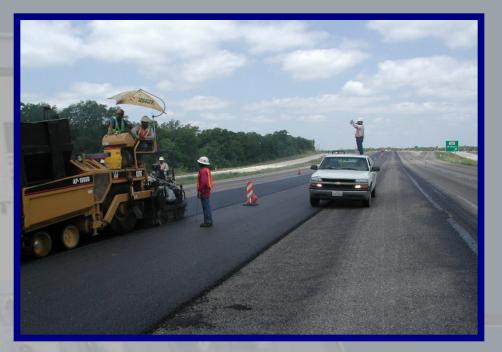
Initial research included the use of a thermal camera operated by a researcher in the back of a pickup truck. In addition to obvious safety considerations, this initial method was found not to be practical. A series of infrared images had to be manually combined to produce a complete profile. Distance and position data were also difficult to incorporate.

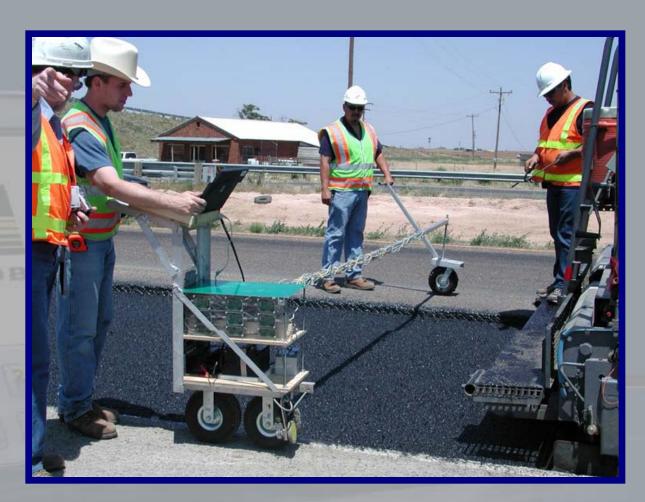
First generation Pave-IR system was first used in October 2003.

- Propelled manually
- Long setup time
- Loose connection wires
- Unstable wheel design
- Battery powered
- Required two operators

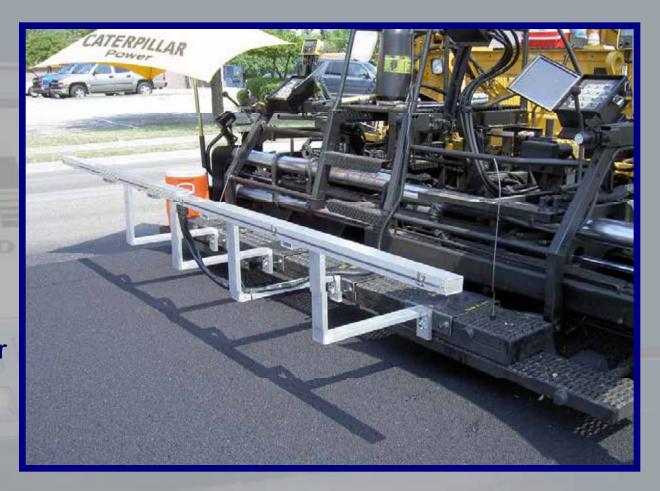
Third generation Pave-IR system was first used in January 2005.

- Paver mounted
- Rapid setup time
- Central master control
- No dedicated operator

- Battery powered
- Distance measuring wheel
- Components not suitable for everyday use on heavy equipment.

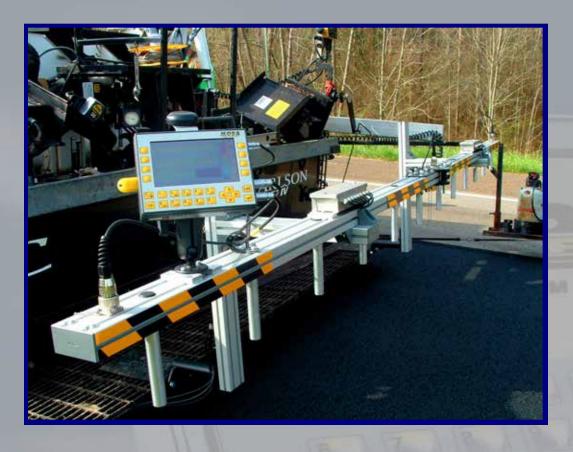
PAVE-IR INSTALLATION

The MOBA Operand™ computer attaches to sensor beam.

GPS antenna mounts above the Operand™ computer.

Memory drive connects directly to Operand™ computer

System is powered by machine voltage (10-28 VDC).

Sensor beam is hinged in center for easy setup and storage.

- 12 Infrared sensors (standard)
- Absolute encoder used for distance measurement
- MOBA OPERAND™ computer
- GPS antenna
- Includes PAVE PROJECT MANAGER™ software for post analysis and reports
- Kit includes system cabling and all necessary screed mounting hardware.

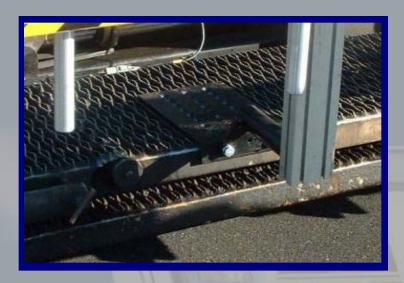
The PAVE-IR™ system mounts to the screed walkway by bolting or welding.

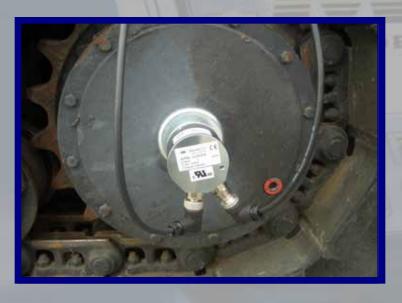
The distance encoder mounts to the wheel or torque hub using a magnet.

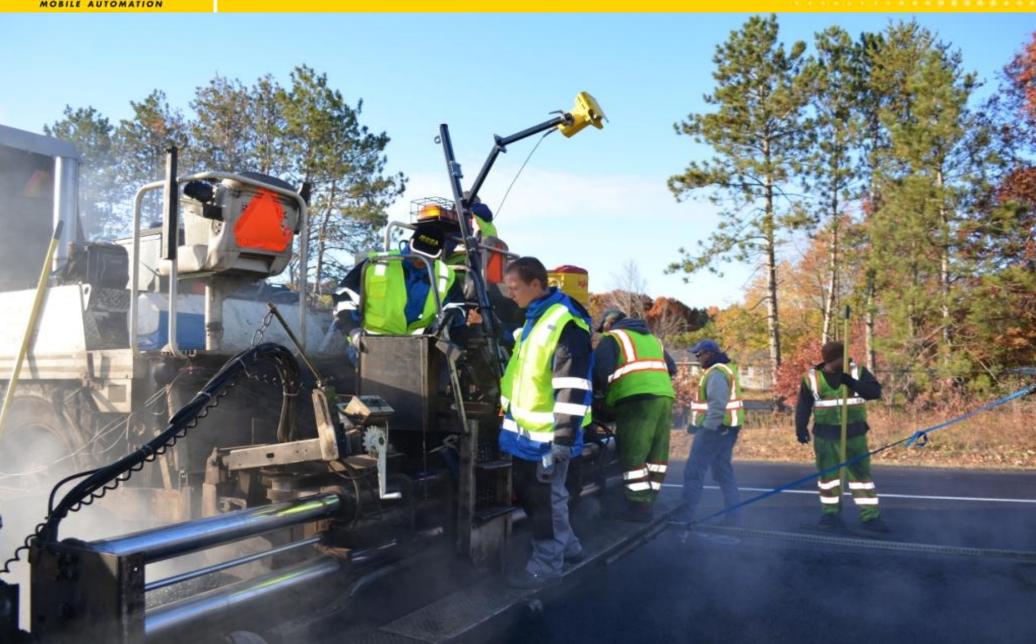
Prototype Scanner

- Next Generation PAVE-IR(I)
 - Real-time (pre-compacted) IRI smoothness measurement.
 - Network (wireless) to onboard compaction systems.
 - Wireless transmission of job data to QC office or plant.
 - Grade and slope control monitoring.
 - Material control (auger/conveyor) system monitoring.
 - Infrared scanner mounted above paver deck.
