# **Pennsylvania's Experience with Thin Asphalt Overlays**

**Northeast Asphalt User Producer Group  
Annual Meeting  
Newark, DE  
October 20, 2016**

**Mansour Solaimanian, PhD, PE  
Penn State University**

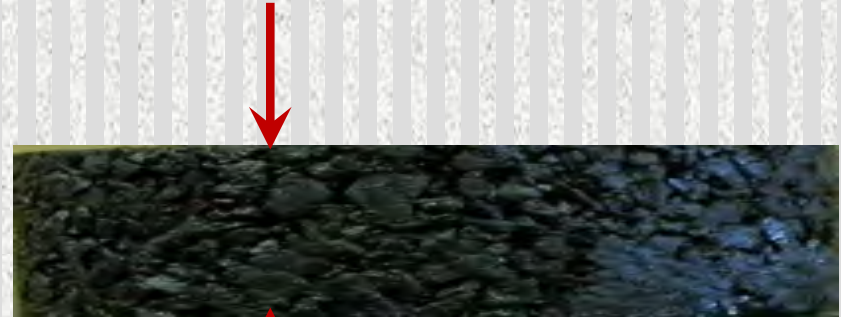
Aggregate  
NMAS

Mat Thickness  
0.5 to 1.25 in

$$3 \leq \text{Ratio of Thickness to NMAS} \leq 5$$

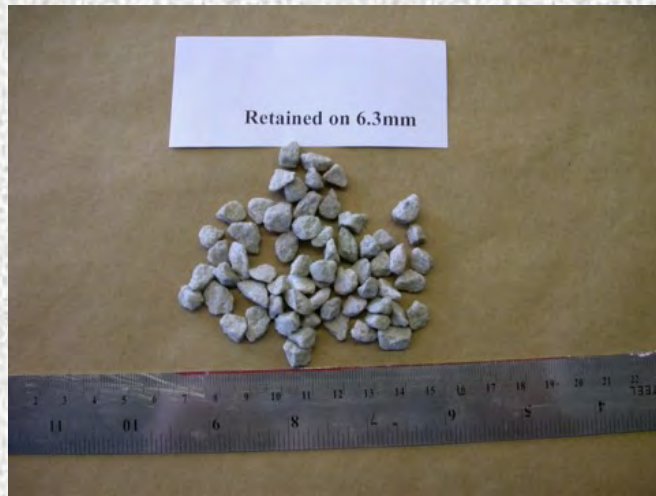
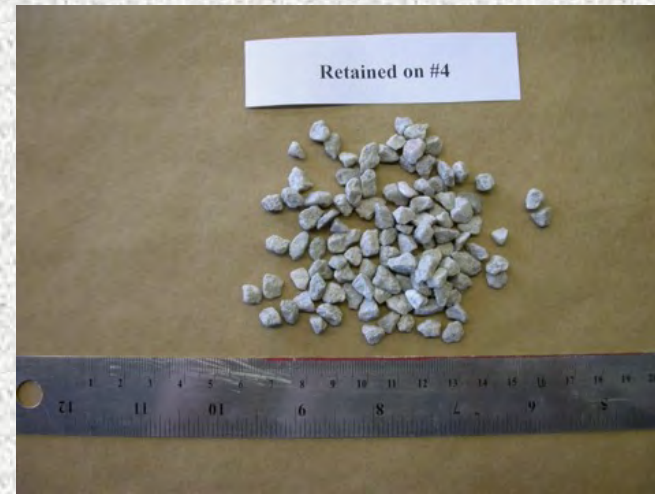
## **6.3 mm NMAS Mix Placed at 1 inch thickness**

**Aggregate: Skid Resistance Level (SRL): E**  
**Polymer Modified Binder: PG 76-22 (for heavier traffic)**  
**Gyrations Level: 75**  
**Design Air Void: 4%, Min. Design VMA: 16.5%**  
**Design Binder Content: 6.7%; 7.0%; 6.9%**  
**NO RAP/RAS**

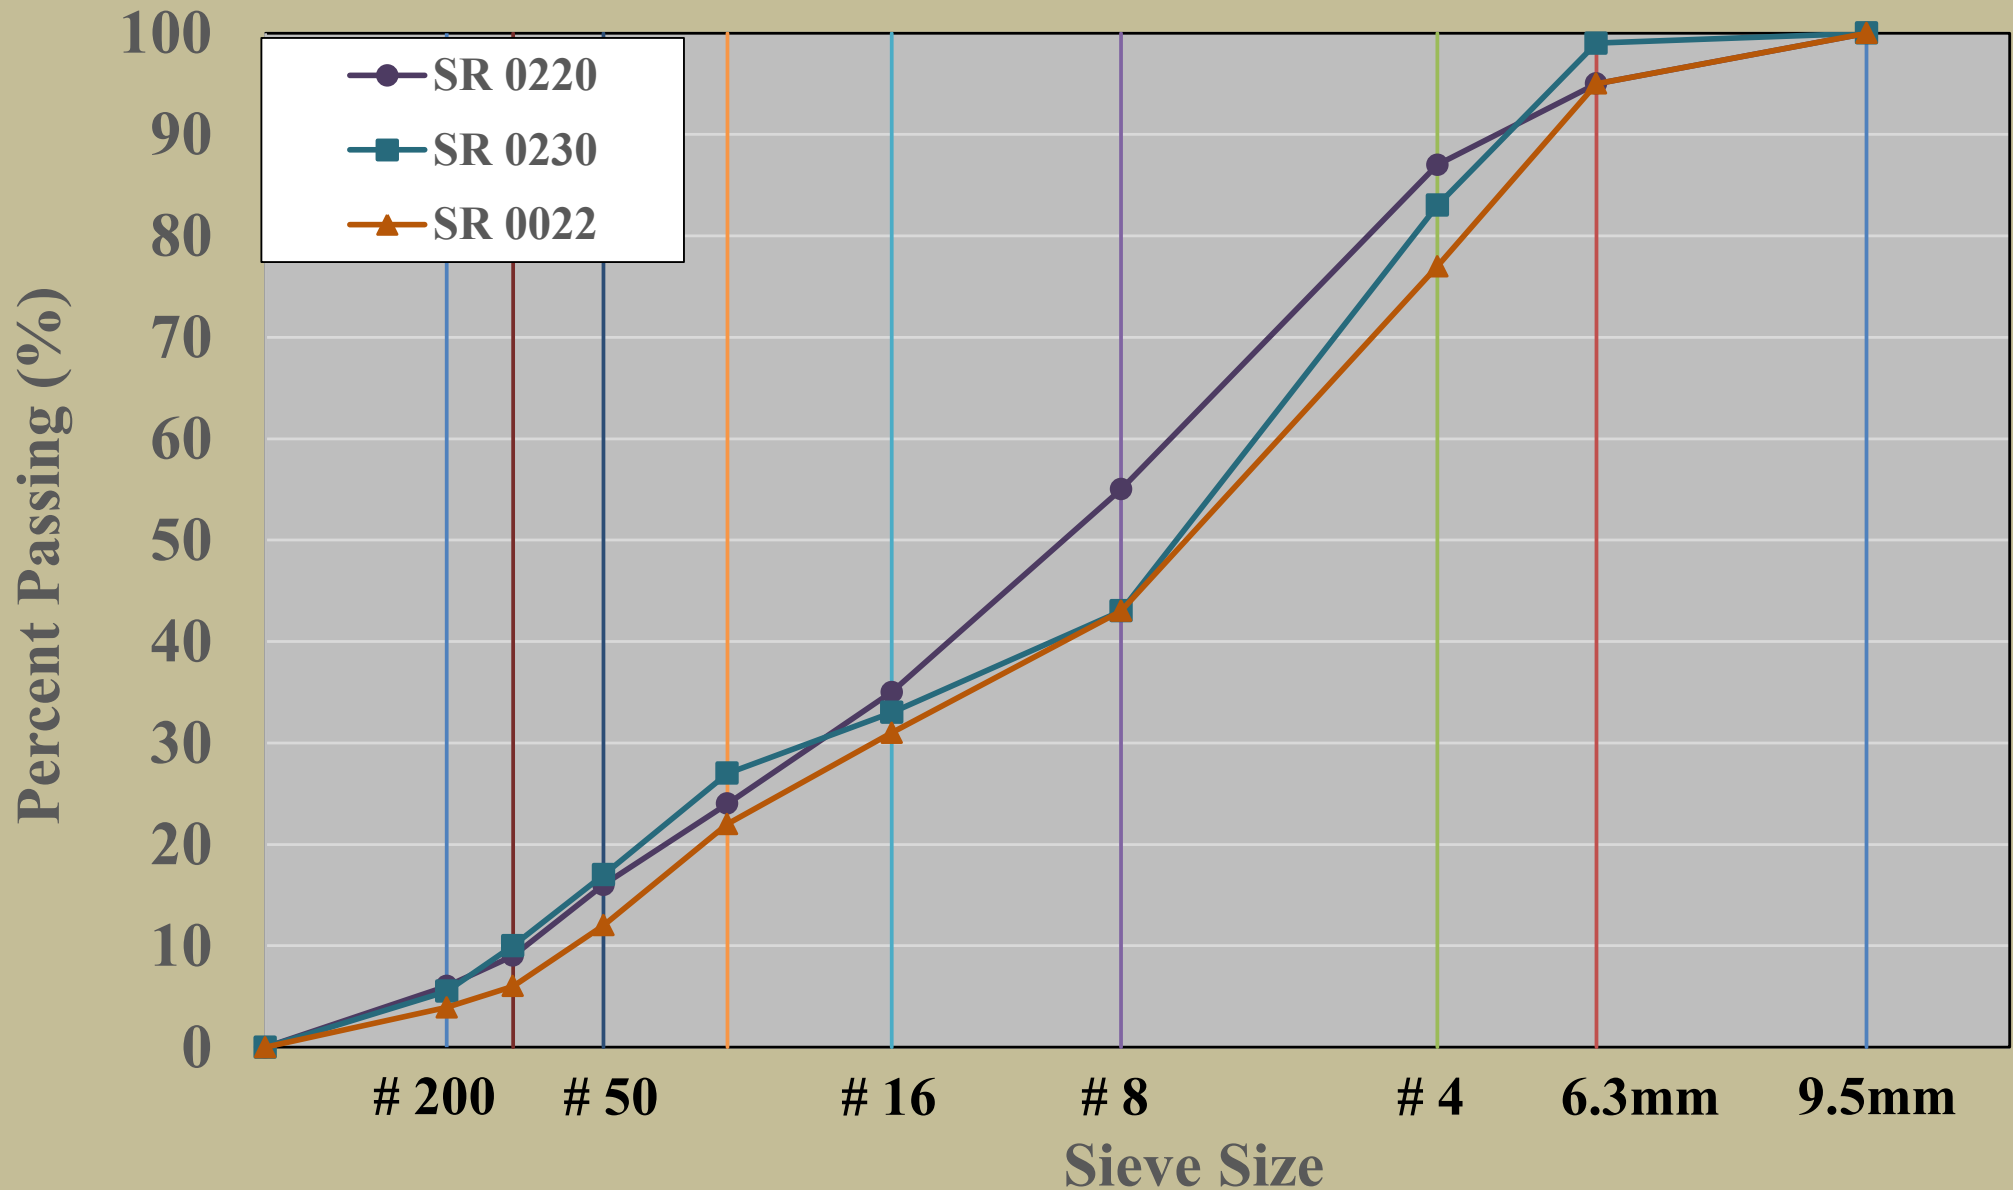
Aggregate Gradation of Three Pilot Projects

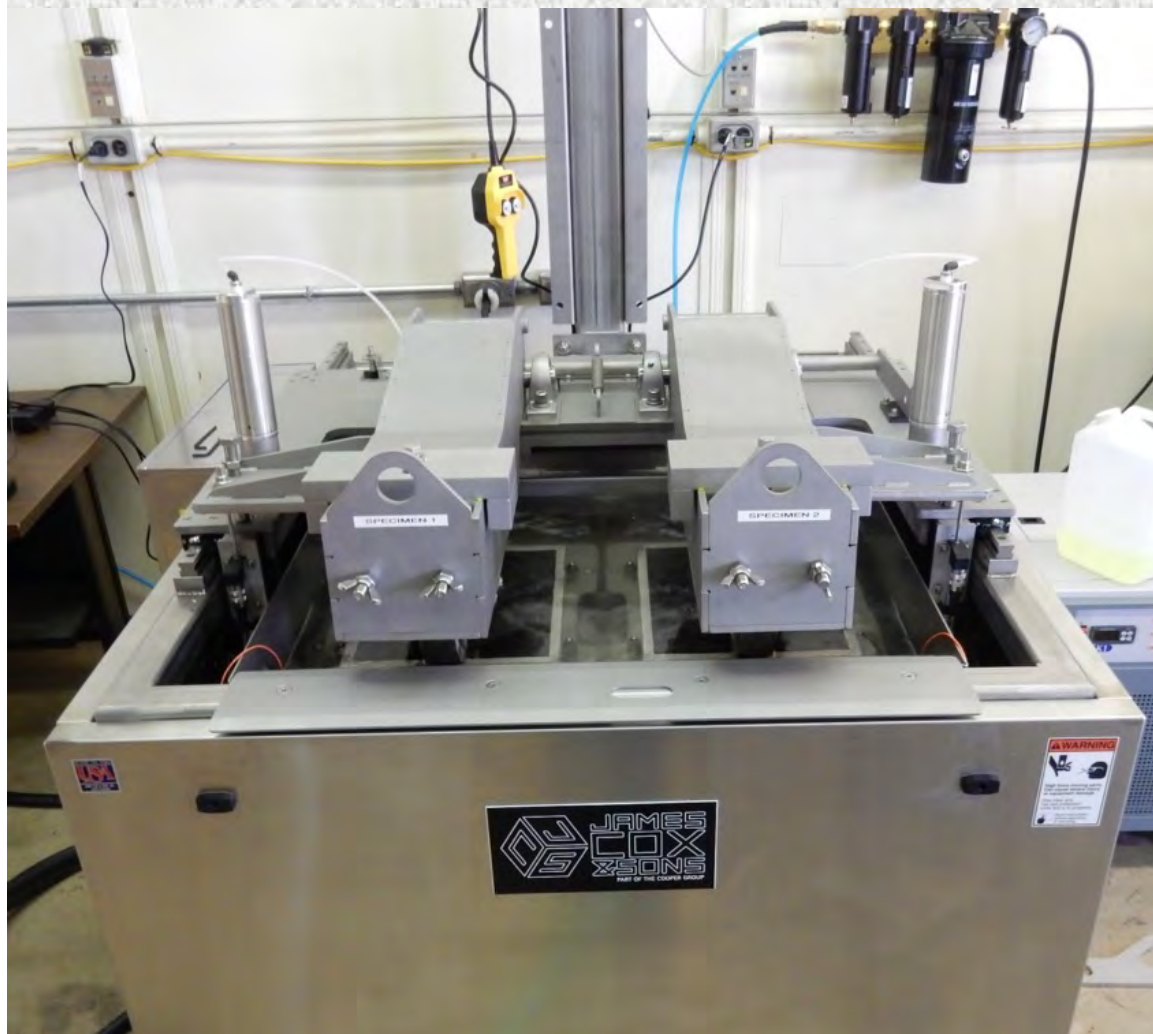
**Specimens under water**  
**Test Temperature: 50°C**  
**20,000 Passes**  
**50 Passes per minute**  
**158-lb load**

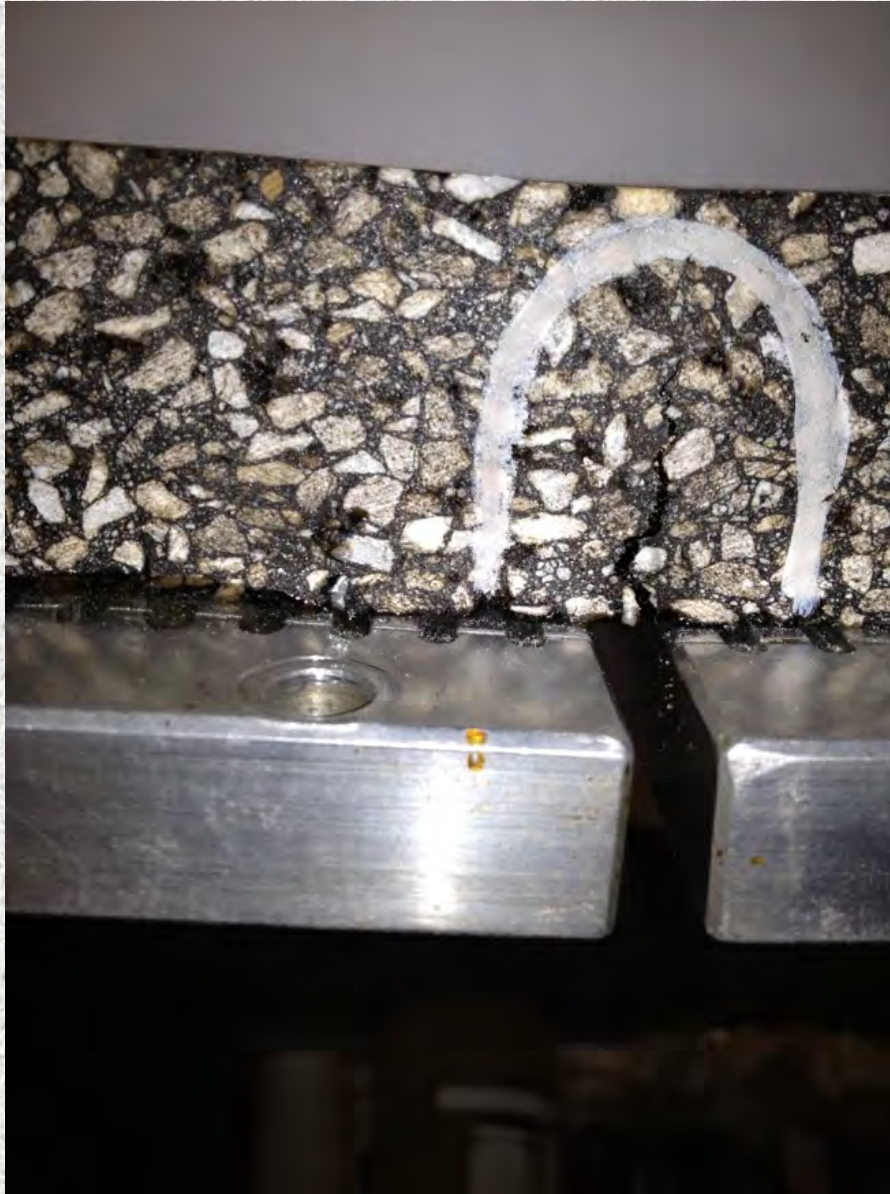
**Test Temperature: 25°C**

**# of load cycles: 1000**

**Or until load reduced to  
93% of original**

- **Repeated loading (triangular form) under constant deformation**
- **Deformation magnitude per load cycle: 0.025 inches (0.6 mm)**
- **Duration of each load cycle: 10 seconds**

**Cycles to failure > 500**

**Good Performance**

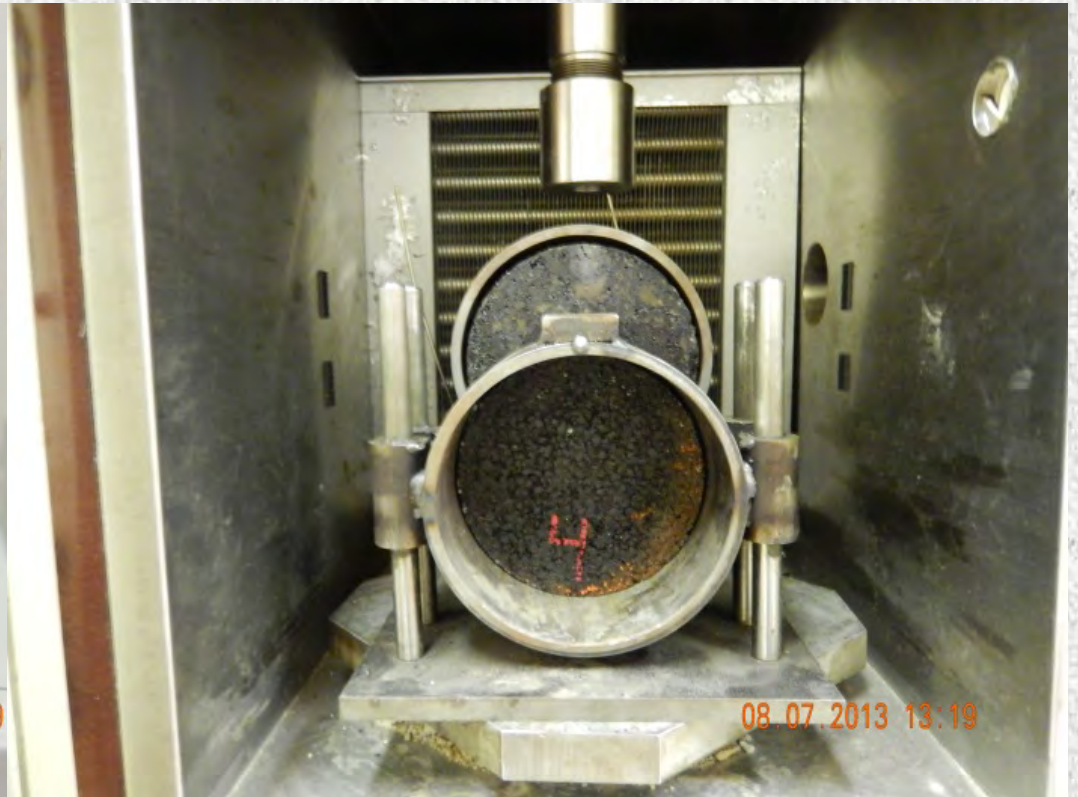
**Tested Specimen  
in Direct Shear**

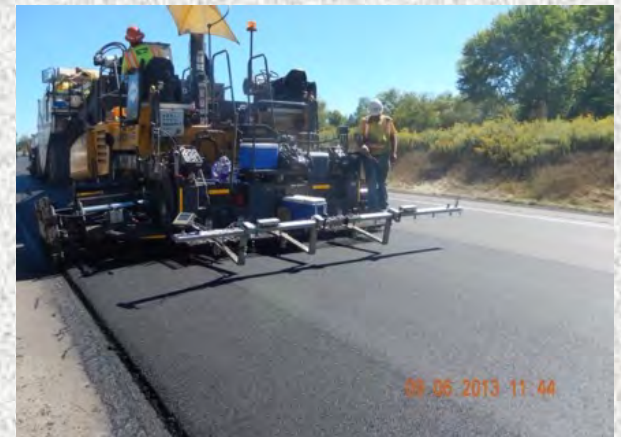
- Continuous Temperature Measurement Using Infrared Sensor Bars
- Gives Paver Speed, Idle Time, Position

A large yellow Volvo Pave-IR thermal profiling machine is shown on a road. Two workers in safety gear are visible. The machine has a large yellow canopy and various sensors and equipment mounted on it. The road is paved with asphalt, and there are trees and bushes in the background.

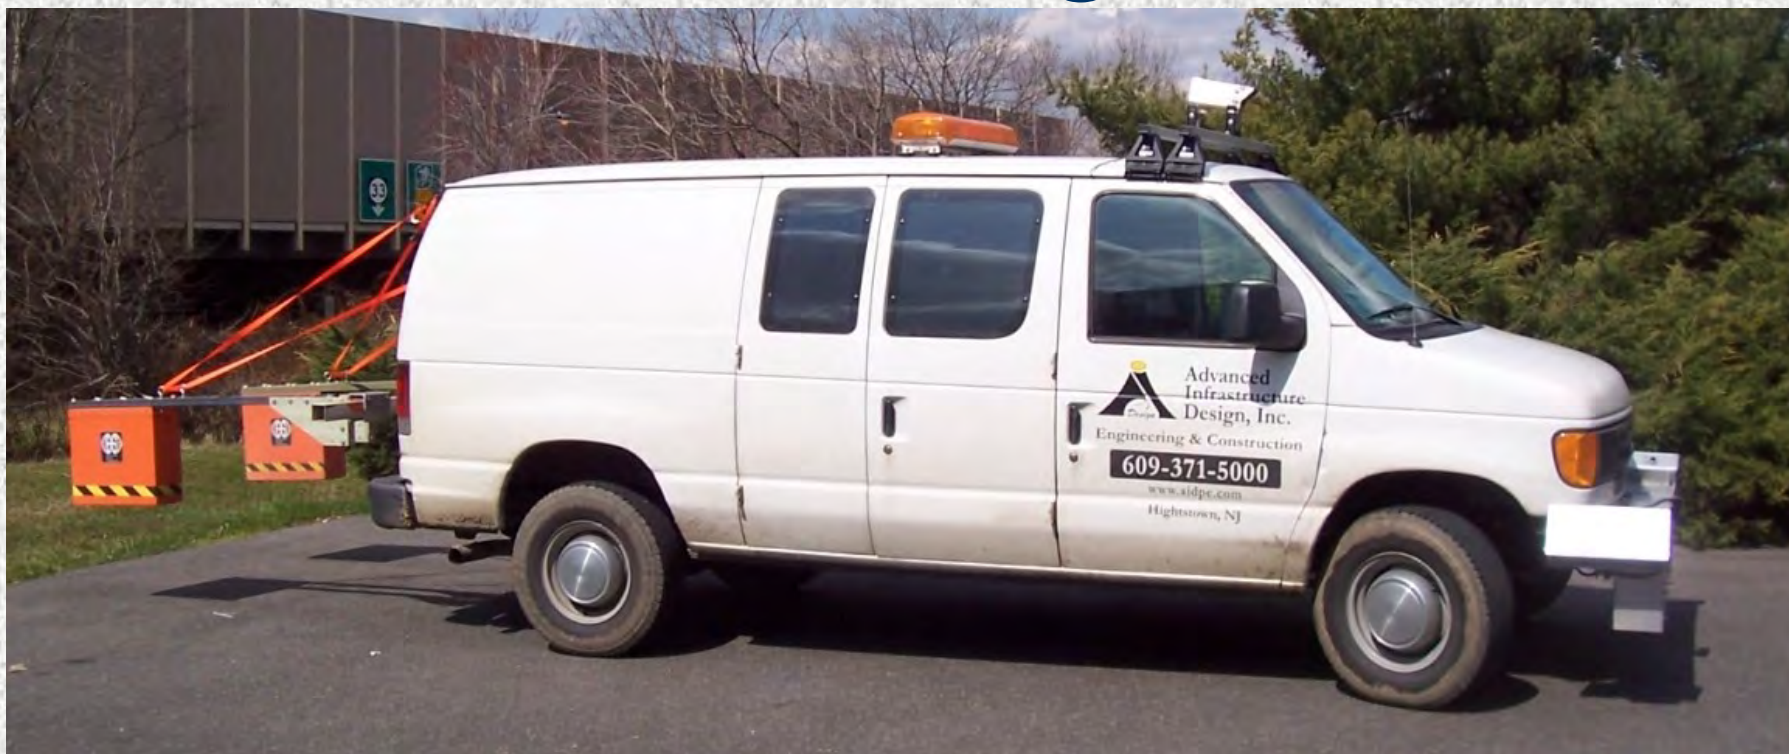
**AID Integrated Testing Vehicle**  
**Courtesy of Advanced Infrastructure Design, Inc.**

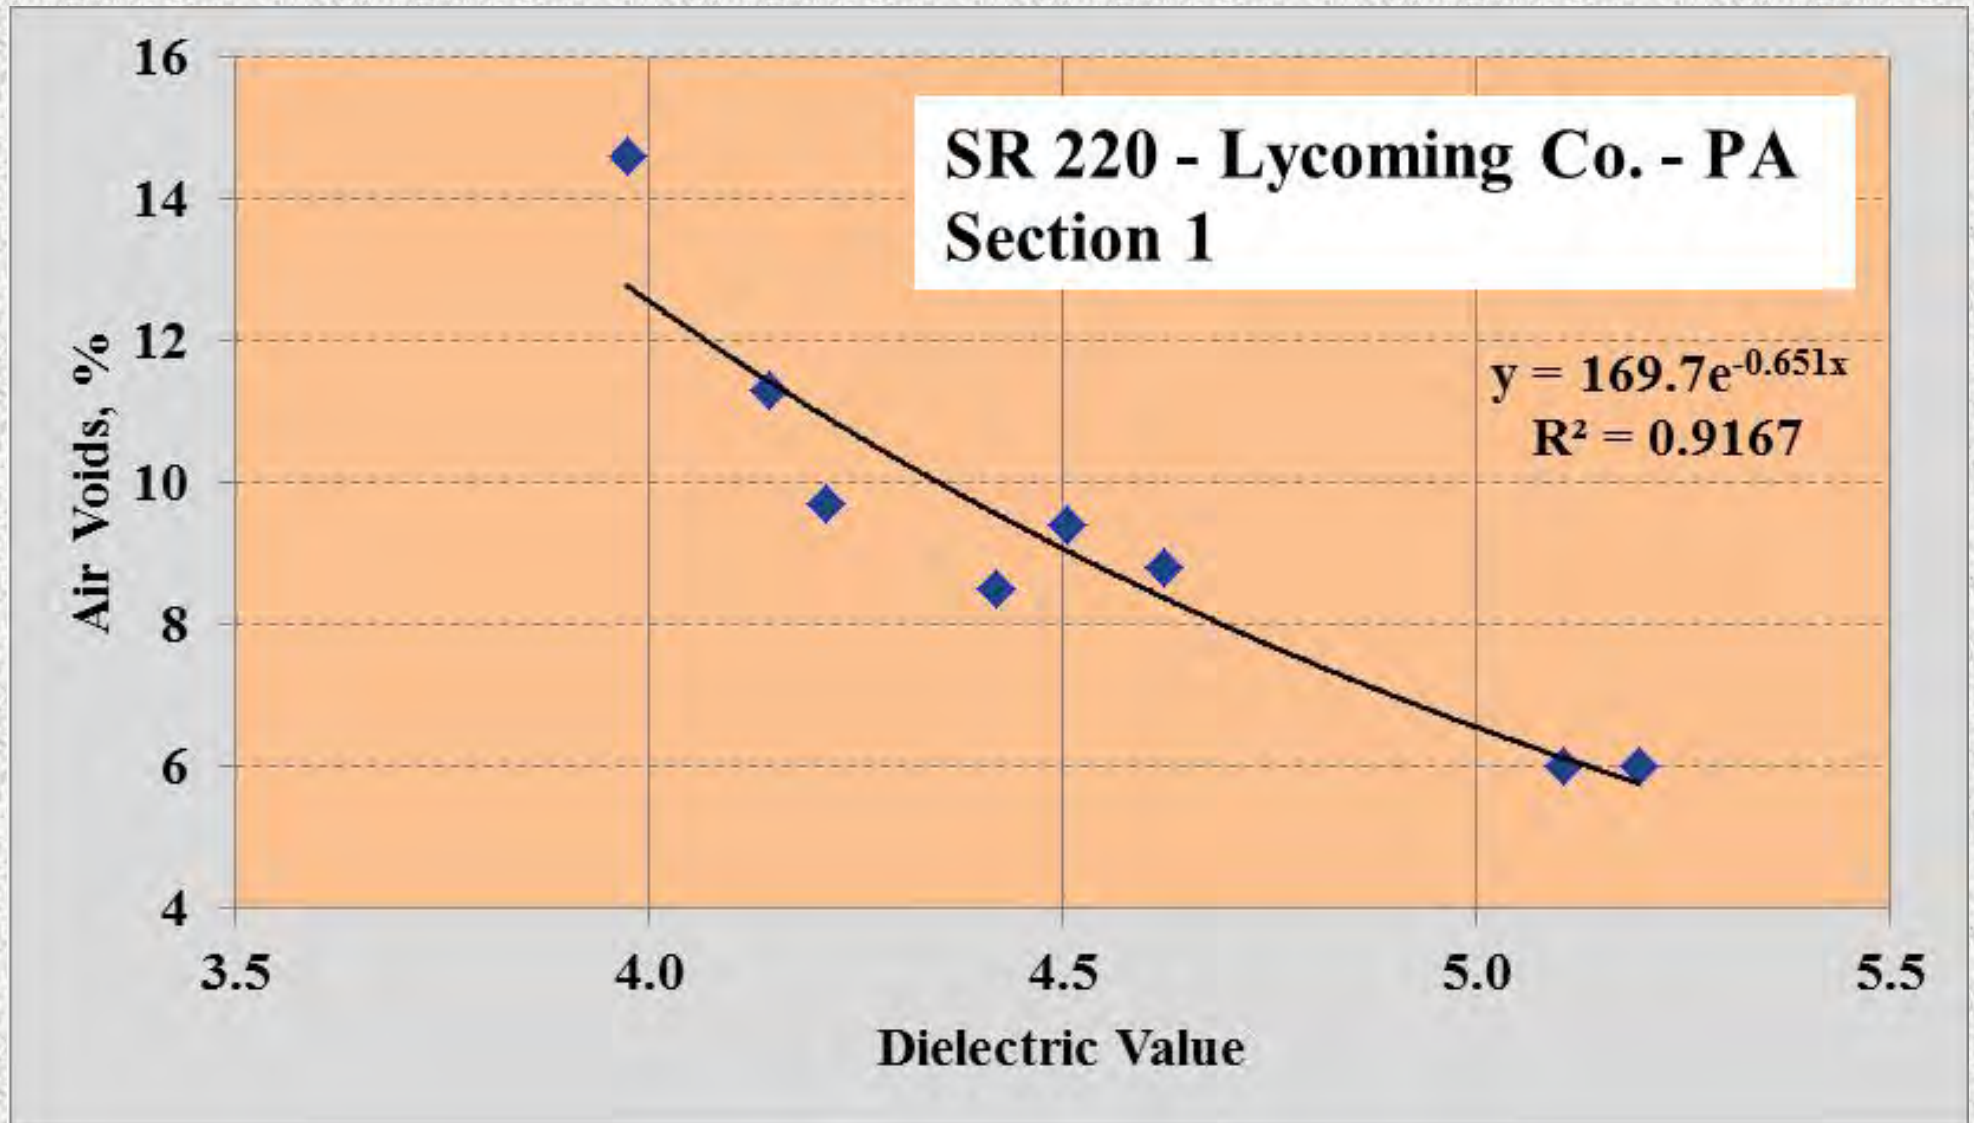
# GPR Dielectric-Air Void Relationship

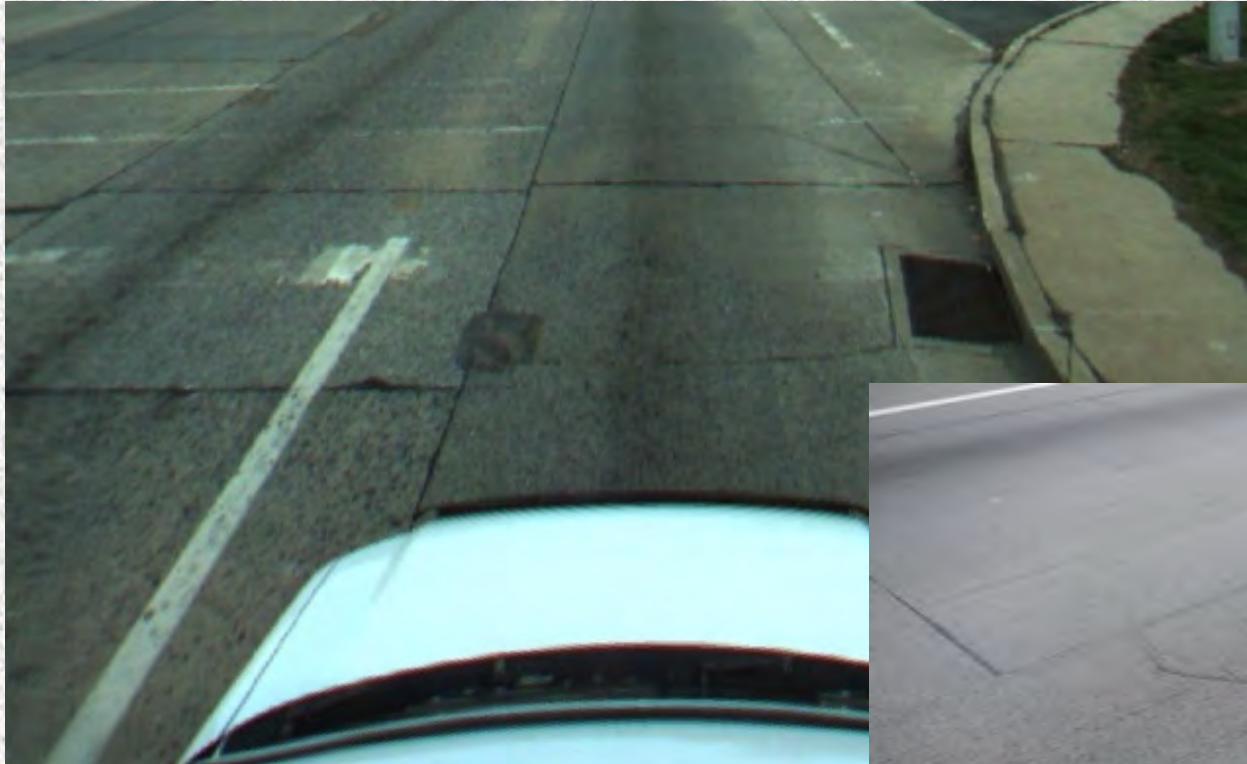
**Before  
paving**

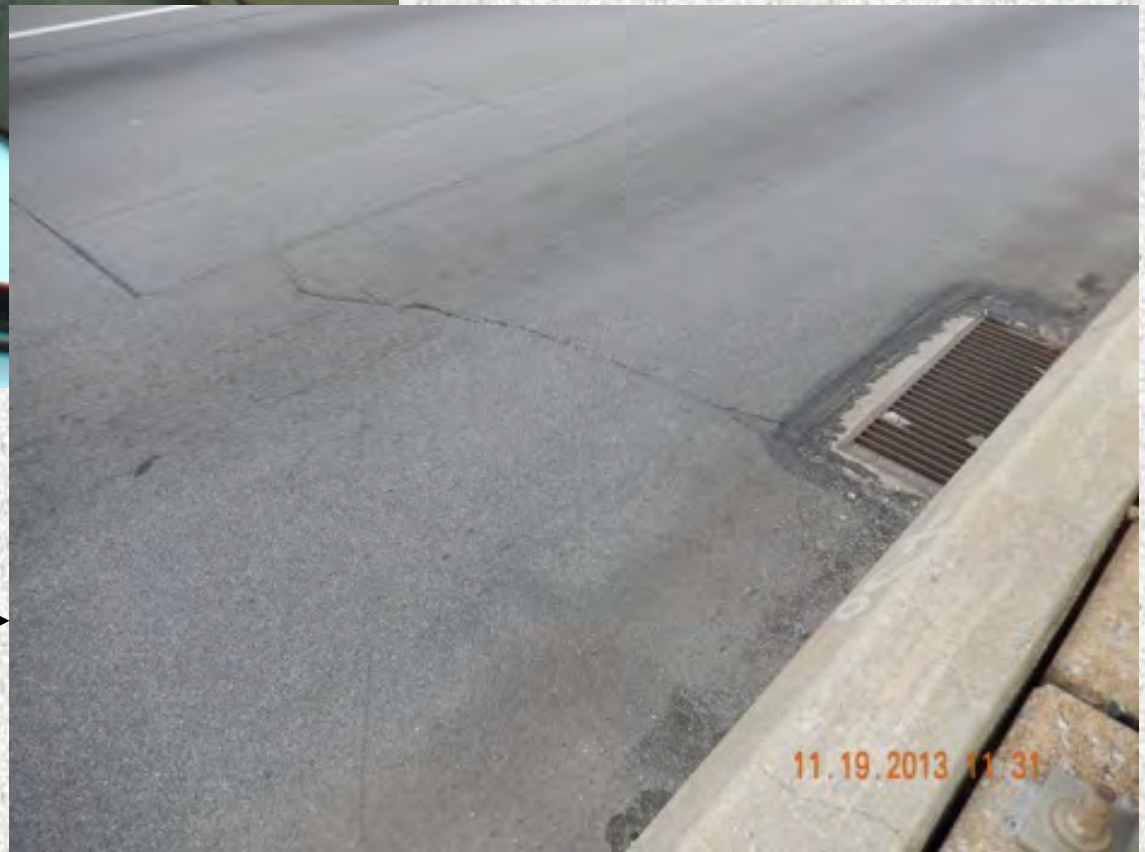
**Nov. , 2013  
≈ 15 months  
after paving**

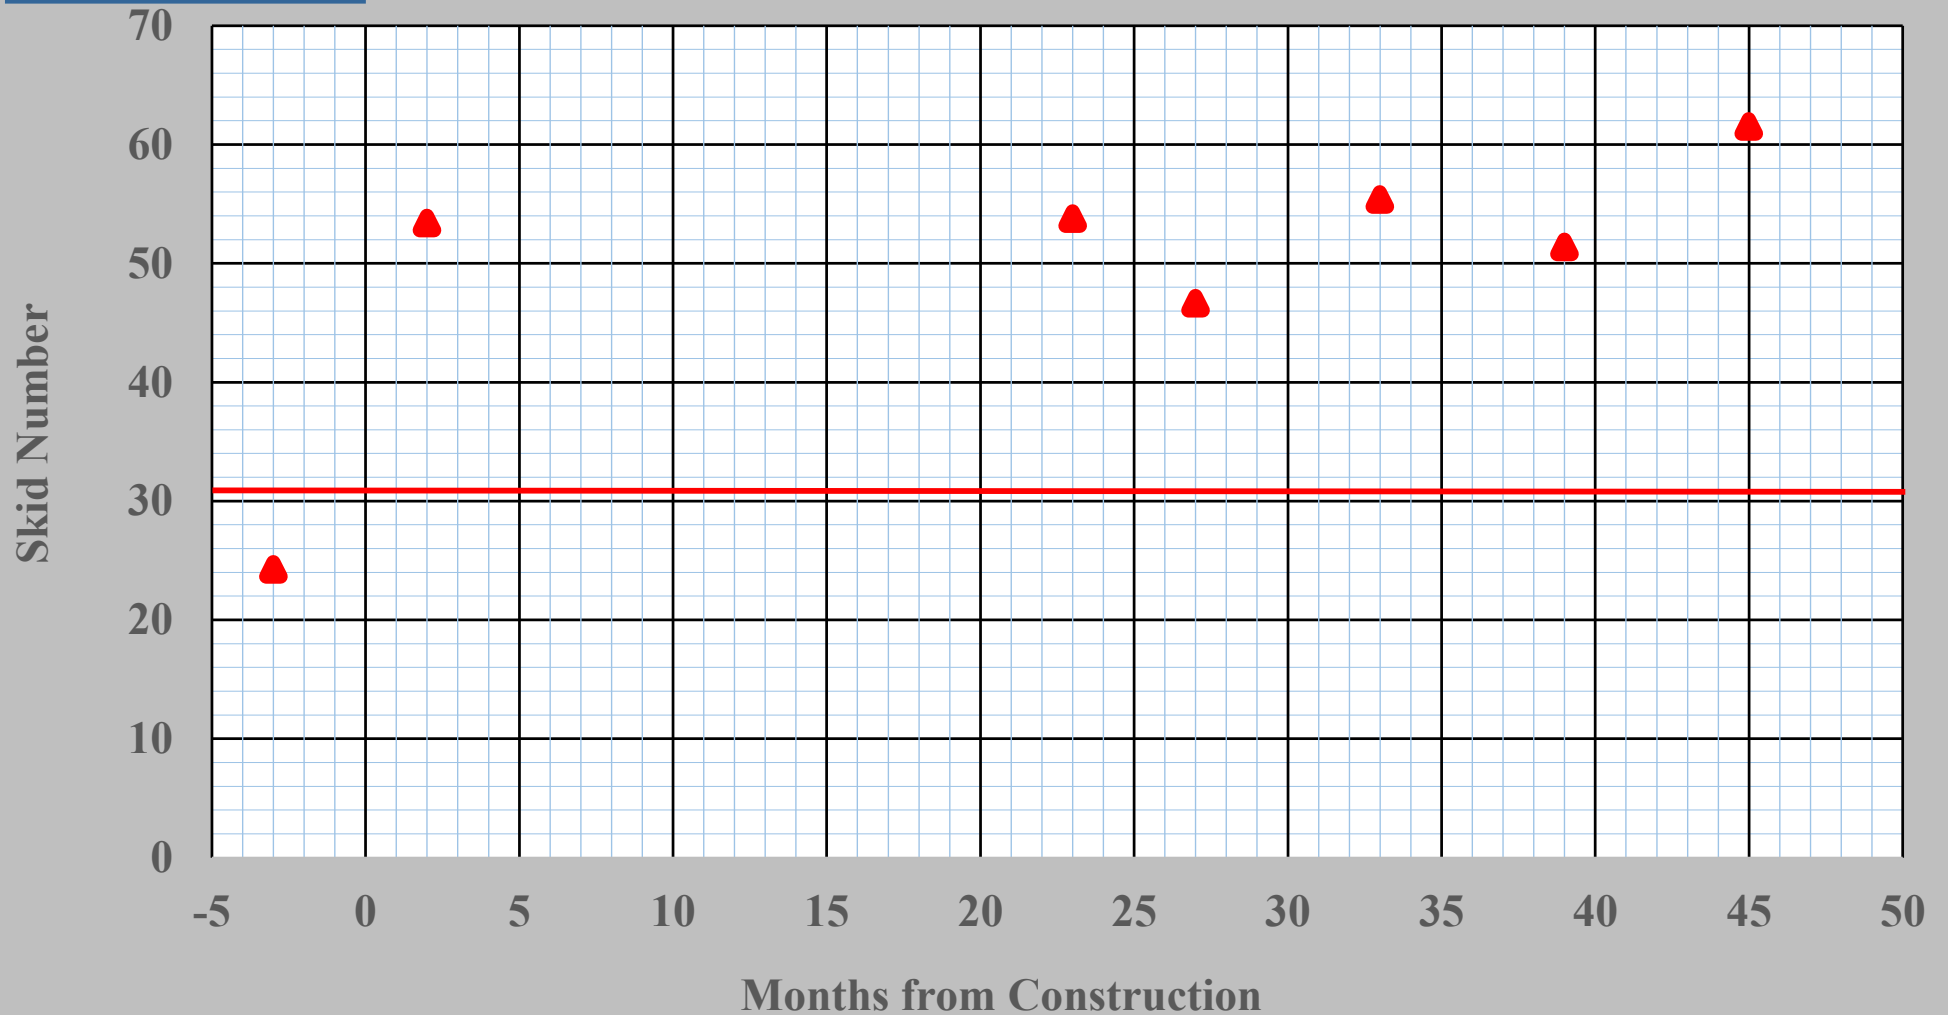
Average Skid Number vs. Month of Service  
Constructed in July 2012

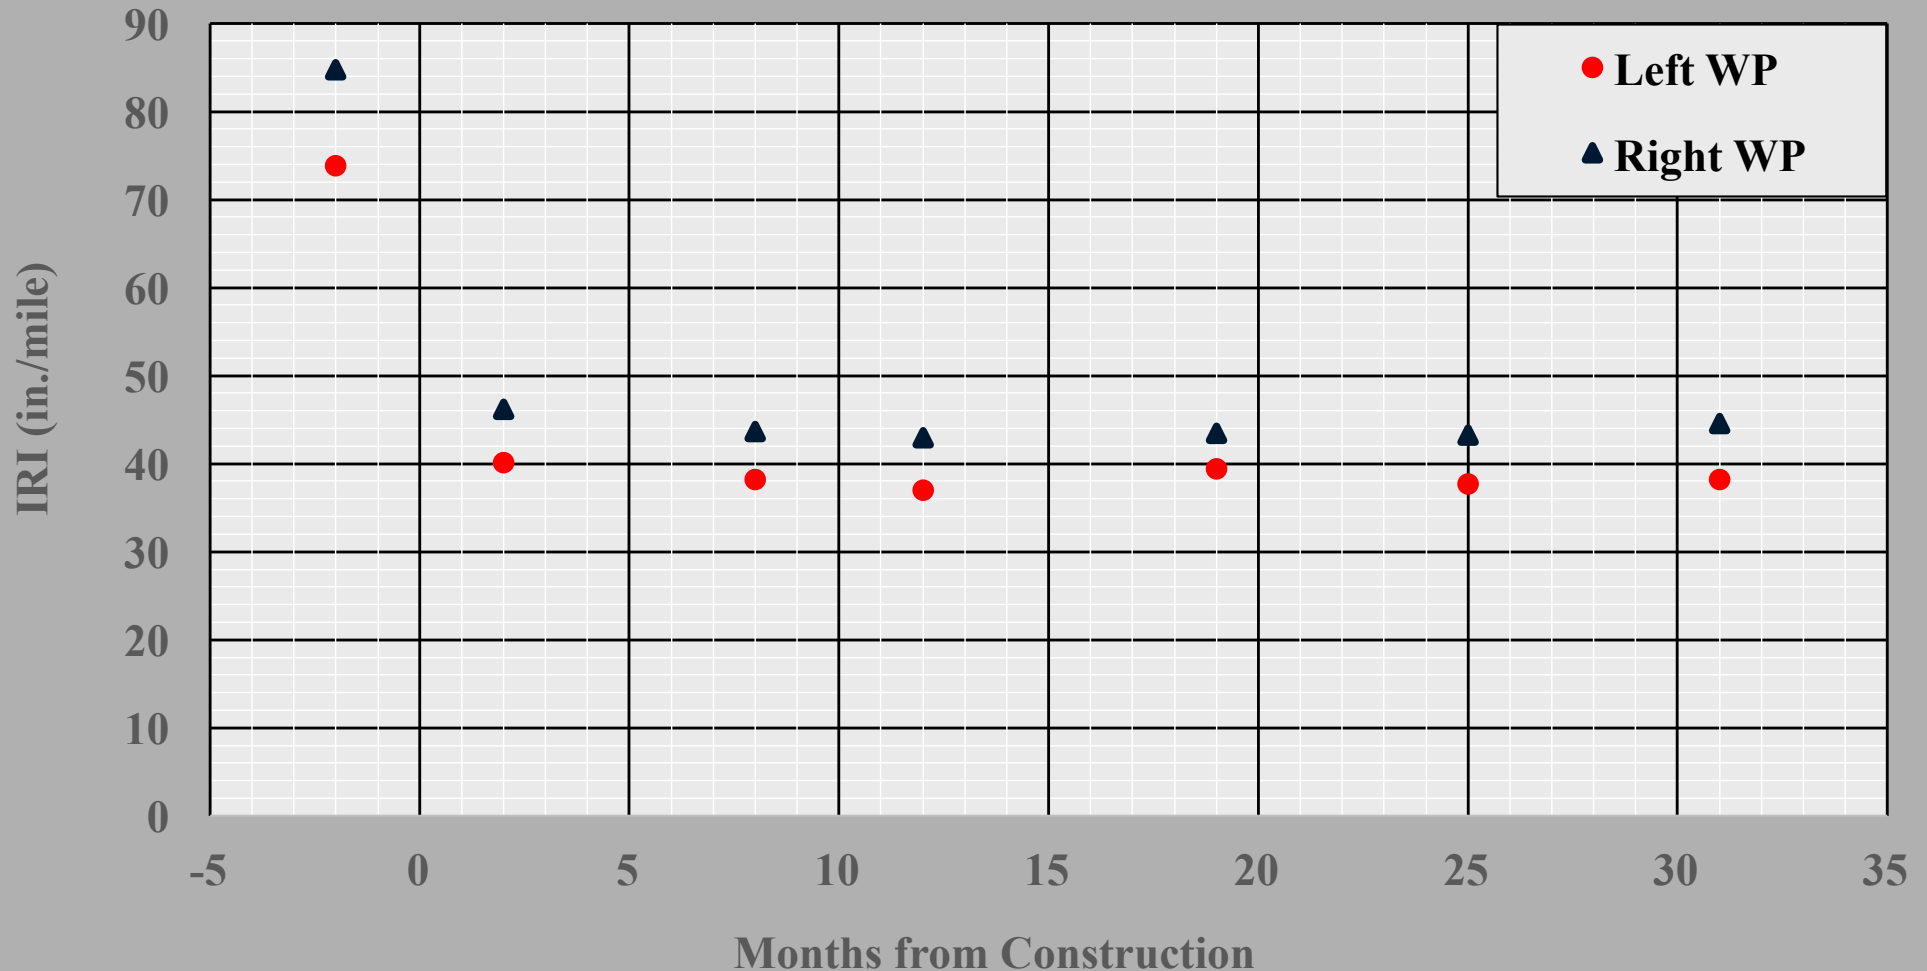
IRI vs. Month of Service  
SR220-Seg 10 North Passing Lane  
Constructed in September 2013
